FRIENDS OF BRANDY BOTTOM COLLIERY, PUCKLECHURCH

Newsletter N° 10, February 2016

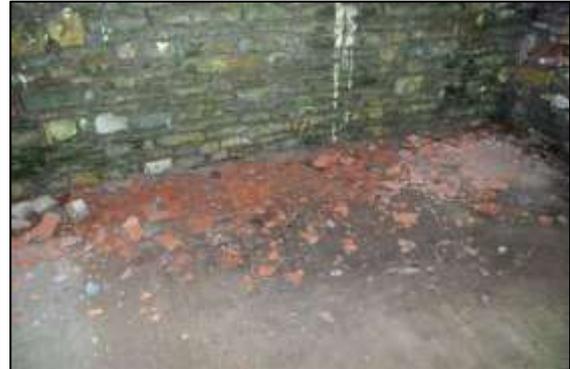
A waterproof membrane was laid on the roof of the Horizontal Engine House in November 2014, again by CWS Landscaping. This has stopped water percolating down to the roof, where it caused spalling of the bricks in frosty weather (photo right), and formed puddles on the floor. Now the building is dry inside, it can be used for the storage of construction materials, and also provide a shelter for the volunteers should it rain during a work party. Photos 29-31 show various stages in the clearance of vegetation from the roof and photo 32 the membrane in place.

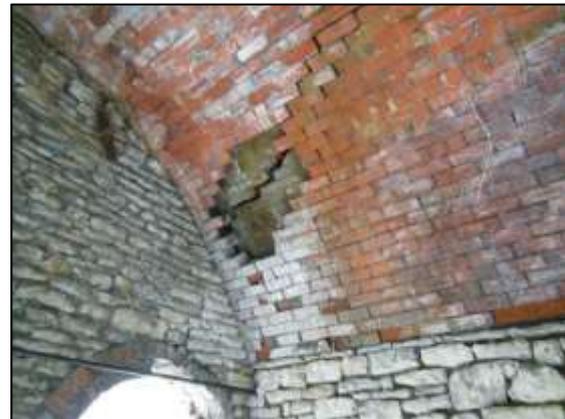
Tie rods in the Horizontal Engine House had been removed at some time in the past, possibly when a scrap metal merchant had been working on site. (From what we have been told by a passer-by, this was probably in the early 1960s as the adjacent mainline railway was still running.) The removal of the tie rods had allowed the walls of the building to move outwards, resulting in cracks appearing in the brickwork of the arched roof inside. New tie rods were fitted in July 2011 (photo above right), which have stabilised the structure. The outer (visible) layer of bricks in the arch had become detached in part of the eastern corner of the building (photo 6), and most of these bricks were replaced in 2013 (photo 7). This outer layer was secured to the inner layer of bricks by pressure grouting in May 2013. For some reason the two layers had not been bonded together when the roof was built.

Photo 6 – Eastern corner of the inside of the Horizontal Engine House. The dark area in the middle of the photo shows the area where the outer layer of bricks had fallen. Running through that area is a crack in the next layer of bricks.

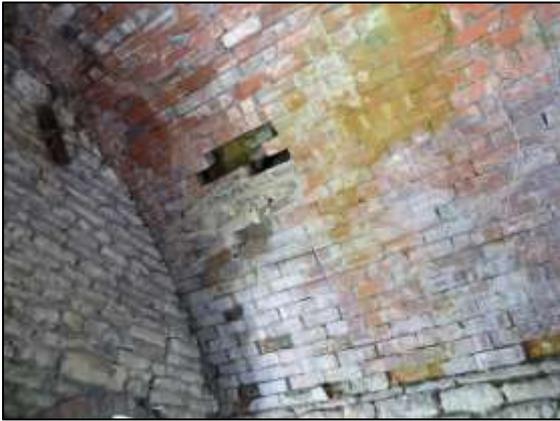
Photo 7 – Eastern corner of the inside of the Horizontal Engine House after most of the missing bricks had been replaced.

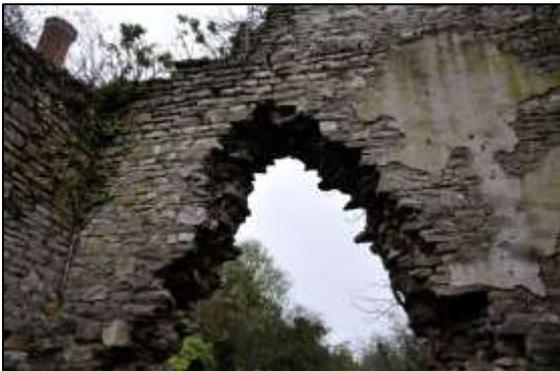
Photo 8 – The dogtooth gap of missing masonry in the north-east wall of the Cornish Engine House, taken from the inside of the building.

The first major piece of reconstruction work was the November 2011 rebuild of the north-east wall of the Cornish Engine House by CWS Landscaping. Two of the photos on this page show the wall before the rebuild started (middle photo) and afterwards (bottom photo). As well as rebuilding the wall to eliminate the dogtooth gap, the base of the wall was rebuilt, especially at the eastern (left hand side of photo) corner. Photo 8 is a close-up of the dogtooth gap before rebuilding started, taken from the inside of the building. Photo 9 is the same area during the rebuild and photo 10 the

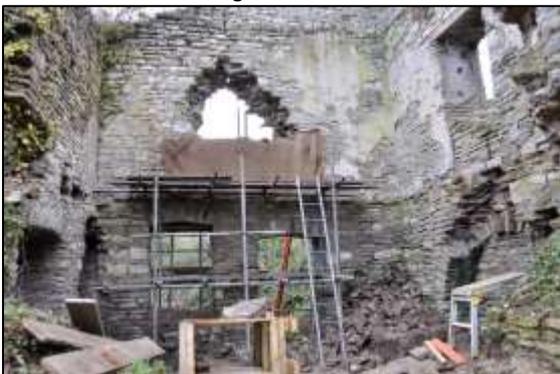
Photo 9 – The inside of north-east wall of Cornish Engine House during the rebuild ...

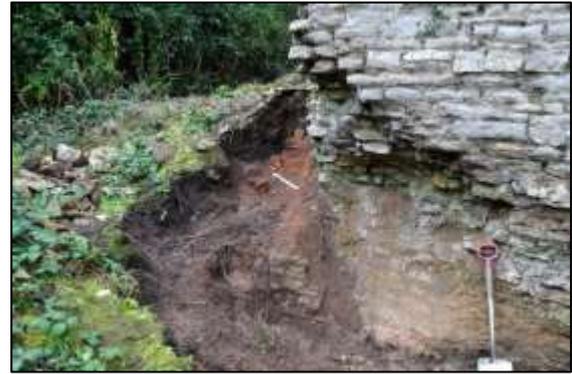
Photo 11 – Close-up of the eastern corner of the Cornish Engine House before rebuilding ... (1ft scale in centre of photo)

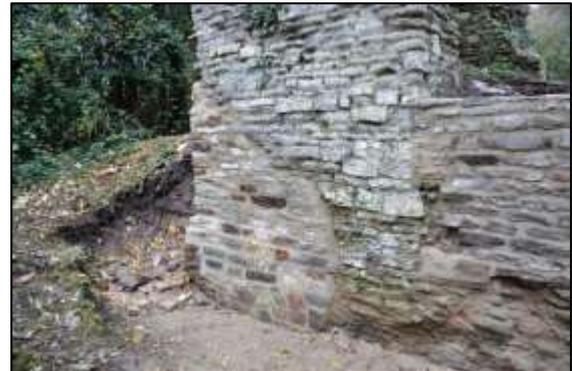
Photo 12 – ... and afterwards.

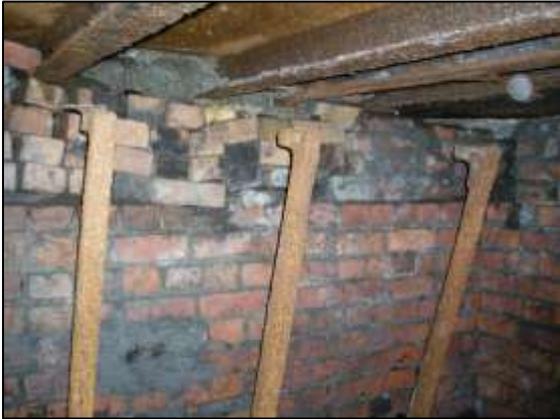
repaired by the Coal Authority, and one of shots is seen in photo 23. In it the brickwork supporting the concrete capping looks decidedly suspect.

Photo 23 – The underneath of the New Pit shaft capping.

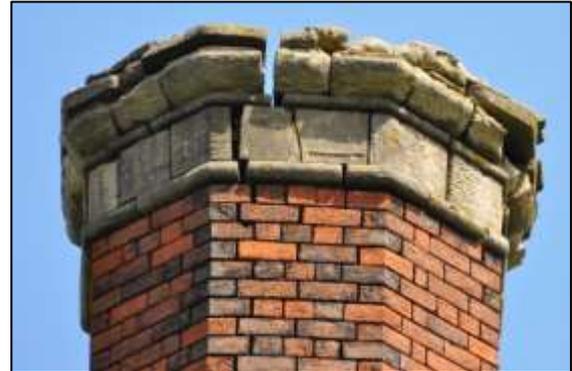
Conservation of the iconic chimney by CWS Landscaping started in 2014. Work progressed in stages, as each had to be completed before the specification for the next one could be drawn up for approval by Historic England. Before any work started, a bonfire was lit outside the entrance to the flue in January 2014. The natural draft up the chimney drew the smoke into the flue and out of the top (photo right). The first stage saw the installation of a ladder up the inside. But before that could be completed the brickwork at the top of the inside of the chimney had to be repointed, to provide a solid structure for securing the ladder (second phase). Only then could the top be inspected and the specifications for rebuilding the top agreed with Historic England. Gaps between the stones at the top were visible from ground level, but a close-up inspection showed they were caused by the loss of the mortar between the stones, and not by any displacement of the masonry (photo 26). In September 2014 the top was

Photo 26 – The top of the chimney in 2011 showing the poor state of the stone capping, and the gaps between the stones where the cement had crumbled away. (This and photos 27 and 28 were all taken from approximately the same spot)

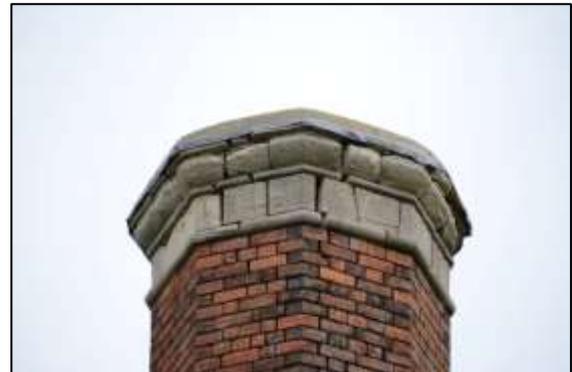
rebuilt, including the installation of the reinforced concrete ring which is bolted to the brickwork beneath it (photo 27). The fourth stage was to repoint the stonework at the top (photo 28), when it was noticed that the top 6 feet or so of brickwork also need repointing. That is scheduled for completion in February 2016.

Photo 27 – September 2014 after the top had been rebuilt, but before the ornate stone top had been reported...

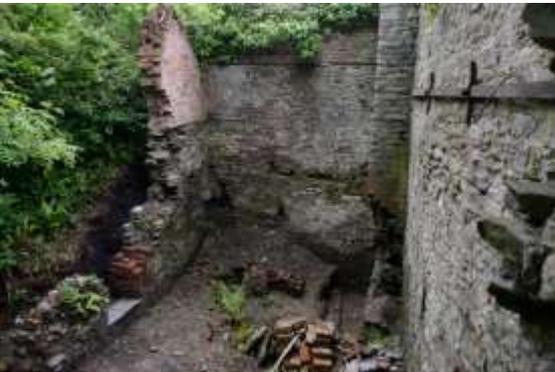
Photo 37 – The bulge in the north-east wall of the Old Boiler House can be seen in the left of the photo. This has been caused by pressure from material in the batch to its left.

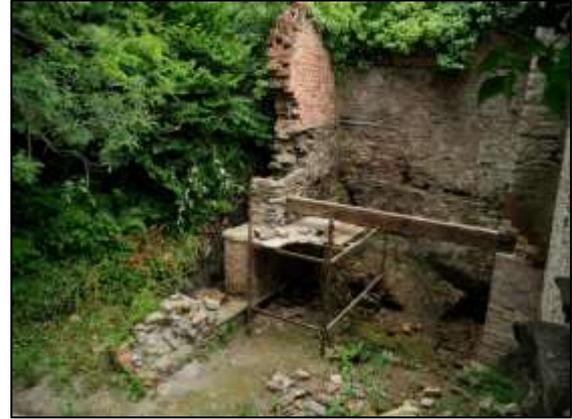
Photo 38 – Rebuilding of the north-east wall of the Old Boiler House in progress, with the bracing beam in place. The stone section of the wall has still to be built up to support the overhanging part of the brick section.

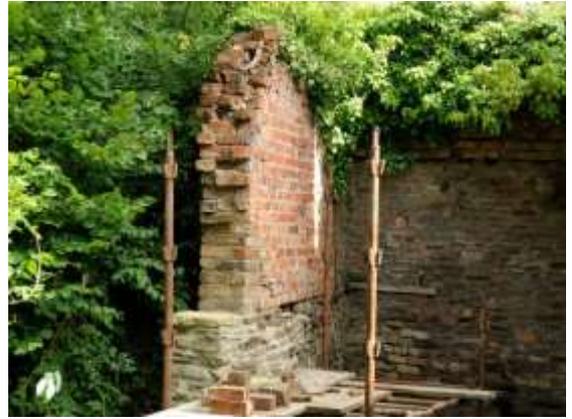
Photo 39 – Rebuilding of the north-east wall of the Old Boiler house almost complete.

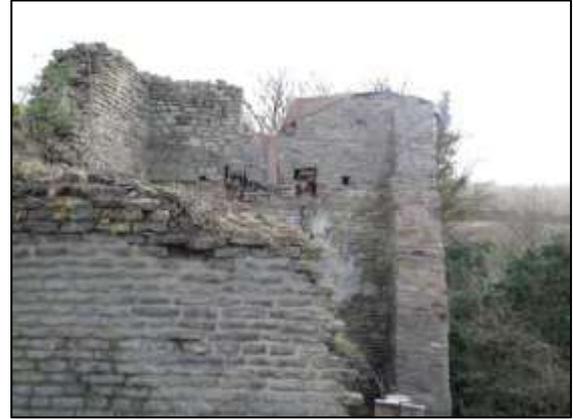
Photo 44 – Top of south-east wall of Cornish Engine House in background on 23 January 2016 after repairs to masonry of southern corner...

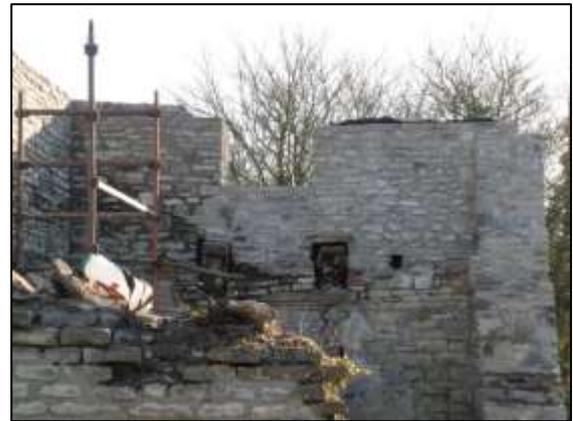
Photo 45 – ...and on 30 January 2016 when the whole of the top of that wall had been repaired.

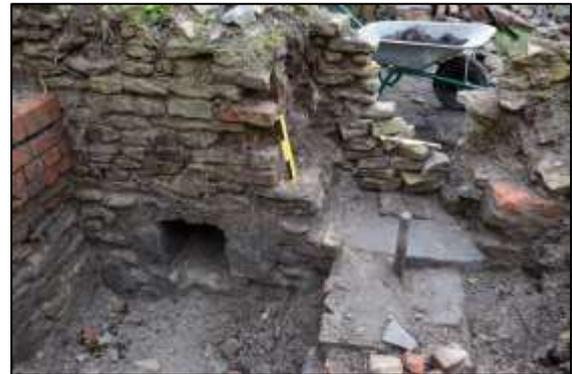
Photo 52 – Inside of south-east wall of Vertical Engine House before the rebuild started. The fireplace was located behind the remains of the holding down bolt, and the hole to its left is a channel through the wall. (30 cm scale)

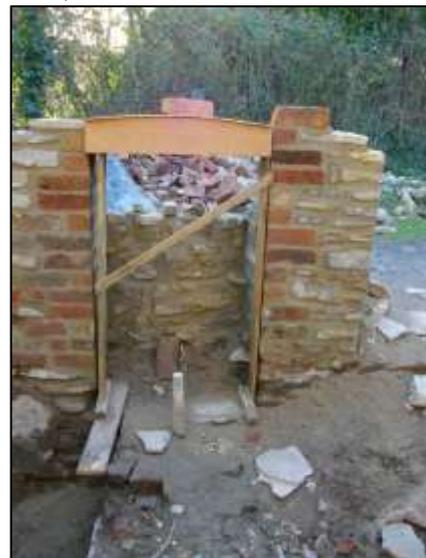
Photo 53 – A relatively early stage in the rebuilding of the south-east wall of the Vertical Engine House. (© K Kemp)

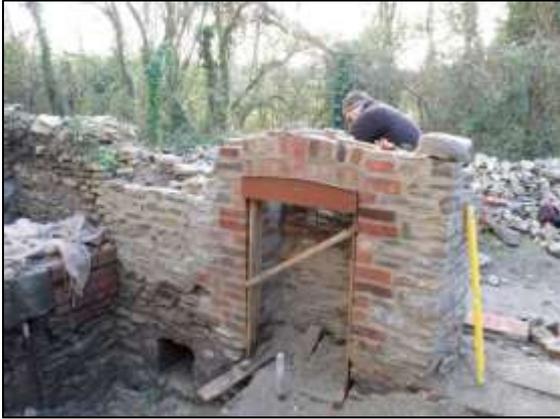
Photo 54 – The rebuilding of the south-east wall of the Vertical Engine House, and its inset fireplace, on 10 February 2016.

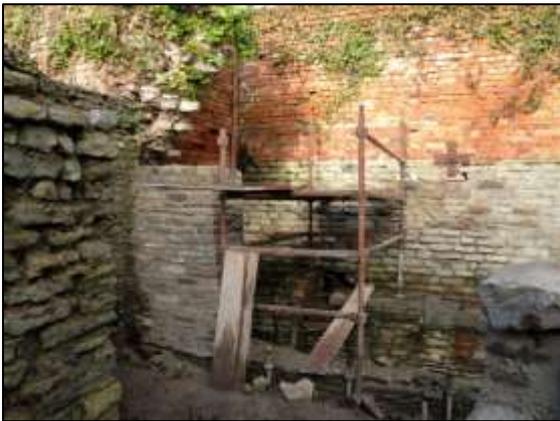
Photo 55 – Building of a buttress against the south-west wall of the Vertical Engine House in progress on 10 February 16.

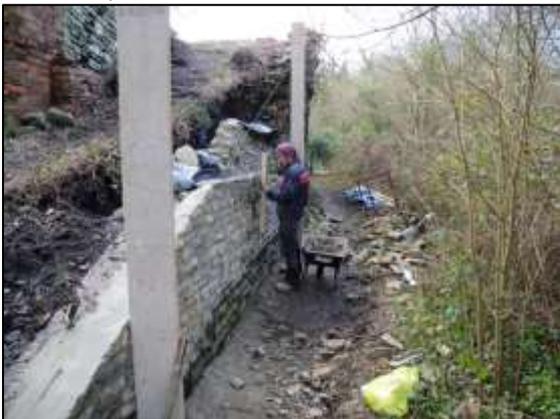
Photo 56 – Rebuilding the wall of the Old Pit heapstead ramp in progress on 10 February 2016.
