FRIENDS OF BRANDY BOTTOM COLLIERY, PUCKLECHURCH

Newsletter N^o 22, February 2019

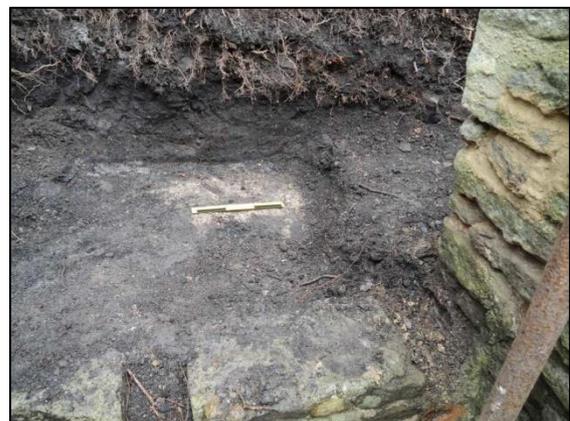
Repointing of the outside of the south-east wall of the Vertical Engine House continues, and a start has been made on repointing the eastern corner of the winding drum pit and the inside of the wall above the engine bed. However we have still to start on the major task of repointing the inside of the building. A path was cleared around the north-east end of the building to make it easier to get building materials to the winding drum pit. This has a secondary purpose of catching minor sloughs of materials from the batch before they fell into the drum pit. Most of the spoil removed along the line of the path was dark and full of coal, but a small section near the drum pit had been covered in a white layer of mortar (photo right, 30 cm scale).

Careful probing revealed that there was nothing solid below. Why the mortar was put there is yet another Brandy Bottom mystery, and the area has been covered up again for its protection.

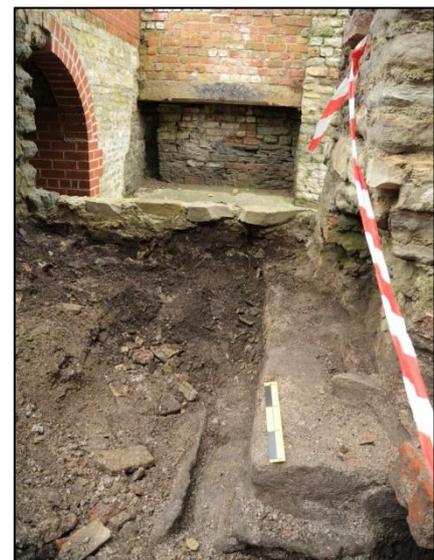
Spoil was also removed from the inside of the opening in the bob wall (photo right). Work here is still at an early stage, and the significance of the structures found has yet to be determined. For example there is a channel running towards the edge of the building, which can be seen to the left of the yellow/black 30 cm scale. (The light coloured stonework running across the photo marks the edge of the engine house. The Pumping Shaft capping and wall of the Old Pit heapstead, which can be seen in the background, are separated from the engine house by a passage.) Another structure whose purpose is as yet unknown is the semi-circular shaped groove found below the north-west edge of the engine bed (photo 15). Photo 16 shows the edge of the vault on the south-west side in the course of being excavated. This side is in a far worse condition than that of the vault on the north-east side. Here some

2 or more feet of brickwork has been lost from the inner edge. More spoil will have to be removed before it is possible to make an assessment of the conservation work required.

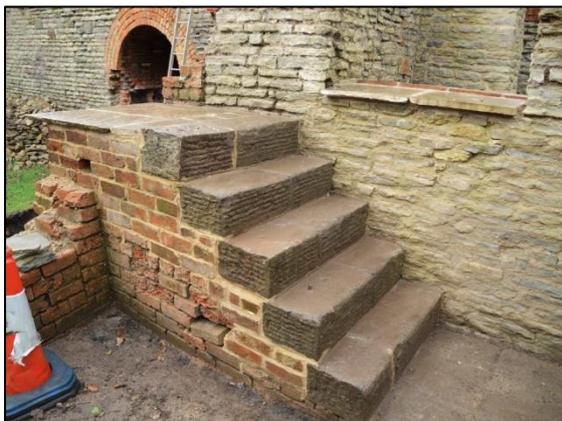
Photo 1 – Steps outside entrance to Vertical Engine House in January 2019. There is still some repointing to be completed on the brickwork at the bottom of the base.

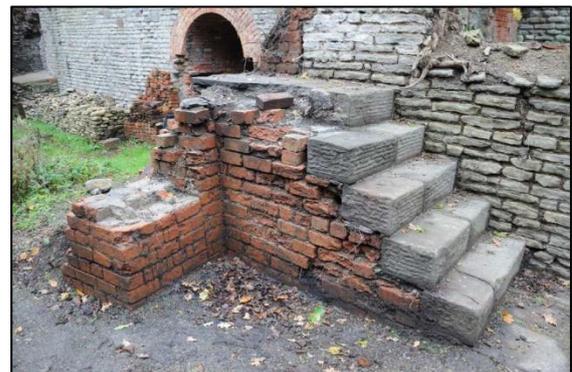
Photo 2 – For comparison, this photo was taken on 16 Nov 13, and shows the state of the brick plinth and steps shortly after excavation.

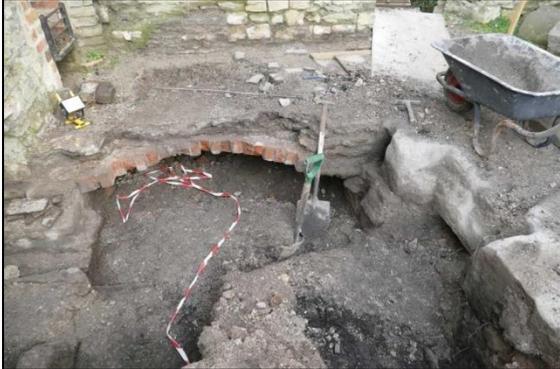
Photo 10 – The exposed edge of the brick arch on the north-east side of the building. The wheel barrow on the right is sitting on the engine bed.

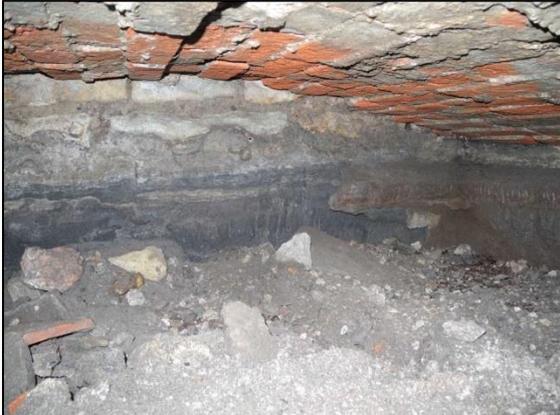
Photo 11 – View looking north-eastwards into the cavity seen in the previous photo. Note the shallowness of the arch.

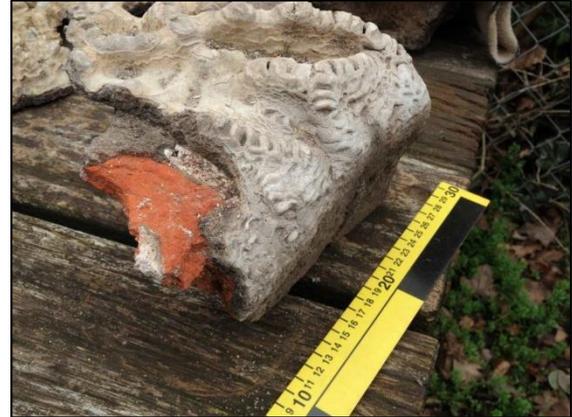
Photo 12 – This piece of the edge of the brick arch (BB 090219-2) was found in the top level of the spoil. It has been inverted for photography, and the rough lime scale deposit on the 'top' would actually have been on the underside of the arch. (30 cm scale)

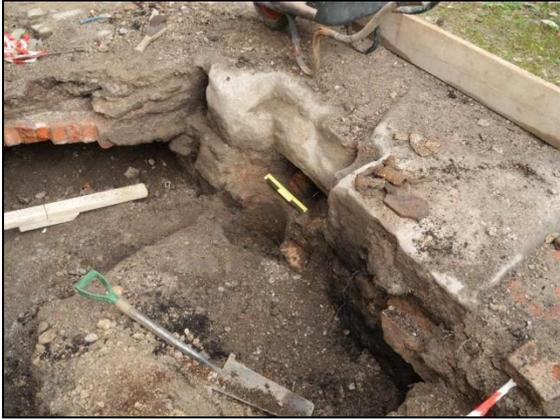
Photo 15 – Close-up of the engine bed area of the excavations in the Cornish Engine House. The bed is in the top right of the photo. Below it, and just to the left of the 30 cm yellow/black scale, is a semi-circular groove cut into the engine bed foundations.

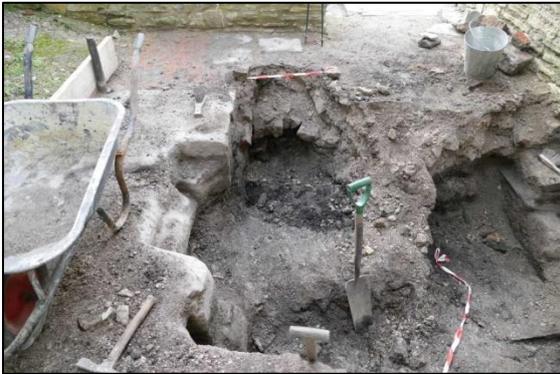
Photo 16 – View of the vault on the south-west side of the Cornish Engine House.
