FRIENDS OF BRANDY BOTTOM COLLIERY, PUCKLECHURCH

Newsletter N° 11, May 2016

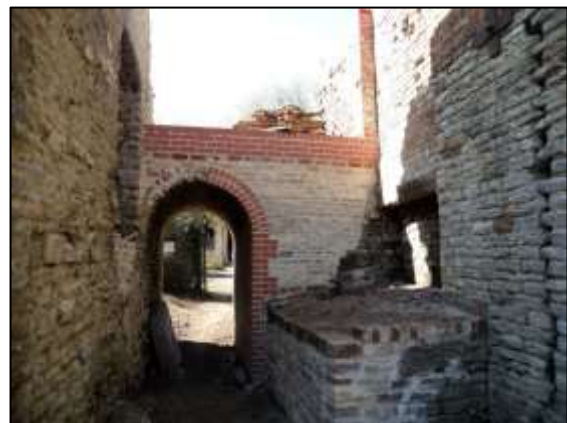
In the area of the Pumping Shaft, part of the inside of the passage, the masonry supporting the capping of the shaft itself, and the wall and platform above it have been rebuilt. The photo to the right shows the area after the rebuilding was finished, while the original state can be seen in photo 12. Photo 13 is a close-up, showing the parlous state of the masonry below the concrete capping with all of the front face missing, while photo 15 was taken after the rebuild. When the masons removed the flagstones from the platform above the passage, prior to relaying them after the adjacent wall was rebuilt, they uncovered a stone-lined shaft (photo 19). Its position is marked in photo 18, and its purpose is one of the many things that have still to be determined. In photo 20, taken from the Cornish Engine House end, the wall has been rebuilt and the flagstones have been re-laid, however the area around the stone-lined shaft has still to be finished.

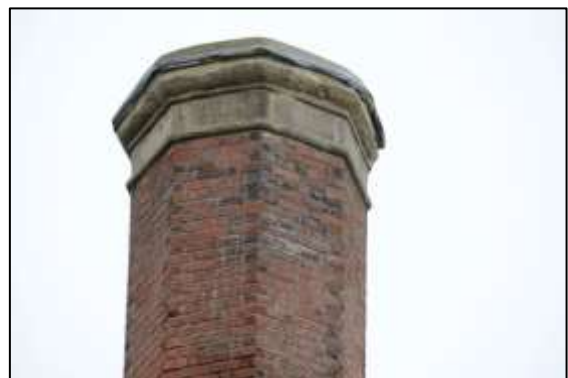
The top of the outside of the chimney was repointed at the end of March (photo right). This photo was taken from the same position as photos 26-28 in Newsletter N° 10.

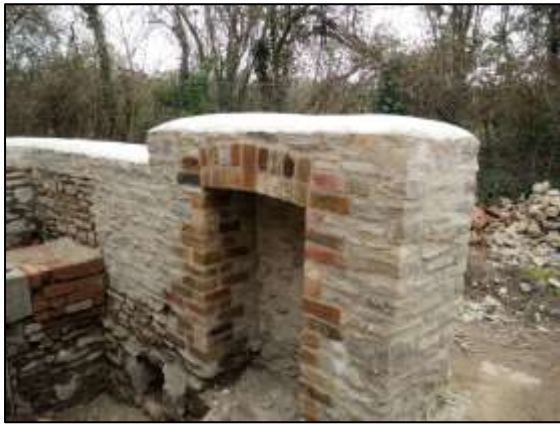
wall of the Vertical Engine House and the brick top of the Old Pit heapstead. The two walls were must have been built at different times as they were not keyed together. Photo 2 shows the inside of the south-east wall of the building around the fireplace after rebuilding and capping.

Photo 1 – Close-up of the top of the finished buttress in the Vertical Engine House, showing the gap between the original wall of the engine house and the brick top of the heapstead.

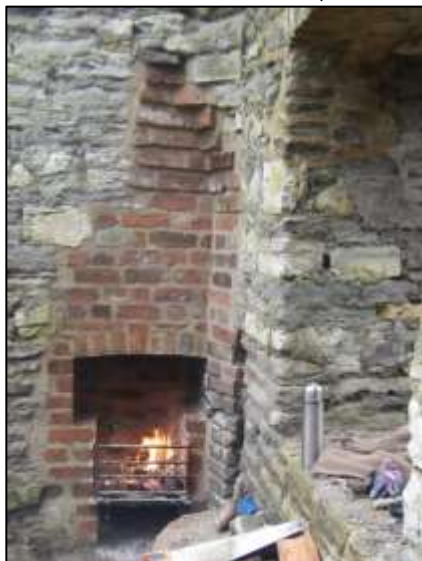
Photo 8 – Fireplace in northern corner of the Cornish Engine House before reconstruction ... (30 cm scales)

The fireplace in the northern corner of the Cornish Engine House has been rebuilt, and photos 8 and 9 are 'before and after' photos of that corner. The keystone of the arch above this fireplace has, like the one in the Vertical Engine House, been marked "AIBT 2016". Photo 9 was taken on a cold wet day in early March, hence the fire. The next two photos show the inside of the bob (north-western) wall of the engine house. The first, photo 10, was taken in July 2014 and shows how little of the left-hand end of the wall remained to support the weight of the masonry above the arch. The second, photo 11, shows the area after the supporting buttress was built.

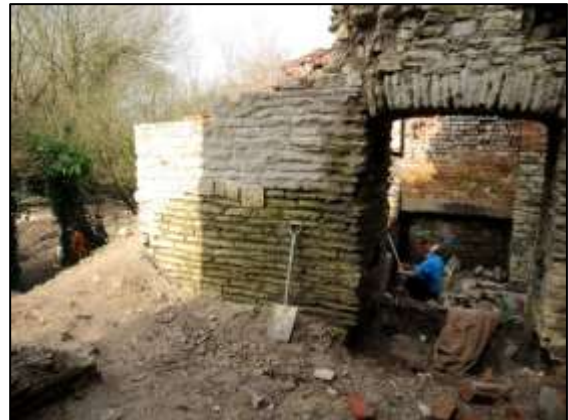
Photo 10 – Inside of the bob (north-western) wall of Cornish Engine House in July 2014 before reconstruction started ...

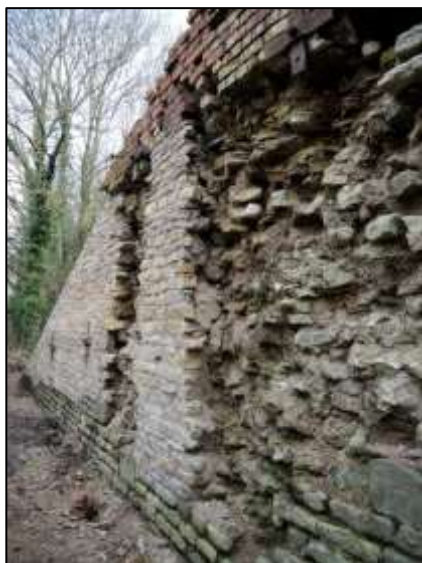
Photo 25 – A pillar is being built upwards to support the brick top of the north-western wall of the Old Pit heapstead.

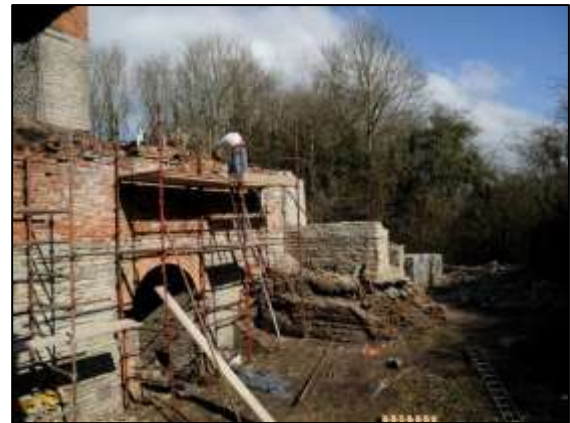
Photo 27 – The south-eastern wall of the Old Pit heapstead in June 2013.

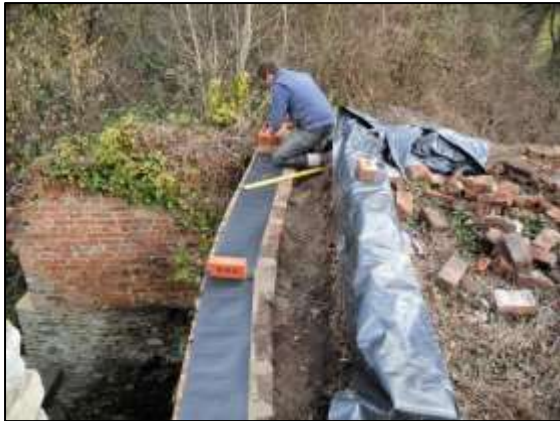
Photo 30 – A section of top of the wall of the Old Pit heapstead, located above the Old Boiler House, cleared of vegetation and ready for recapping ...

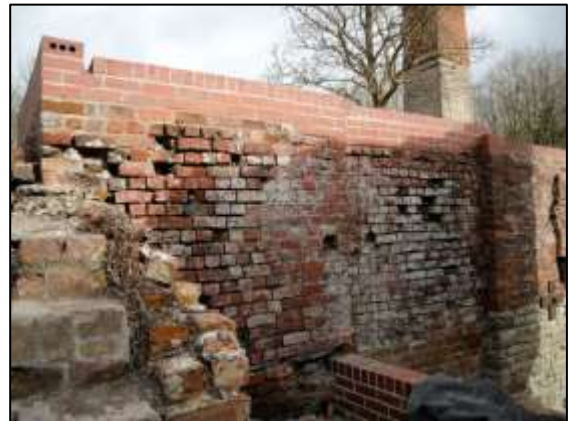
Photo 35 – The southern corner of the Old Pit heapstead in mid-March, before rebuilding started ...

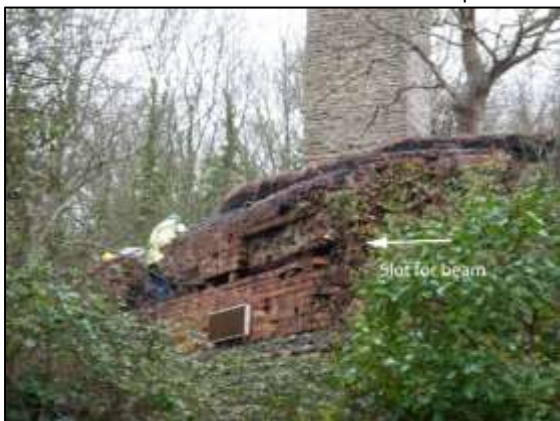
Clearing the vegetation from the top of the north-west wall of the Old Pit heapstead showed just how dilapidated the brickwork had become, with empty slots running along the length of the wall. Fragments of wood showed that these had once been filled with wooden beams. These had rotted away leaving the brickwork above the slots unsupported. This can clearly be seen in photo 38. Reclaimed sleepers have been inserted into the slots and the surrounding brickwork has been rebuilt. Photos 39 to 41 show various stages of the rebuild. Photo 42 shows the rebuilt southern tippler slot.

Photo 38 – The dilapidated state of the brickwork around the southern tippler slot before reconstruction started. The end of a slot which should have held a wooden beam can be seen in the centre of the picture.

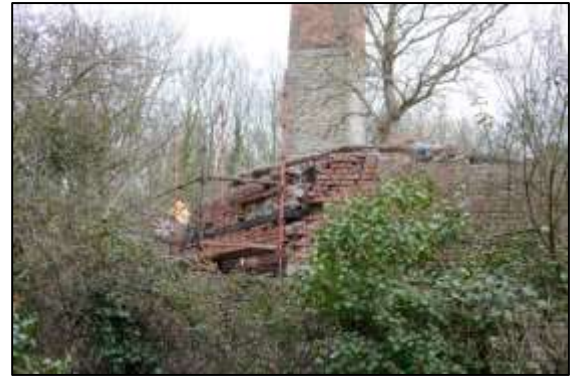
Photo 39 – The southern end of the north-western wall of the Old Pit heapstead, showing the gap in the brickwork where the wooden beams had been.

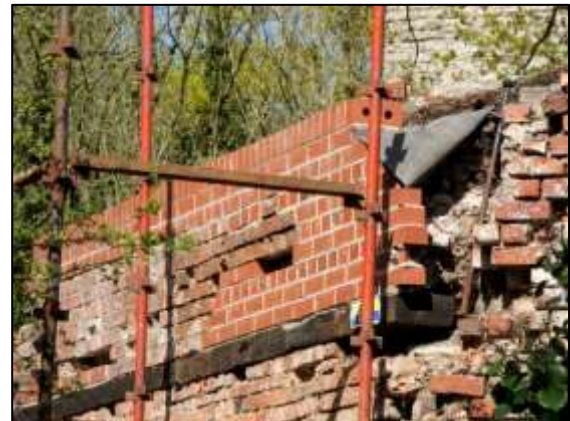
Photo 40 – The same area as the previous photo, with the replacement beams in place ...
