# FRIENDS OF BRANDY BOTTOM COLLIERY, PUCKLECHURCH

Newsletter N° 12, August 2016

## Progress: May – August 2016

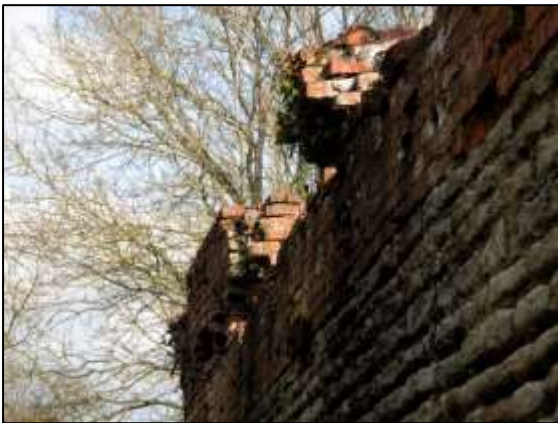
Photo 1 – North-west wall of Old pit heapstead from below, showing part of the brick pillar between the tippler slots balancing over the edge of the wall.

CWS Landscaping completed rebuilding the tippler slots (photo right) in May, topping the brickwork with wooden beams made from old railway sleepers. Some overhanging brickwork has been straightened, as can be seen by comparing the 'before' (photo 1) and 'after' (photo 2) views of this area. The masons have also completed repointing the outside of the octagonal section of the chimney.

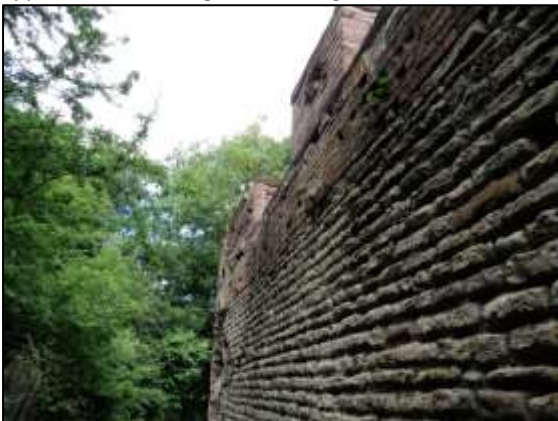
Photo 2 – the same stretch of wall after rebuilding was completed, with the pillar between the tippler slots at the top of the photo.

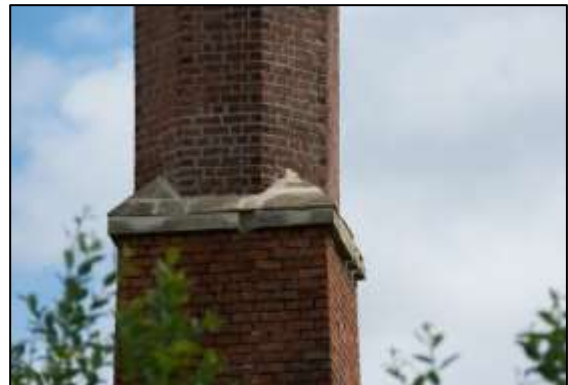
Photo 3 – The shaped stones on the shoulder of the chimney have been replaced in their original places.

They replaced the shaped stones on the top of the shoulder in their original positions (photo 3), and replaced some missing stones below the shoulder (photos 4 and 5). Photo 6 shows a mason at work on this part of the chimney.

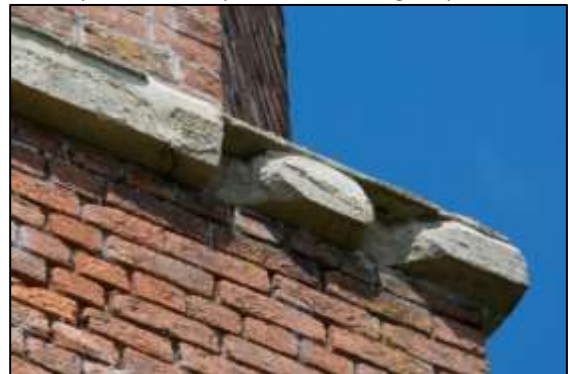
Photo 4 – Close-up of the south-east shoulder, showing where some stones were missing ...

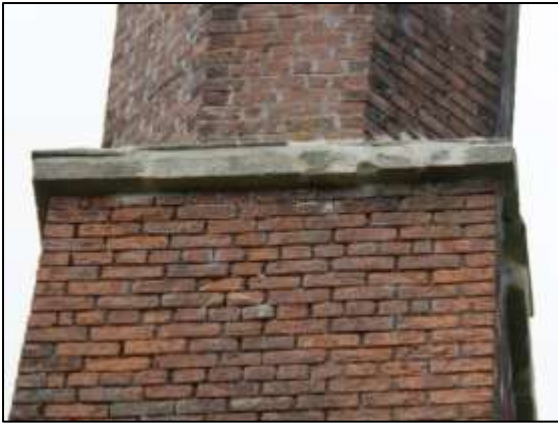
Photo 5 – ... and after the replacements had been pointed in.

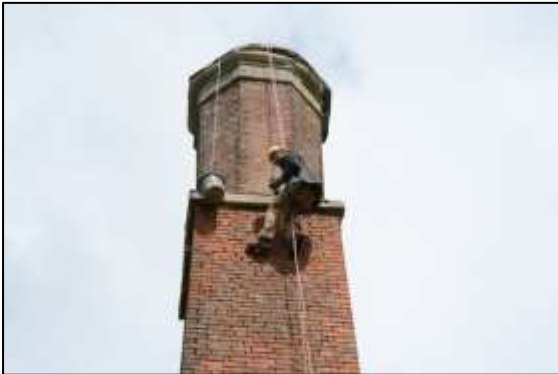
Photo 6 – Pointing in progress around new stonework at the shoulder of the chimney.

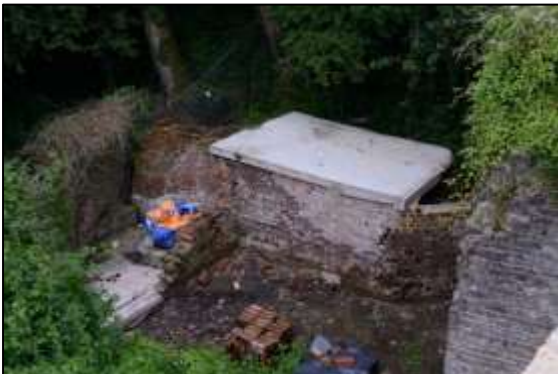
Photo 7 – Completed concrete roof over fan ducts in July 2016.

Once the masons had finished, there was a site clear-up that took several work parties to complete. One task was to clear new concrete from the northern corner of the Fan Engine House, which had been spilt while the new roof was constructed over the fan ducts (photo 7). The spilt concrete was successfully removed with the aid of hammer and broad chisel, without damaging the underlying floor. While working in this area we noticed that one of the original bricks of the fan duct walls had 'GS 17' inscribed into it (photo right). We still have to discover whether this is a piece of modern graffiti, or whether it was inscribed by a mason with the initials 'GS' when the fan ducts were

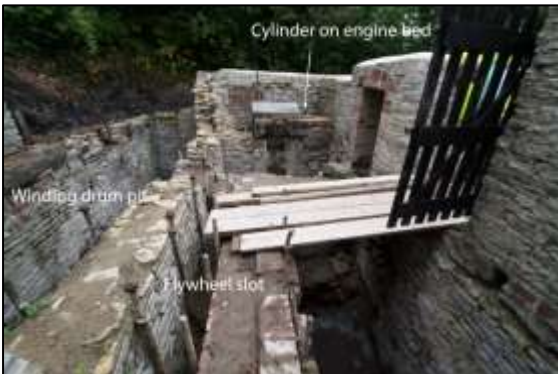
Photo 8 – View of Vertical Engine House from the south-west, with the positions of the engine bed, flywheel slot

and winding drum pit marked. This is taken from a similar view point as the photo of the engine on page 2.

There has been much discussion about the layout of the engine in the Vertical Engine House. Current thinking is for a single cylinder at the north-east end, connected by an overhead beam to either gears or a crank at the other end of the bay. From there the drive went to a flywheel in the narrow slot and then to the winding drum. An example of this layout was photographed at the Think Tank museum in Birmingham during a BIAS visit to earlier this year (photo right, © K Kemp). The cylinder is at the far end of the overhead beam on the right. The other end of the beam is connected to the gear in the right foreground, while the flywheel can be seen in the centre of the photo and the final drive gear is on the left. Photo 8 is a view of the Vertical Engine House from a similar sort of viewpoint as that of the Birmingham photo – the south-western wall gets in the way of a true comparison photo.

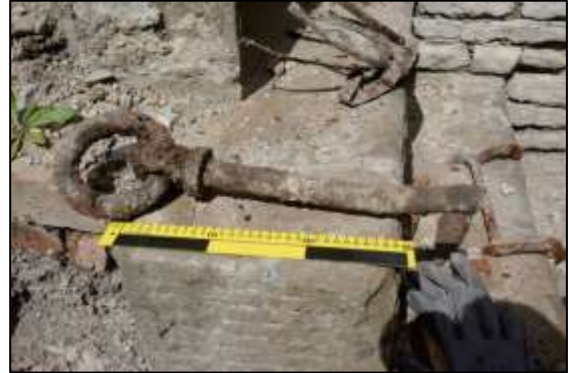
Photo 9 – 15" long eye bolt with a 5½" diameter ring at one end. The other end has been threaded. (30 cm scale)

More spoil has been removed from the engine bed bay of the Vertical Engine House. A layer of sooty spoil was uncovered near the bottom at the south-west end, containing several stones covered in soot which could be easily rubbed off (photo 17). A 21" wide, 1½" thick metal plate was uncovered spanning the width of the bay in early August. At present its purpose is unknown, but may be discovered at a later date. A considerable quantity of good building stone has been recovered, and the height of the nearby stockpile has grown from a couple of feet in March to the current 5 feet at its tallest point. Among the artefacts found is the 15" long eye bolt seen in photo 9. This has a 5½" outside diameter ring attached to the eye, and a 2½" long thread cut into the other end. Three similar 15¼" long bolts have been found, one of which can be seen in photo 10 before cleaning.

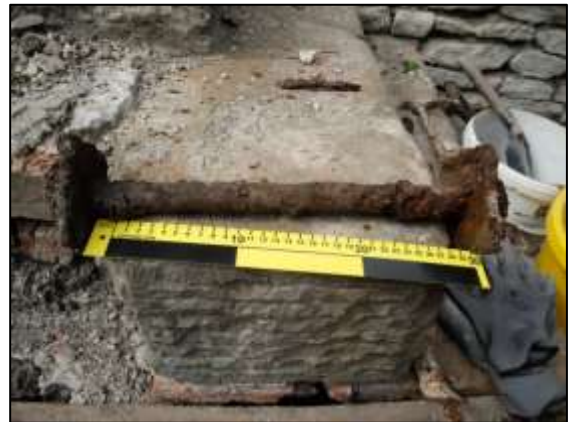
Photo 10 – 15¼" long bolt before cleaning. (30 cm scale)

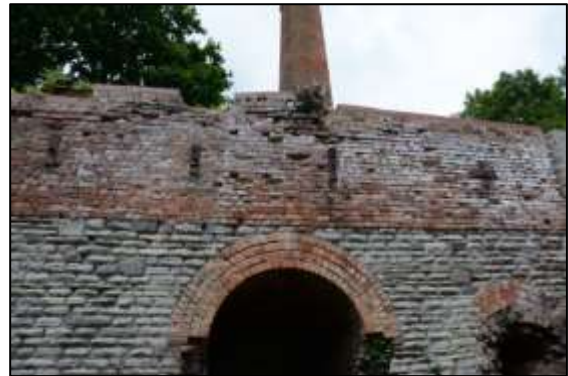
Photo 11 – South-eastern wall of the Old Pit heapstead, showing the position of the two spreader plates above the alcove.

Traces of old structures were spotted on the south-east wall of the Old Pit heapstead. The two spreader plates above the entrance to the Old Pit alcove are of a different pattern to most of the others around the heapstead. Photo 11 shows the position of these plates, while the photo on the right is a close-up of one. The remains of four studs and the mark of a ring around them suggest that the plate was used to support a structure over the boilers. There are also traces of a structure butting up to the masonry around the entrance to the East Flue (photo 12), in the form of shallow

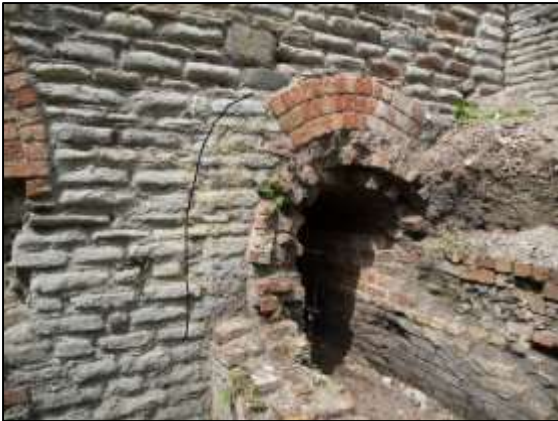
Photo 12 – The black line has been drawn around the outline of a possible structure around the entrance to the East Flue (see text).

depressions in the masonry of the heapstead wall. These traces are hard to see in real life, let alone in a photograph, so a black line has been drawn on the outside as a guide.

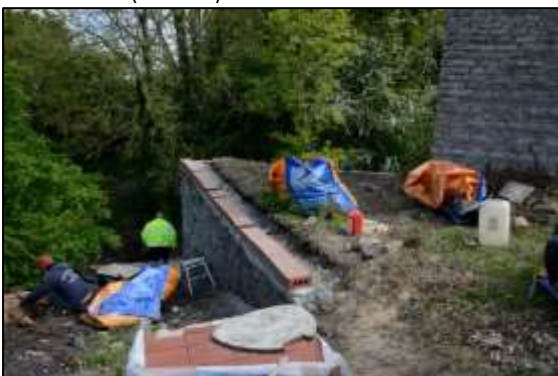
Photo 13 – Capping of the wall above the Old Pit heapstead ramp almost complete on 14 May 16 ...

It is amazing how quickly nature tries to reclaim the site. Photos 13 and 14 were taken a month apart, and show the bracken growing along the section of the Old Pit heapstead wall above the ramp. As a result the strimmers have been in action at several work parties. Cutting back the invasive species has allowed wildflowers to recolonise the top of the Old Pit heapstead.

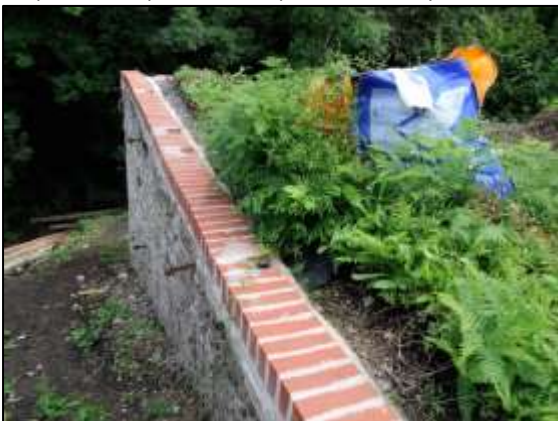
Photo 14 – ... and the same area on 6 Jun 16 as the bracken threatens to take over.

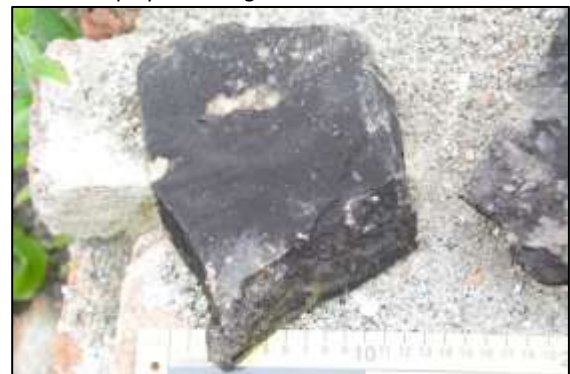
Photo 17 – Soot covered stone found in the Vertical Engine House. 30 cm scale just visible at the bottom of the photo.

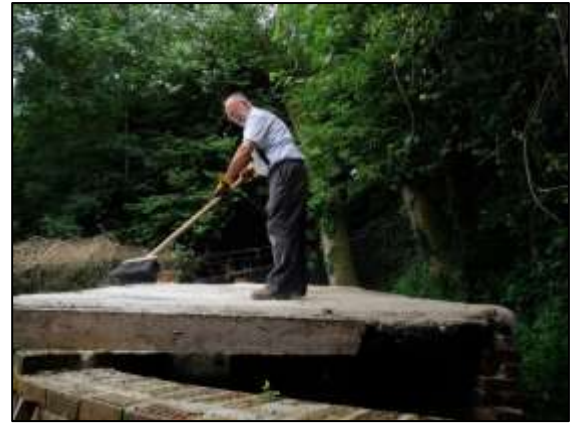
Photo 22 – Sweeping construction debris from the new roof of the Fan Ducts.

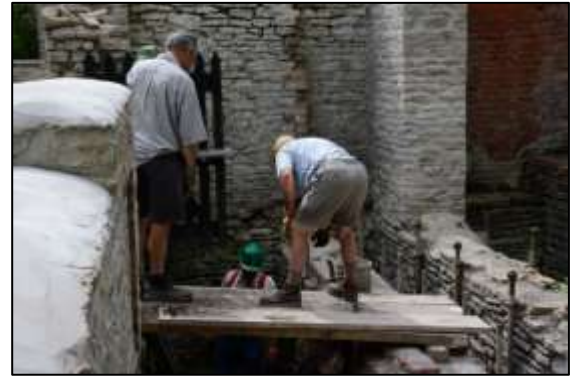
Photo 23 – Clearing spoil from the south-west end of the engine bay, Vertical Engine House ...

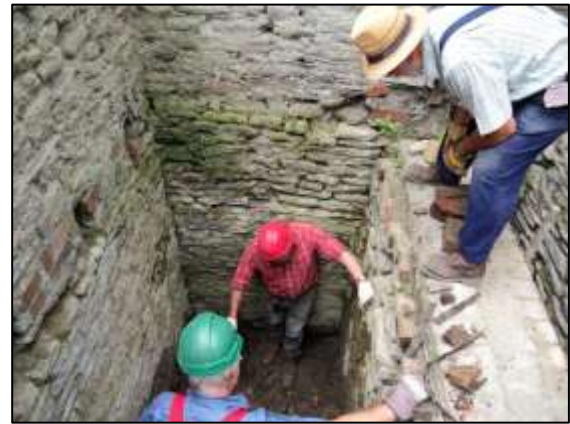
Photo 24 – ... and on 10 Aug when the excavation was much deeper.

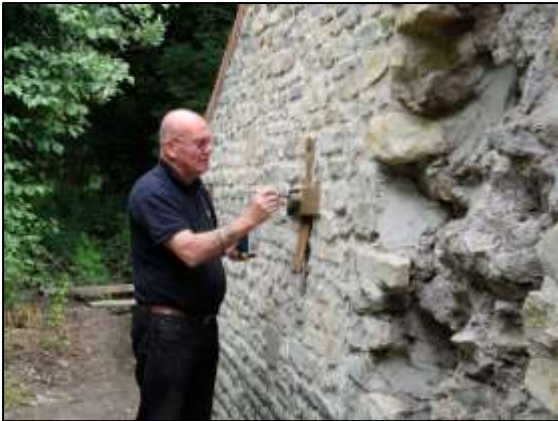
Photo 25 – Metal fittings on the Old Pit heapstead wall are given a protective coat of paint ...

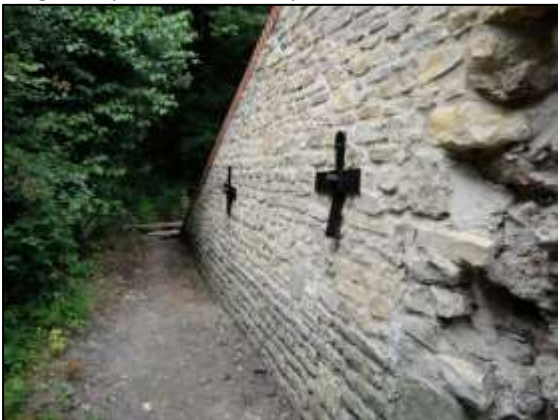
Photo 26 – ... and the finished result.
