# FRIENDS OF BRANDY BOTTOM COLLIERY, PUCKLECHURCH

Newsletter N° 13, November 2016

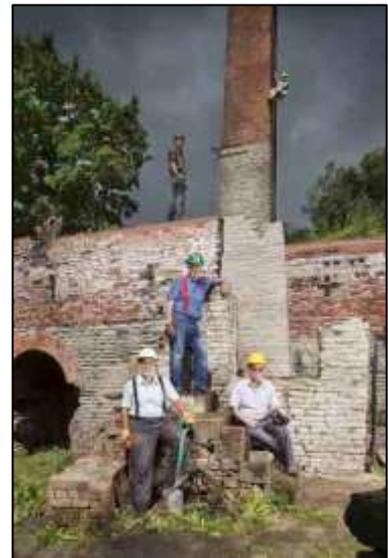
Brandy Bottom featured on the front cover of the South-west section of Historic England's 2016 *Register of Heritage at Risk*. It has been used as an example of a successful partnership between Historic England and other organisations, which could lead to the site being removed from the register in the future. Its inclusion is recognition of the conservation work we are doing. The photo, seen on the right, was taken by a photographer from Historic England in July while the masons were working on the outside of the chimney and a work party was in progress. It is used here by permission of the photographer (Copyright Historic England Archive, James O. Davies).

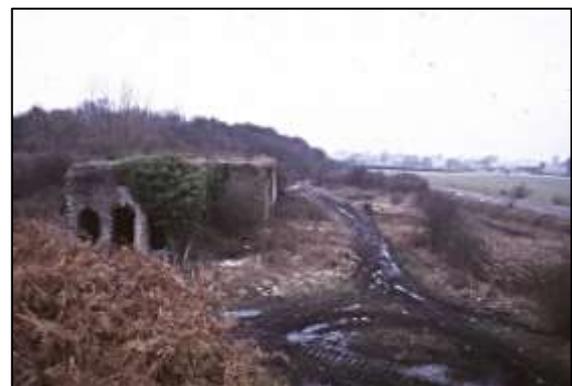
A SGMRG member unearthed some photos he took of Brandy Bottom in 1985, and has allowed us to use them – Thank you. They show: the Horizontal Engine House from the top of the Old Pit heapstead (photo right, © T Rendall); the Old Pit heapstead from a position to the west of the present cycle track (photo 1); and the now-ruined platelayers hut to the north of the site (photo 2). What is evident is how much the vegetation has grown in the 30-odd years since they were taken. In photo on the right there is no sign of the willow that now stands near the northern corner of the Horizontal Engine

House, or of the trees around the edge of the pond on the right of the photo. Photo 1 shows that

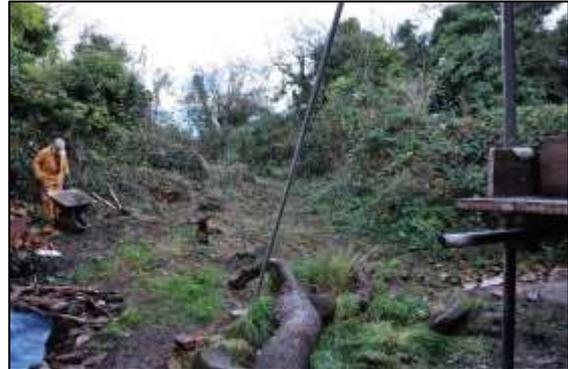
Continuing on the theme of what the site looked like in the past, photos 3 and 4 were taken in February 2012 and October 2016, and show the Vertical Engine House from the south-east. In the first the engine bed is hidden below a mass of spoil and rubble, as are the set of steps outside the entrance. The little that remained of the south-east wall is hidden by yet more spoil. In the second the wall to the right of the door opening has been raised during the rebuild earlier in the year. The opening is the flue for the rebuilt fireplace on the inside of the wall. The photo on the right was taken in November 2012 looking north-eastwards from the corner of the Cornish Engine House. It shows the mass of vegetation that has been slowly cleared since, and keeps on trying to return. The scaffolding on the right was used in the rebuilding of the north-east wall of the Cornish Engine House.

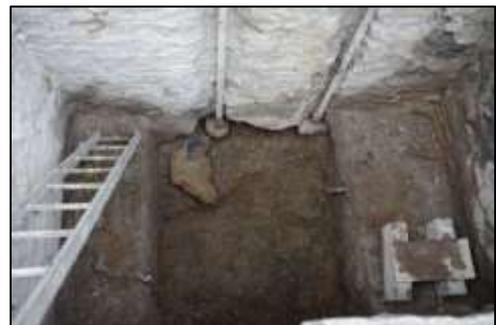
Spoil clearance in the pit below the engine bed uncovered the two platforms seen in the photo on the right. The pit is thought to have contained the condenser, which could have been supported on the platforms. Photo 6 shows an earlier stage of the excavation and photo 7 shows spoil removal in progress. In the bottom were the pieces of wood seen in photo 8, which may have come from the roof.

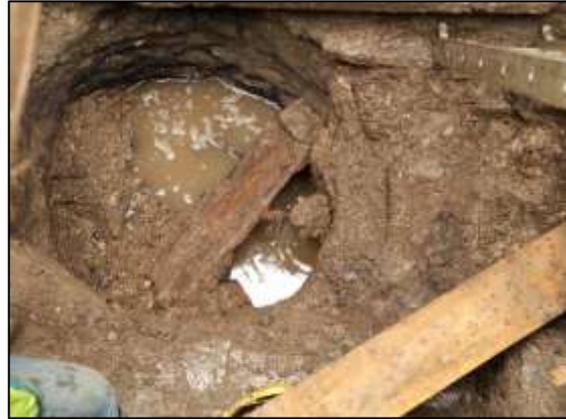
Spoil removal in the adjacent engine bay pit uncovered the large spanner seen in photo 15, and a well that could have been the hot well for the condenser (photo right). This photo had been taken at the end of a work party, when the water had been stirred up by the removal of spoil and artefacts. The water was a clear blue by the start of the next work party (photo 14), which deceived a couple of idiot frogs. They must have seen the water and jumped in without working out how they were going to get out of both the well and the surrounding pit. The first task of the work party was to rescue them. Hidden in the depths of the well were the iron guide seen in photo 16 and the cast iron bracket seen in photo 17. The baseplate of the former has  $\frac{3}{4}$ " wide slots to allow for some adjustment of the alignment, and the hole in the latter is tapered from  $1\frac{1}{8}$ " to  $1\frac{3}{8}$ ".

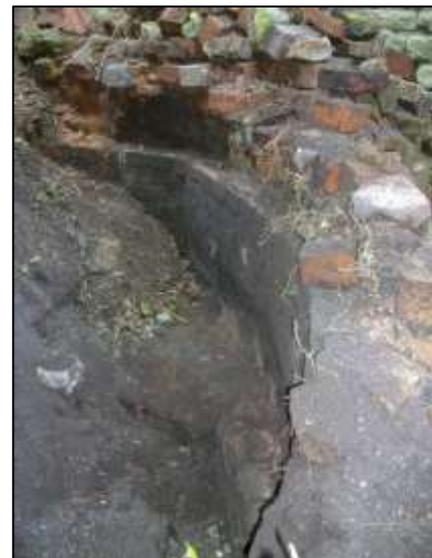
A chance decision in October to return to the outside of the south-eastern wall of the Cornish Engine House has uncovered a brick structure that may be associated with an egg-ended boiler (photo right, © K Kemp). Test pits were originally dug in November 2012 (photo 21), uncovering the traces of brickwork that can be seen in that photo, but these were covered up again as there were more important areas to work on. History is repeating itself here as it was decided at a steering committee meeting that further work in this area was a low priority.

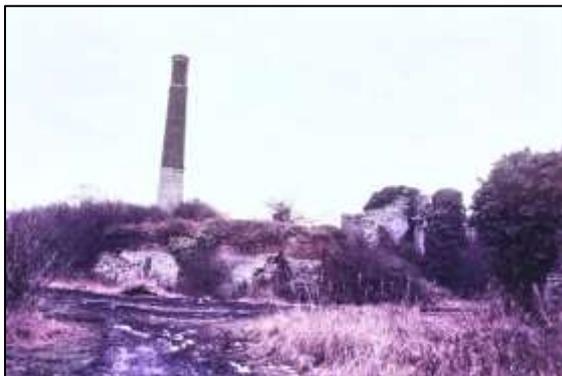
Photo 1 – Old Pit heapstead, with Cornish Engine House on the right. (© T Rendall, 1985)

the stone facing of the Old Pit heapstead had started to collapse before 1985, while photo 2 is of interest as it shows the chimneys of the Shortwood brickworks in the distance.

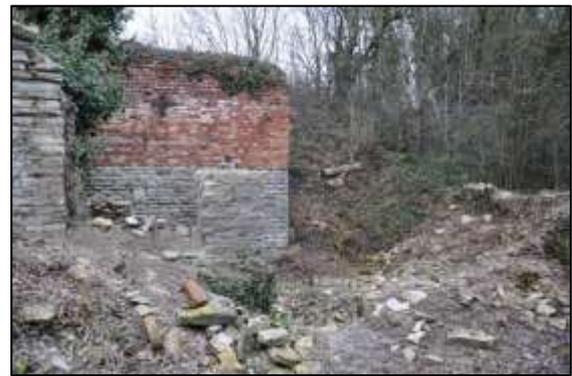
Photo 3 – The view of the Vertical Engine House from outside the south-east wall on 04 Feb 12 ...

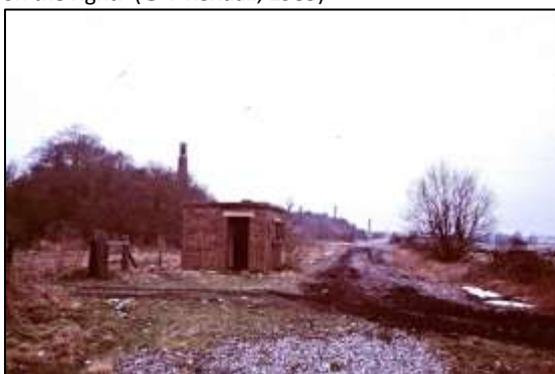
Photo 2 – View south along the line of the former railway, with the platelayers' hut in the foreground. The Brandy Bottom chimney can be seen to its left and in the distance the chimneys of the Shortwood brickworks are seen poking above the tree line. (© T Rendall, 1985)

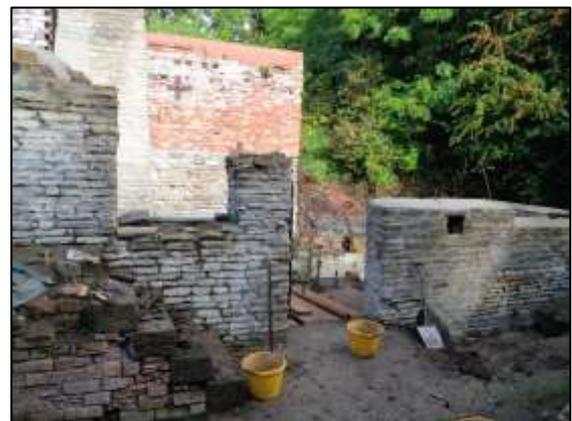
Photo 4 – ... and on 01 Oct 16.

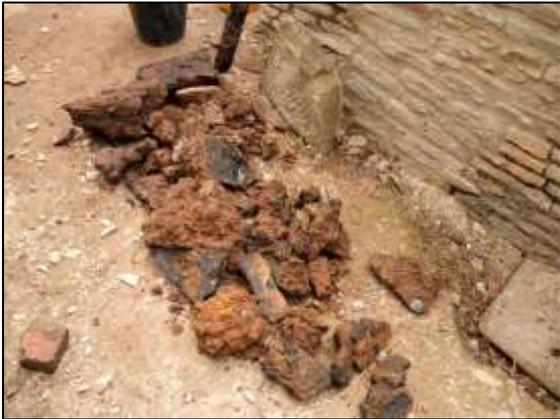
Photo 5 – A pile of metal artefacts covered in caked spoil, found in the pit below the engine bed in the Vertical Engine House.

Work has concentrated on removing spoil from the Vertical Engine House down to the original working surface. Initially the spoil was mixed with good building stone that had come from the now-collapsed walls, but at the bottom there was a rich lode of many metal artefacts. It is probable that they have lain there since the scrap metal merchants were working to clear the place of salvageable materials in the late 50s/early 60s. The artefacts may be the fragments of the machinery that fell to the bottom of the pits when the machinery was dismantled, and which the workers did not consider worth retrieving. Photo 5 shows a collection of objects recovered from the pit below the engine bed before they were freed from the caked spoil that was sticking to them.

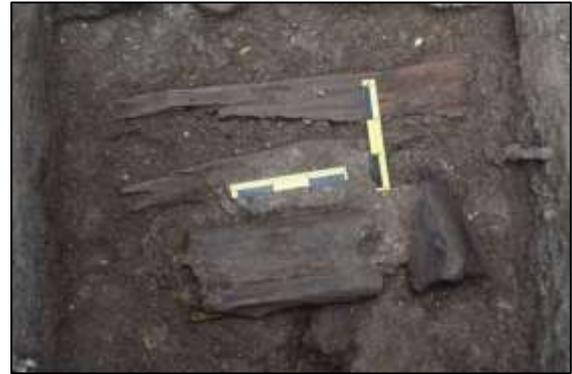
Photo 8 – Pieces of wood found at the bottom of the pit below the engine bed, Vertical Engine House. (30 cm scales)

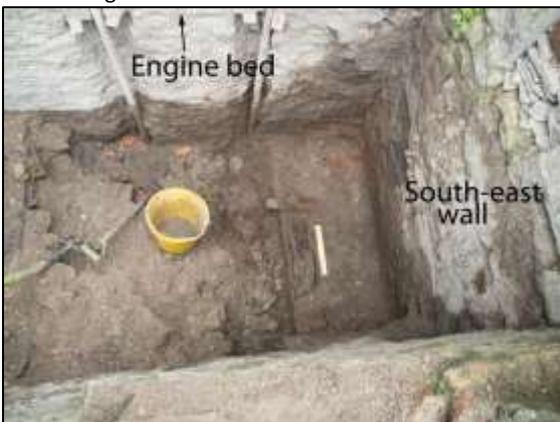
Photo 6 – Excavation of the pit below the engine bed in the Vertical Engine House has reached the level of the tops of the platforms. (30 cm scale)

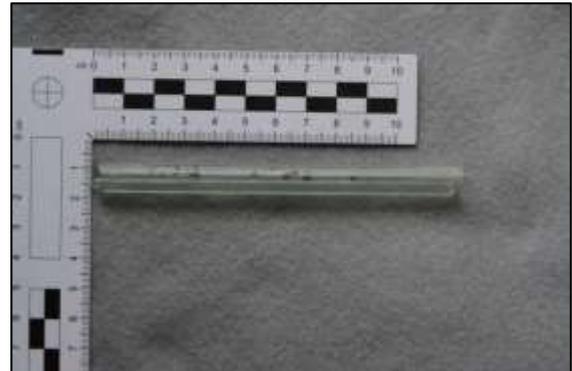
Photo 9 – 4¾" long piece of glass tubing that may have come from a manometer, found in the pit below the engine bed, Vertical Engine House. (10 cm x 10 cm scale)

The piece of glass seen in photo 9 may have come from a manometer used to monitor the performance of the condenser. This supposition is based on a reference in a reprint of an 1824 book<sup>1</sup> on steam engines, which describes James Watt using a manometer for that purpose. Other artefacts found here include the latch hook (photo 10), a bracket with a reinforcing rib (photo 11), and a 4½" long coach bolt and 4¾" long coach screw (photo 12). The coach bolt has a pronounced flat cut into one side of the head, with a less pronounced flat on the opposite side. The bracket is very similar in design to the one supporting one of the long holding down bolts on the outside of the

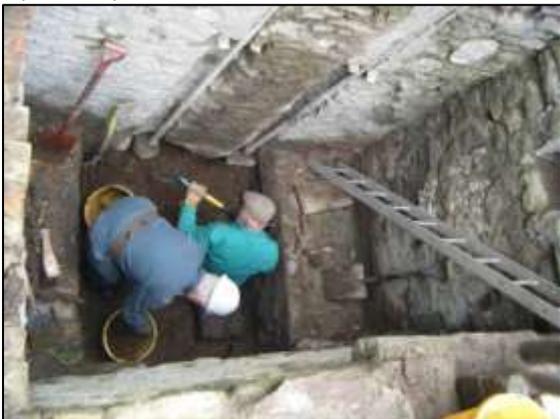
Photo 7 – Clearing spoil from the bottom of the pit below the engine bed, Vertical Engine House. (© M Taylor)

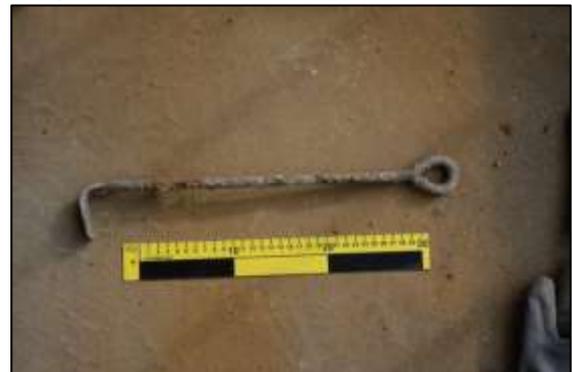
Photo 10 – 15½" long latch hook, found in pit below engine bed, Vertical Engine House. (30 cm scale)

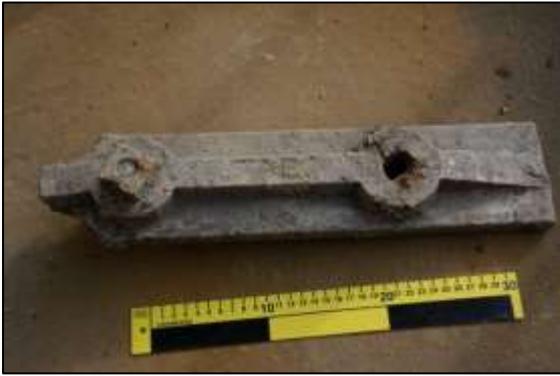
Photo 11 – Bracket found in pit below engine bed, Vertical Engine House. (30 cm scale)

south-west wall of the house, and may have performed a similar function for one of the bolts at the other end of the building. There have also been a number of nuts and bolts recovered. Some appear to have been handmade, for example the heads of some bolts are offset to the centre line of the bolt. Others, such as the hexagonal nuts, have been machine made.

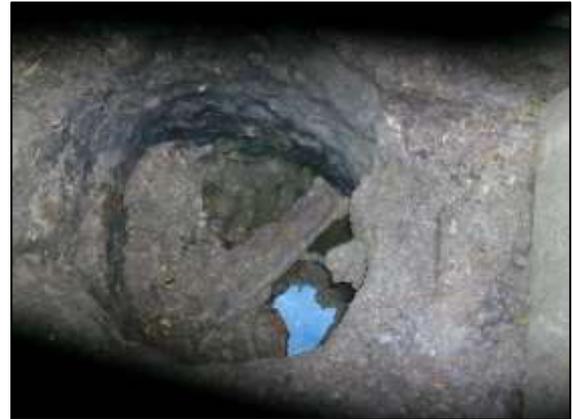
Photo 14 – Well in the engine bay pit, Vertical Engine House, at the start of a work party. (© K Kemp)

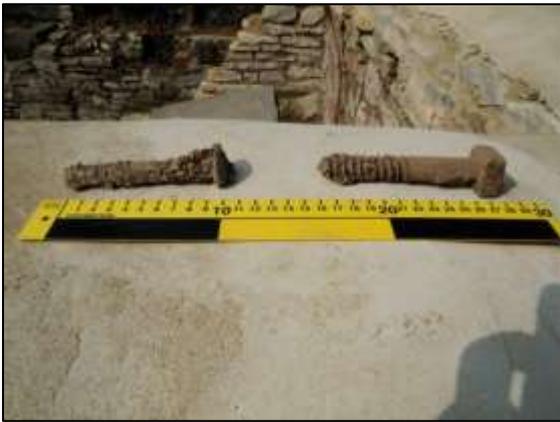
Photo 12 – A 4½” long coach bolt (left) and a 4¾” long coach screw found in the pit below the engine bed, Vertical Engine House. (30 cm scale)

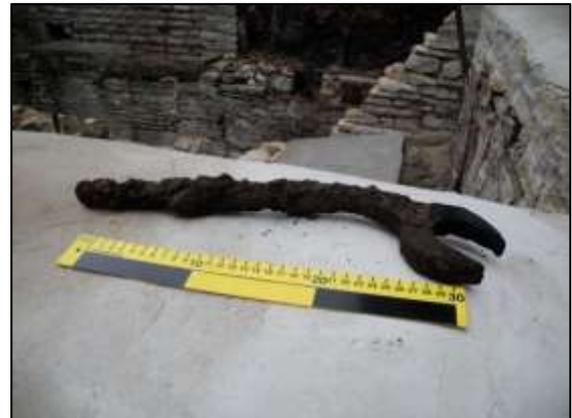
Photo 15 – 15” long spanner, with 1½” wide jaws, found in engine bay pit, Vertical Engine House. (30 cm scale)

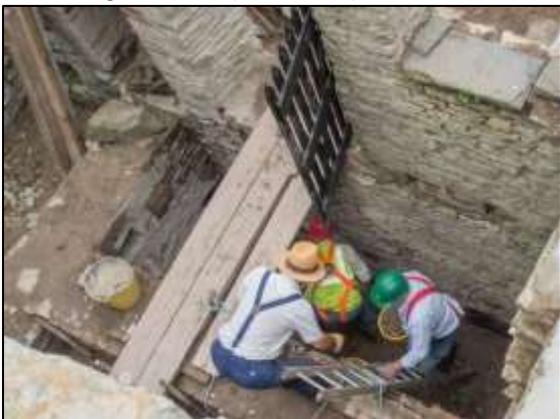
Photo 13 – Excavating spoil from the pit in the engine bay, Vertical Engine House.

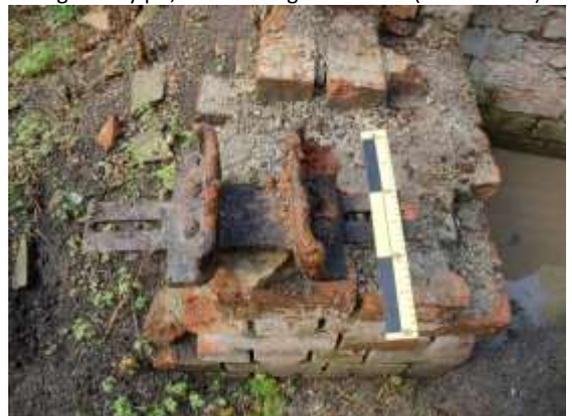
Photo 16 – Iron guide found in engine bay well, Vertical Engine House. (30 cm scale)

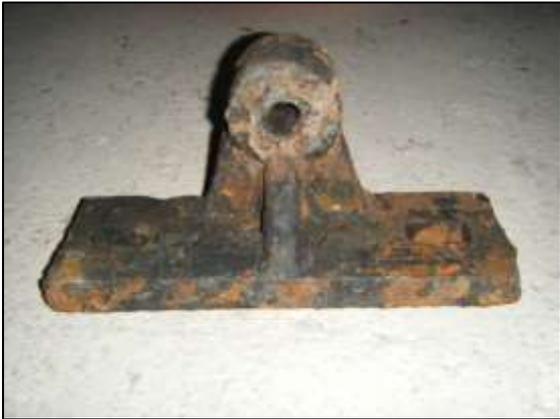
Photo 17 – Cast iron bracket found in engine bay well, Vertical Engine House. (© M Taylor)

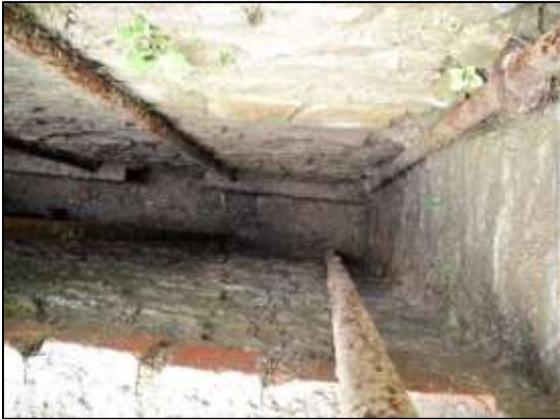
Photo 18 – North-east end of flywheel slot, Vertical Engine House, after the spoil had been cleared.

Spoil has been removed along the length of the flywheel slot, which has had to be done by the more 'slimline' volunteers as it is a tight squeeze. Photo 18 was taken looking down at the cleared north-east end, and shows the securing plates at the bottom of the holding down bolts. Among the artefacts found in the spoil were the 40" long lifting chain seen in photo 19 and the broken casting seen in photo 20. This looks as if it was part of a pulley, and has a shallow groove cut into the circumference.

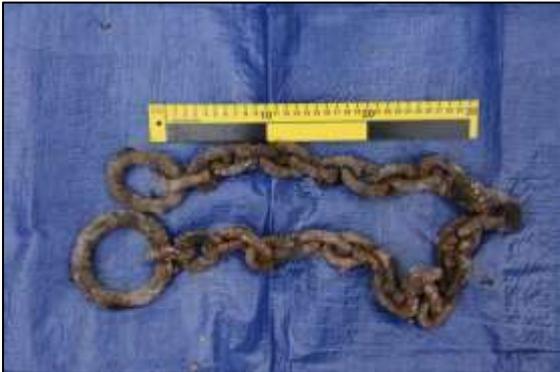
Photo 19 – 40' long lifting chain found in the flywheel slot, Vertical Engine House. (30 cm scale)

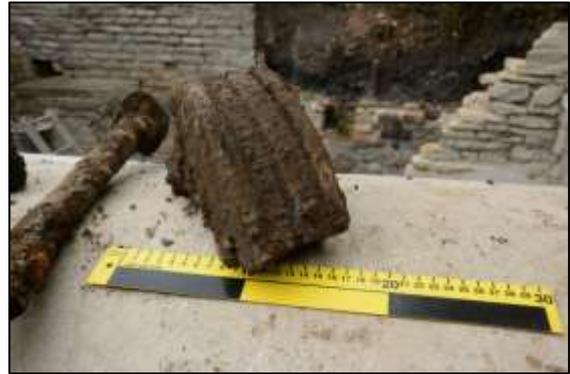
Photo 20 – Broken section of a casting, found in the flywheel slot, Vertical Engine House. (30 cm scale)

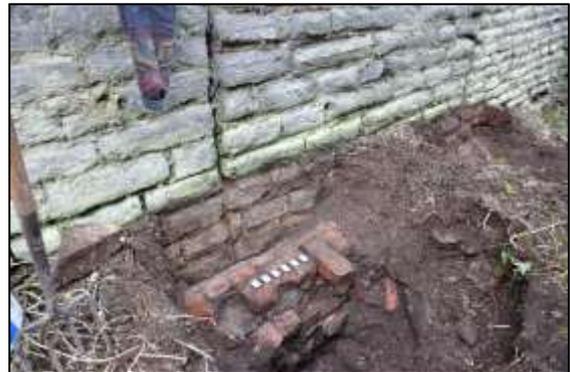
Photo 21 – One of the test pits dug outside the south-east wall of the Cornish Engine House in November 2012.

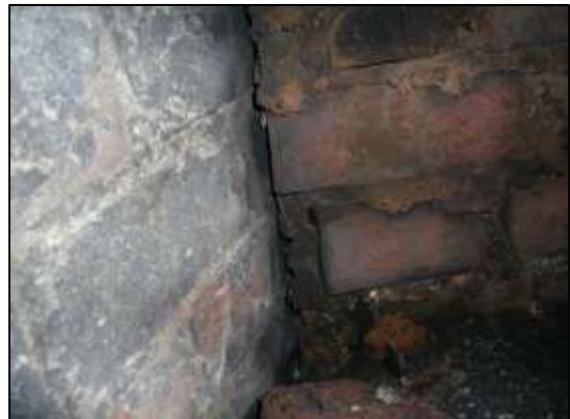
Photo 22 – View inside a cavity at the base of the north-west wall of the chimney.

Another attempt was made to see what lay behind a hole in the internal north-west wall of the base of the chimney, as the re-examination of a photo taken in September 2015 showed there was a small cavity behind the wall of the chimney. Photo 22 is a view of the wall opposite the entry, and it shows that the duct behind the wall has been blocked off at some time after it had been built. The effects of the hot gases on the surface of the roof bricks can be seen in another photo, which has not been included. While it would be interesting to investigate further, it is another of those jobs that has been put into the 'can be done when the important stuff is finished' category. The photography is a slow process, as it involves putting a hand and a small camera through the single brick-sized hole and using the point-and-pray technique – is the camera looking at something of interest and has it focused on it? If so, where was it in relation to the entry hole. If not, return to square 1 ...

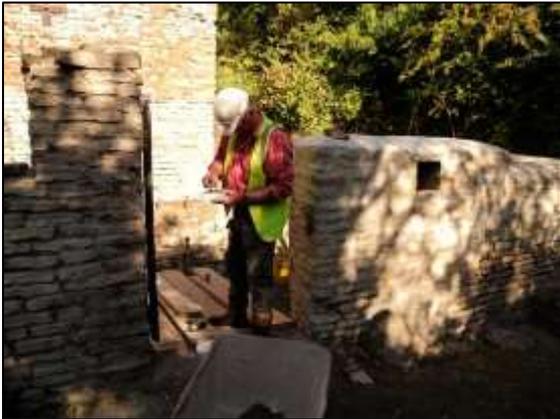
Photo 23 – Repairs being made to the gate into the Vertical Engine House after a visit by vandals.

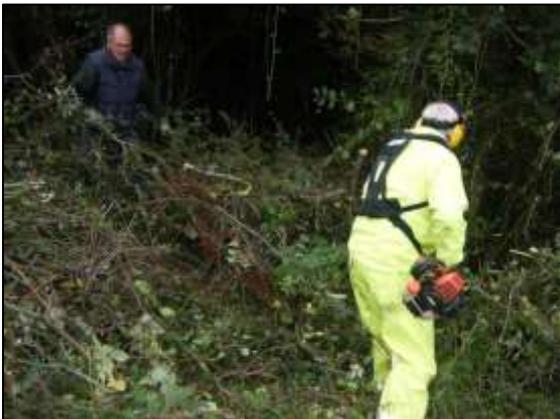
Photo 25 – Vegetation being cleared from the New Pit heapstead in October. (© M Taylor)
