# FRIENDS OF BRANDY BOTTOM COLLIERY, PUCKLECHURCH

## Newsletter N° 23, May 2019

### Progress: February - May 2019

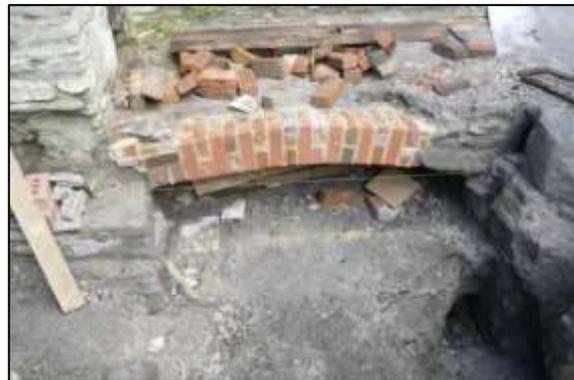
Work continued in the Cornish Engine House. The new arched edge to the north-east vault was completed (photo right). The original arched edge was one brick thick, but the new edge has been built double thickness for extra strength. Photo [1](#) shows this under construction. The brickwork of the arch of the vault on the south-west side was found to be in an extremely fragile state. As it lies on the main route to the inside of the engine house, it has had to be completely rebuilt on safety

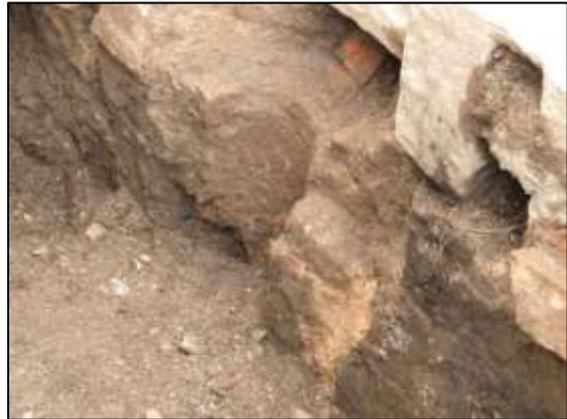
More spoil has been removed from the area just under the bed of the Cornish Engine House, uncovering what is a definite semi-circular channel in the masonry (photo right). (This feature had only been partly excavated by the time photo 15 in Newsletter N° 22 was taken.) This may have fitted round the exhaust pipe from the cylinder. The layout can be seen in drawings of that period, such as the facsimile of the Williams' Perran Foundry Co. catalogue<sup>1</sup> published by the Trevithick Society.

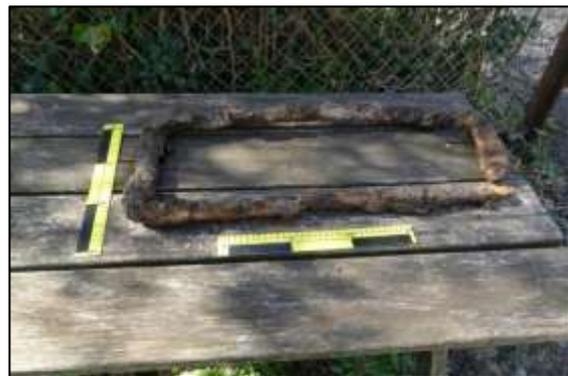
The metal frame seen in the photo on the right was found in the spoil of the engine house (30 cm scales). Measuring 28" x 11" on the outside, it is made from 1½" wide by approximately ½" thick metal and over time had been broken into four pieces. It may well be part of a flange connected with the cylinder/condenser, as there are the remains of what could be a leather gasket attached to one part (photo [11](#)). Traces of wood were found nailed to another part (photo [12](#)).

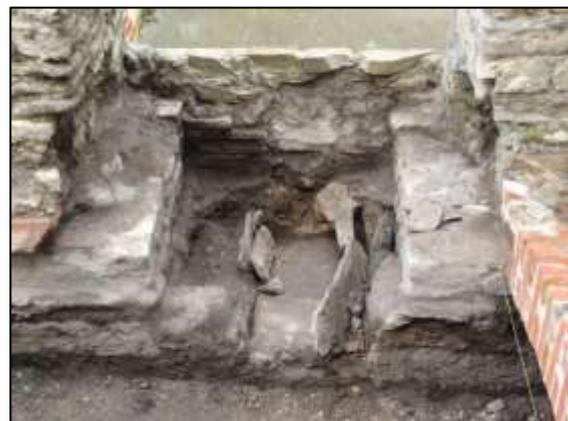
Spoil clearance in the opening at the base of the north-west (bob) wall of the engine house has uncovered a channel that slopes from inside to outside. The fully uncovered channel can be seen in the photo on the right, with several pieces of lime scale replaced in their original positions. The wall towards the top of the photo is not an original feature, as it was built in 2017-18, when the masons were working on the conservation of the walls of the engine house. Photos [13](#), [14](#) and [15](#) shows the excavation of the channel at an earlier stage. A

piece of lime scale was found buried in the spoil nearby. This can be seen being held against the end of the channel in photo [16](#). It fits reasonably well against the scale still in-situ, suggesting that the channel extended beyond the inner edge of the bob wall towards the engine bed. There is a metal bracket at the back of this piece of scale (photo [17](#)), which has fragments of wood attached to it. This leads us to believe that the channel was made from wood, and the scale has been deposited on the inside. Some of the pieces, such as the ones seen in photos [18](#) and [19](#), show that the scale was deposited in layers over a period of time. A drain was uncovered at the Pumping Shaft end of the channel (photo [21](#)). Where it goes has not yet been established – the hole is about 4 feet deep and any water poured into it disappears. Discovering that has been added to the long list of interesting red herrings to be investigated another time.

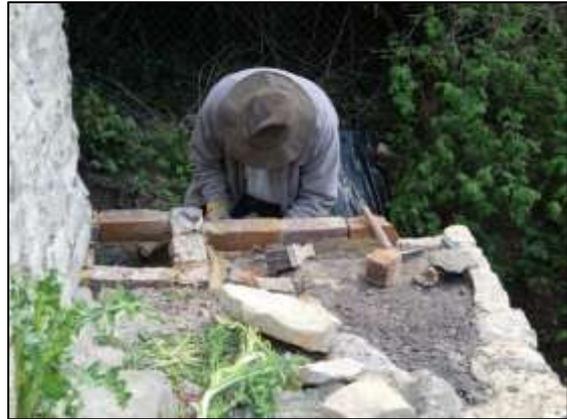
The edge of the platform outside the south-west wall of the Cornish Engine House has been levelled with new masonry (photo [23](#)). The intention is to form a level surface by laying stone slabs, which will make it easier to walk from the steps to the inside of the building. Jeff has started on designing safety handrails for the steps and the edge of the platform. At the same time the edges at the south-eastern end of the platform were rebuilt and the resulting void filled with a weak screed mixture. The photo on the right shows Hamish at work on this area in May.

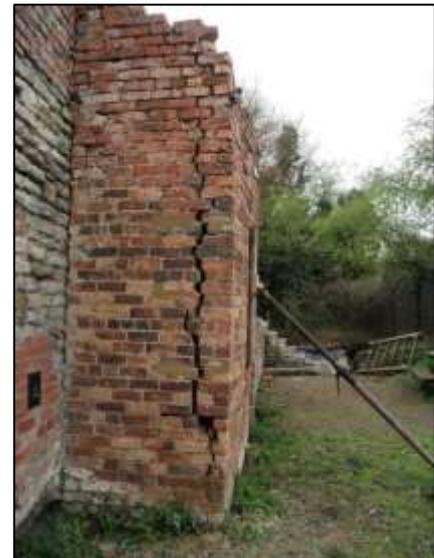
At the work party on 30 March, it was thought that the crack running up the side of the brick extension to the south-west wall of the Old Pit heapstead (photo [28](#)) was widening. No measurements had been taken in the past, but a comparison with a photo (photo [29](#)) taken for another purpose in November 2013 showed that this was indeed the case. At present the cause is unknown. Steps were taken on 06 April to minimise the chances of the wall collapsing, by bracing the outside wall against the ground with an Acro prop and cementing the first three stainless steel ties across the crack (photo right). More ties will be added once we have been able to reduce the outward pressure on the wall. A start has been made on this by removing some of the spoil from behind the wall, starting at the Cornish Engine House end and working towards the cycle path end. Photo [31](#) shows the progress made by the end of April. The excavated spoil has been put to good use. It contains a significant amount of ash, making it ideal for use as the filler in the weak screed mixture used in the Cornish Engine House. The intention is to save the wall, rather than demolish and then rebuild it. But there is more work to be done before we can make that decision.

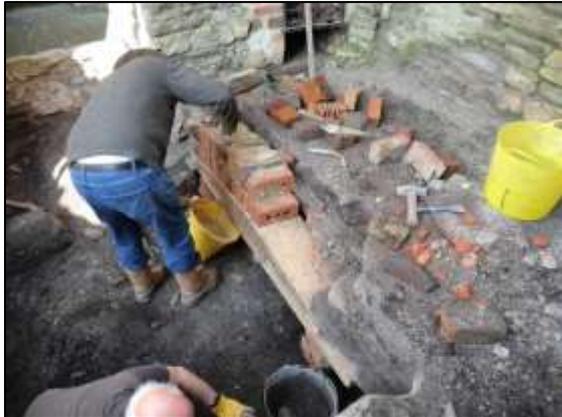
Photo 1 – Hamish building a new edge to the north-east vault of the Cornish Engine House. A view of the finished edge can be seen on [p.1](#).

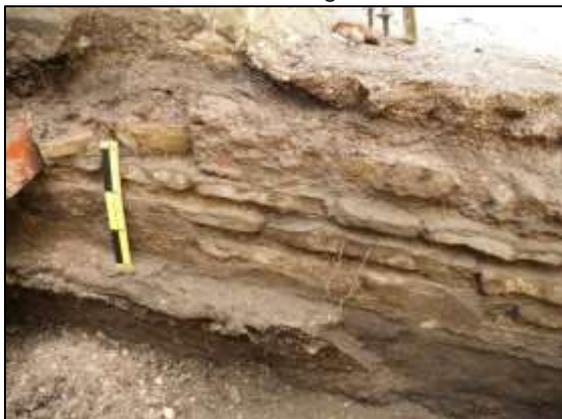
Photo 3 – This view of the inside of the south-west wall of the Cornish Engine House shows that the bricks of the arched roof of the vault on that side were not keyed into the masonry of the wall. (30 cm scale)

grounds. This has been done using reclaimed bricks, many of which came from the undercroft of the Horizontal Engine House. As can be seen from photo [3](#), the brickwork of the arch was not keyed into the masonry of the south-west wall of the engine house, something that has been copied for the rebuilt arch. Photos [4](#) to [8](#) show various stages in the rebuild. A strengthening course of bricks was built into the arch at the midway point, and the edge was also rebuilt with a double thickness. These can be clearly seen after construction finished in photo [9](#), which also shows that the top of the arch has been covered with a weak screed. Almost  $\frac{3}{4}$  of the roof of north-east arch was covered with the screed during the first work party in May (photo [10](#)). The intention is to lay a floor of stone slabs above the screed on both arches. Excavation of the spoil in the well between the vaults can resume once all the remedial work on the arched roofs has been completed.

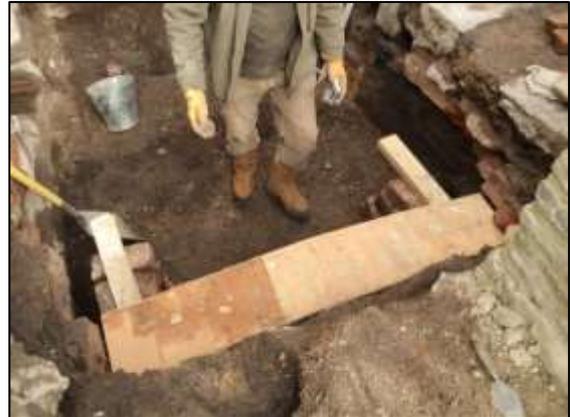
Photo 4 – The arched vault on the south-west side of the Cornish Engine House was rebuilt using this former. A second one was added later so that half of the vault could be rebuilt during a single work party.

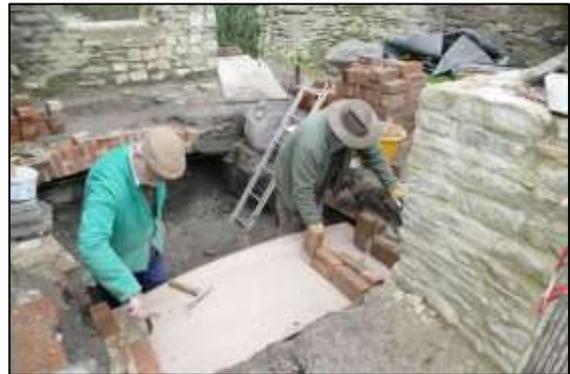
Photo 5 – Ken and Hamish start on rebuilding the arch using bricks recovered from around the site, including those found in the undercroft of the Horizontal Engine House ...

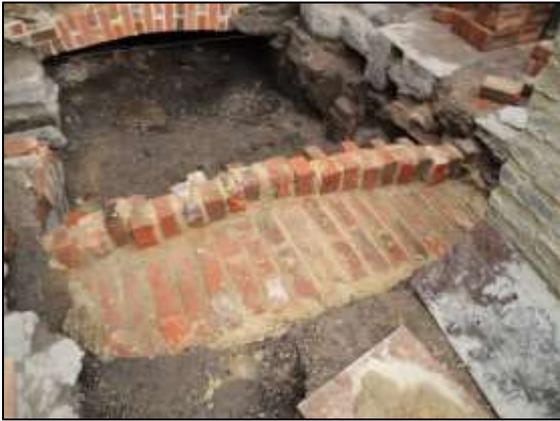
Photo 7 – ... and the completed first half of the arch.

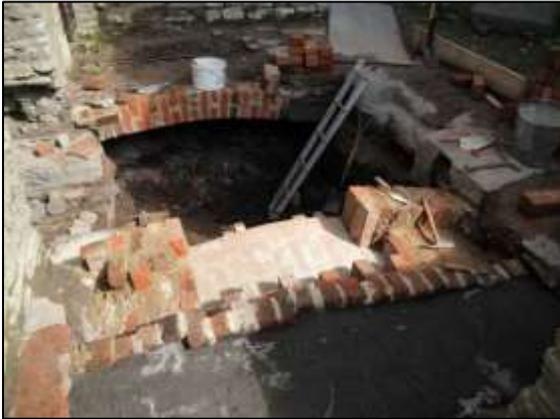
Photo 8 – A weak screed layer has been laid on the top of the first half (foreground) and work is in progress to build the second half.

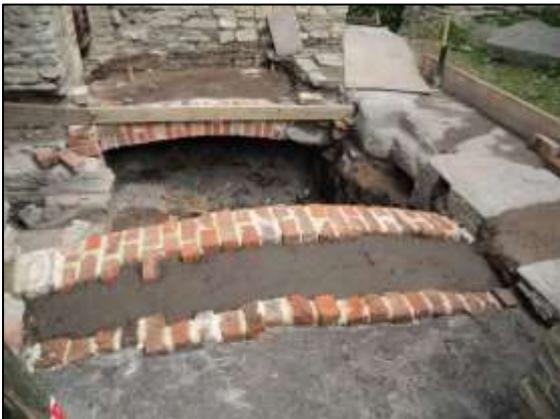
Photo 9 – The completed arch, with a layer of weak screed laid on top.

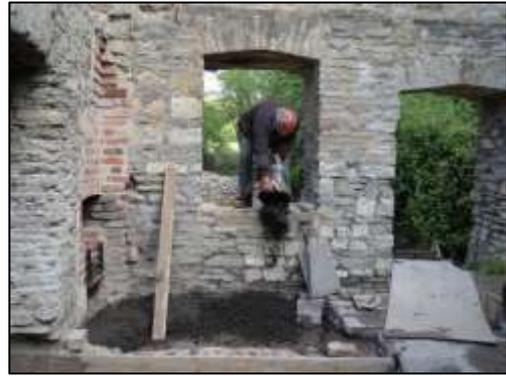
Photo 10 – Ken dumping a bucket-load of weak screed mixture onto the top of the arched roof of the north-east vault.

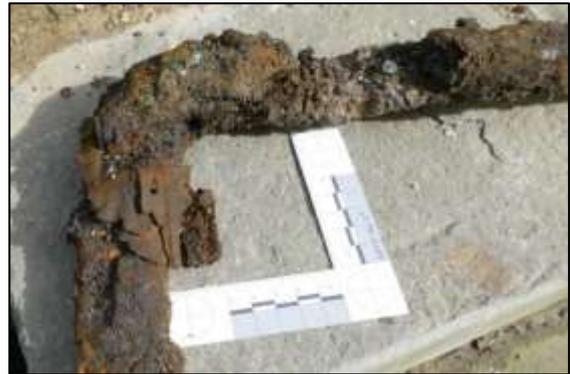
Photo 11 – Remains of what appears to be a leather gasket attached to part of the frame seen in the photo on page 2. (5 cm x 5 cm scale)

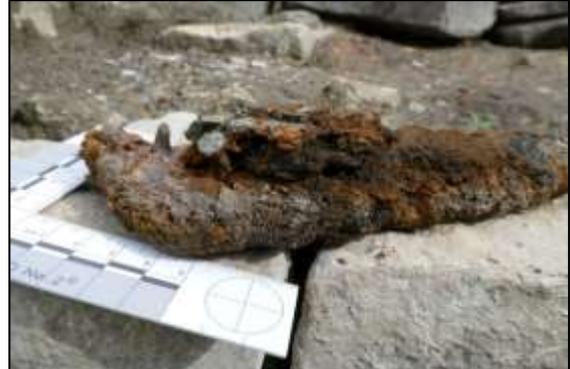
Photo 12 – Another part of the same frame had what appeared to be wood attached. (5 cm x 5 cm scale)

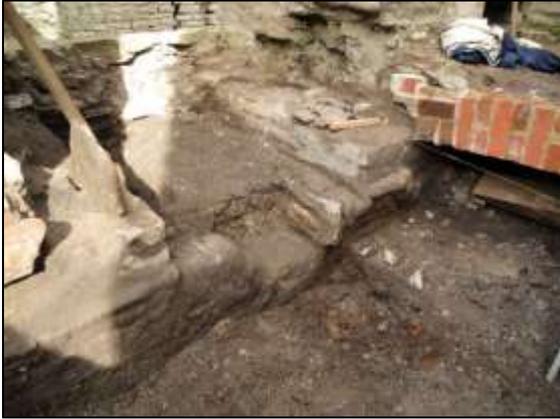
Photo 13 – An early stage in the spoil removal from the channel in the bob wall of the Cornish Engine House.

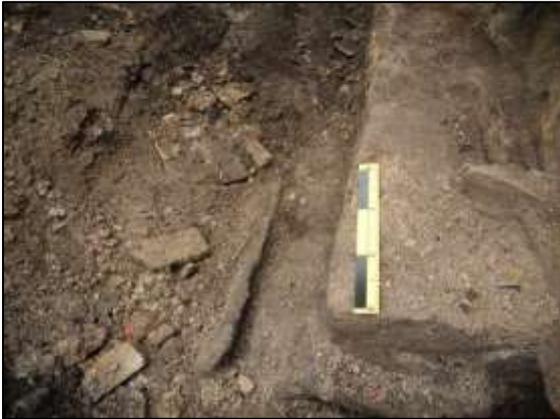
Photo 14 – Spoil is being removed from the channel in the bob wall, with a piece of lime scale still in its original position to the left of the scale. (30 cm scale)

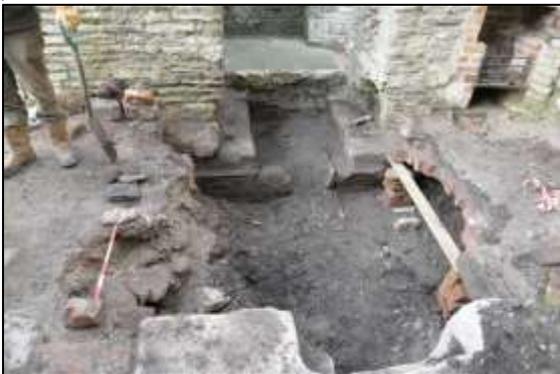
Photo 15 – View of the channel in the bob wall, seen from a position above the engine bed. Work has just started on excavating the roof of the south-west vault, seen on the left below the volunteer's boots.

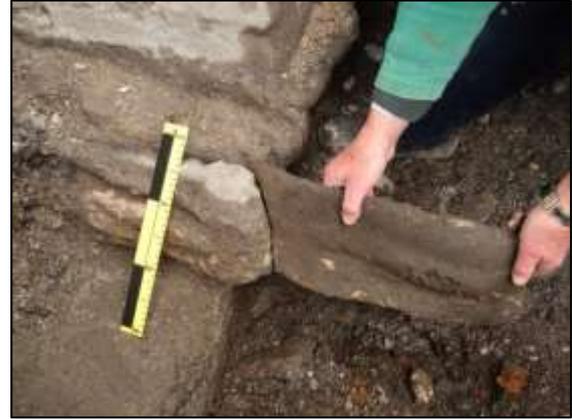
Photo 16 – A piece of lime scale found in the spoil around the arched vaults is matched up to another piece still in situ. (See text on p.2, 30 cm scale)

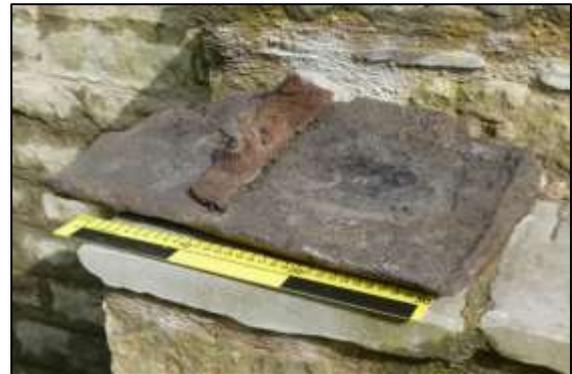
Photo 17 – The reverse of the piece of lime scale seen in the previous photo. There are traces of wood attached to the metal plate. (30 cm scale)

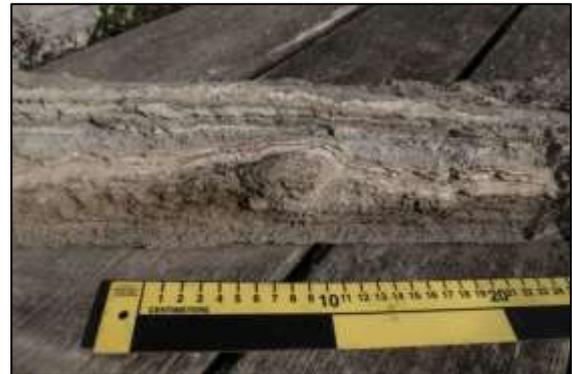
Photo 18 – This close-up of one of the pieces found in the channel in the bob wall shows how the lime scale has been built up layer by layer. (30 cm scale)

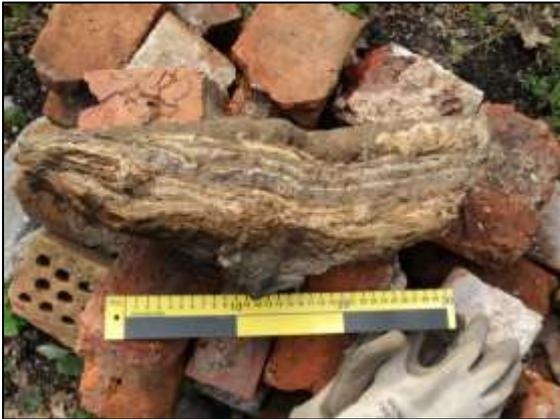
Photo 19 – Close-up of another piece of limescale found in the channel in the bob wall, with more layers of lime scale build up. (30 cm scale)

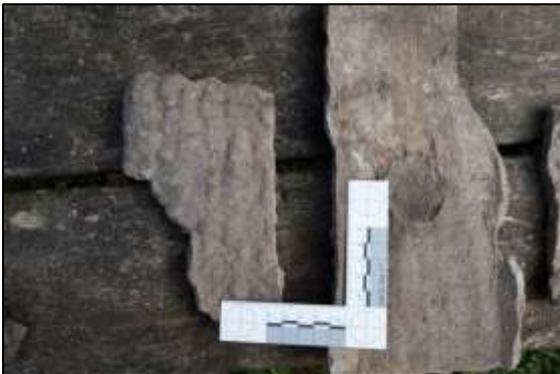
Photo 20 – Two more pieces of lime scale from elsewhere in the channel. The rough surface of the one on the left would have been in the flow of water, while the smooth surface of the one on the right was against the wooden edge of the channel. (5 cm x 5 cm scale)

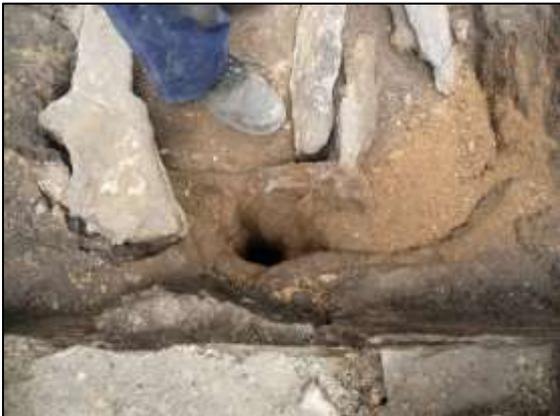
Photo 21 – Drain hole discovered at the Pumping Shaft end of the channel in the bob wall of the Cornish Engine House. (See text on p.2)

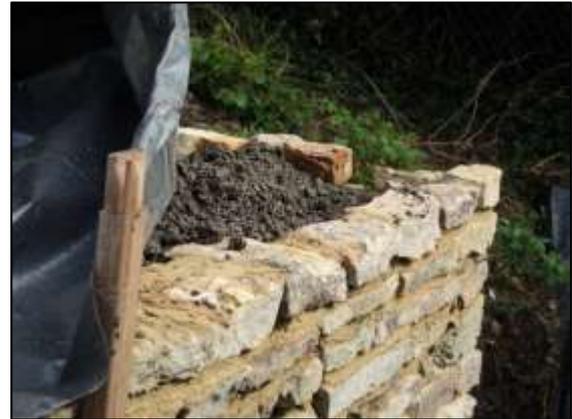
Photo 22 – The end of the wall of the platform outside the south-west wall of the Cornish Engine House has been built up, and the resulting void is being filled with a weak screed mixture.

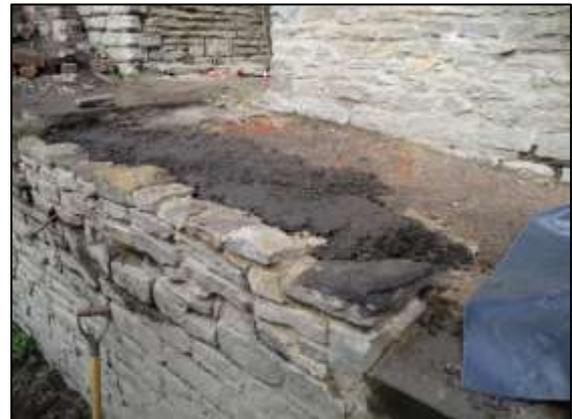
Photo 23 – The outer edge of the platform outside the south-west wall of the Cornish Engine House has been built up, and a weak screed mixture has been laid on the area behind the edge.

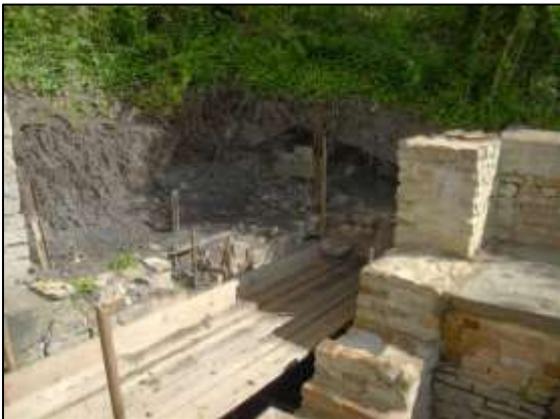
Photo 27 – ... and the result of the spoil clearance work by both Mark and Pete. (See text on p.3)

Spoil has been removed from behind the top of the north-west wall of the Vertical Engine House (photo [27](#)). The aim is to give enough room to work on the top of the wall, and the top few inches of the outside, without spoil falling from the batch onto the working area. The top of the wall can then be capped to stop rain from soaking into the masonry. There has been more repointing of the outside of the walls of the engine house.

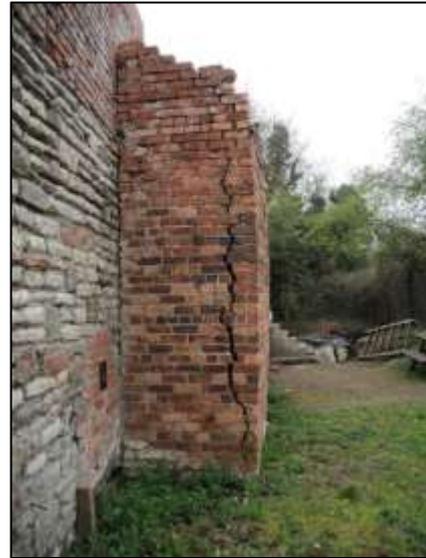
Photo 28 – Crack in the brick extension to the south-west wall of the Old Pit heapstead on 30 Mar 19. (See text on p.3)

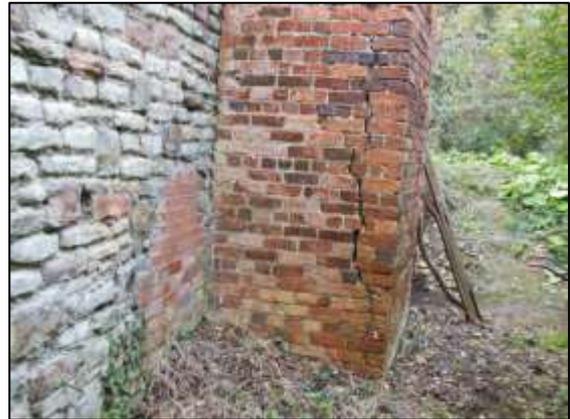
Photo 29 – For comparison this photo of the crack was taken on 16 Nov 13.

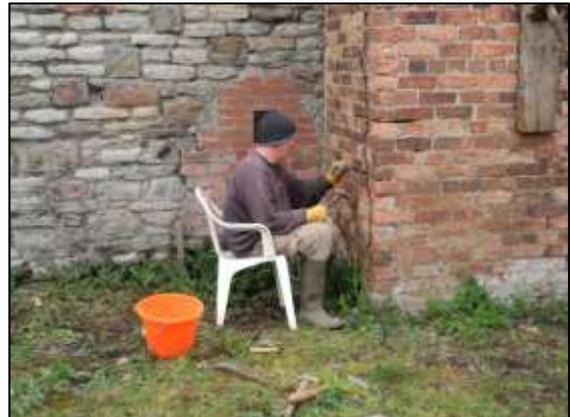
Photo 30 – Mick chases out the pointing at the south-west end of the Old Pit heapstead before fitting the stainless-steel ties.

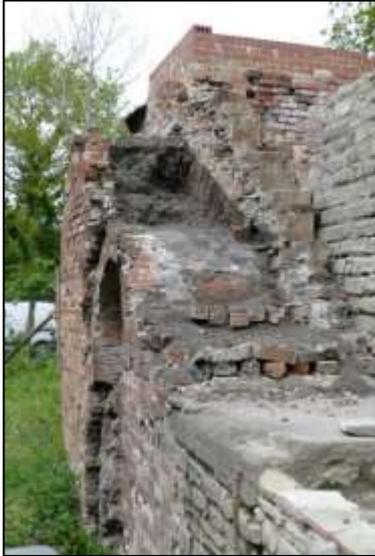
Photo 31 – Spoil has been removed from above the entrance to the Pumping Shaft passage, and part of the area behind the brick wall at the end of the Old Pit heapstead. (See text on p.3)

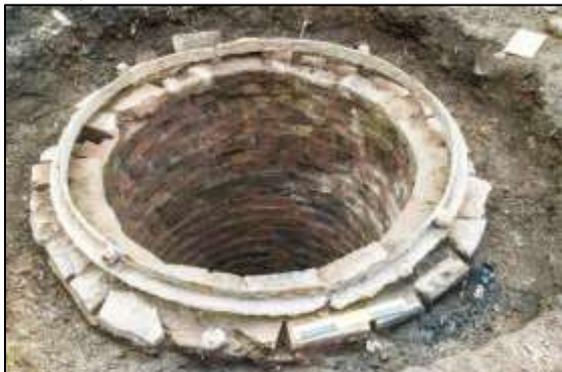
Photo 33 – The brick top of the shaft outside the entrance to the Vertical Engine House has been fully exposed, ready for repairs. (30 cm scale in foreground) (See text on p.3)

There was more work on the shaft outside the Vertical Engine House. The brickwork around the top was fully exposed, allowing repairs to be made (photo [33](#)). Jeff has made a metal cover (photo [34](#)), which will be bolted down to the top and the brickwork will be flanchued to protect it. The cover will allow visitors to peer safely down into the shaft. However, based on experience, it will not stop any kamikaze frogs from making the leap to the water.

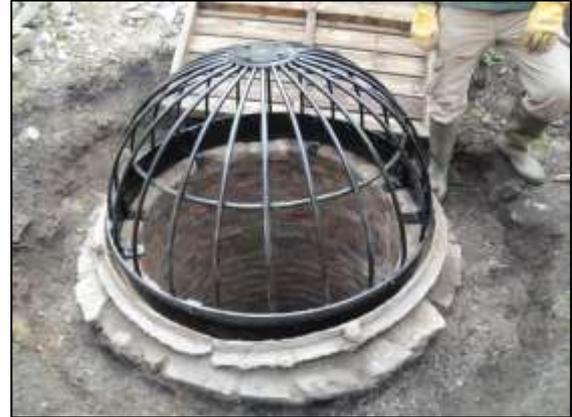
Photo 34 – Jeff has constructed a frame to cover the shaft.

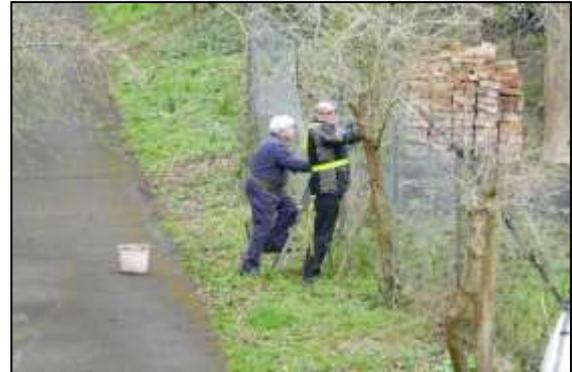
Photo 35 – Jeff and Mike repairing damage to the fence near the Old Boiler House.

And while some volunteers got on with the glamorous tasks of excavating and rebuilding, others did the less glamorous work of repairing fences (photo [35](#)), clearing the accumulated leaves from various parts of the site (photos [36](#) and [37](#)), and tending to the hawthorn growing around the perimeter fences (photo [38](#)). The hawthorn whips planted out in early 2017 have started to thicken out, and this will help to make the fence more secure.
