Progress: May – August 2020

Photographs (May - August 2020)

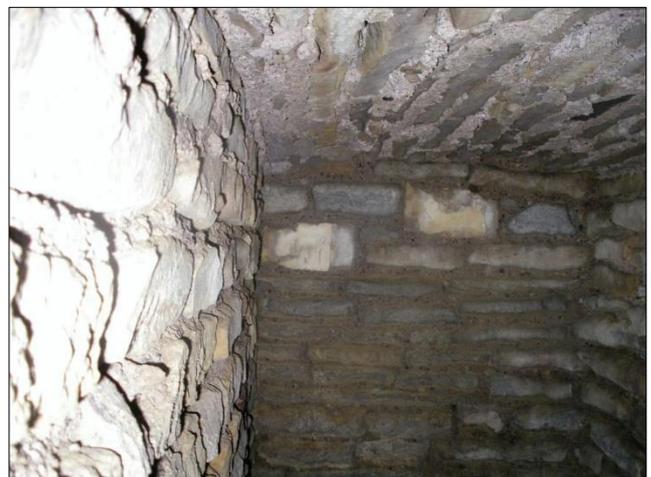
The vandals had enlarged an existing hole by the engine bed in the Cornish Engine House, making it easier to put a camera down the hole to see what lies under the floor on the south-east side of the building. One of the resulting photos can be seen on the right. The stonework at the back forms part of the north-eastern wall of the building, while the 'roof' in the picture is the underside of the floor at engine bed level. Some of the other photos can be seen in photos [27](#) to [29](#). The chamber does not appear to connect with the outside world, nor does it appear to give access to the space under the engine bed so that the engine holding down bolts on the north-east and south-west sides could be tightened. The access point for that area has still to be discovered. The holding down bolt on the north-west side would appear to have been mounted in the condenser pit while the masonry slot seen in photo could be associated with the bolt on the south-east side. If there is no access to the underneath of 3 of the 4 bolts, then how are they tightened? As is always the case at Brandy Bottom, every answer comes with a new set of questions attached.

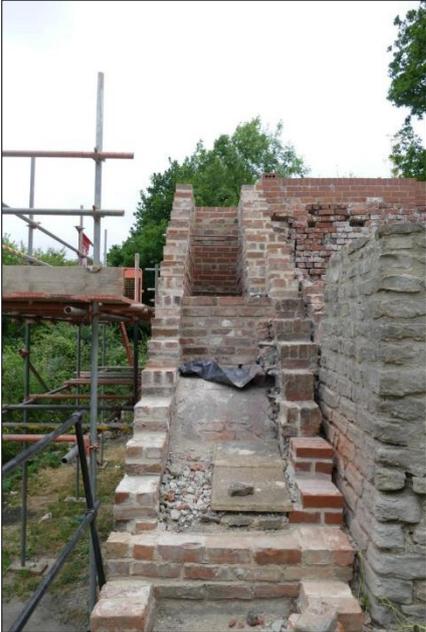
Photo 1 – View of the rebuilt brickwork at the south-west end of the Old Pit heapstead. Photos 5 and 6 in the previous newsletter (Nº 27) show the original layout and the vandalised state respectively from the same viewpoint.

The masons have made progress with the conservation works paid for by the grants from the Ibstock Enover Trust and the Enover Community Trust. So far they have rebuilt the top of the brick extension at the south-west end of the Old Pit heapstead, which had been one of the areas targeted by the vandals (photo 6 in newsletter N° 27). That rebuild includes the restoration of a flight of steps that now connect the platform outside the south-west wall of the Cornish Engine House with the top of the heapstead (photo right). Jeff is making a set of railings for the steps. Both the north-east and south-west walls of the Vertical Engine House have been raised and are now at a height that would have supported the engine beams that spanned the building along a north-east/south-west axis. This height was based on the length of the holding down bolts at the south-west end of the building. Photo 4 shows the completed north-east wall and photo 6 the south-west wall. Photo 8 is a close-up of the rebuilt western corner of the Old Pit heapstead. Not all of the face of the south-west wall has been rebuilt, as the intention has always been to restore

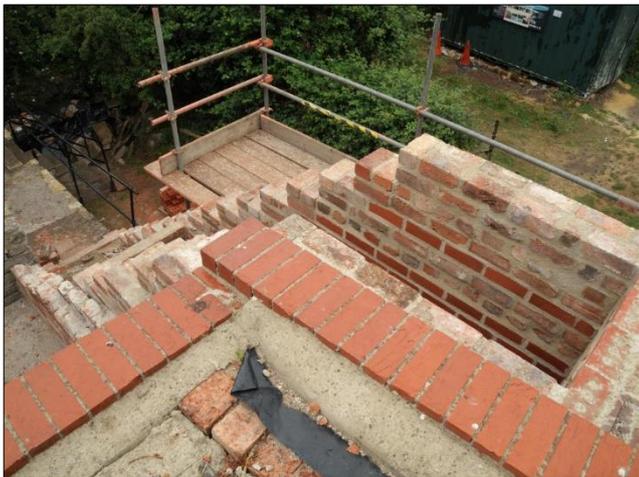
Photo 2 – A view of the same area as the previous photo, but this time taken from the top of the heapstead. This view makes it easier to see the layout of the reinstated steps ...

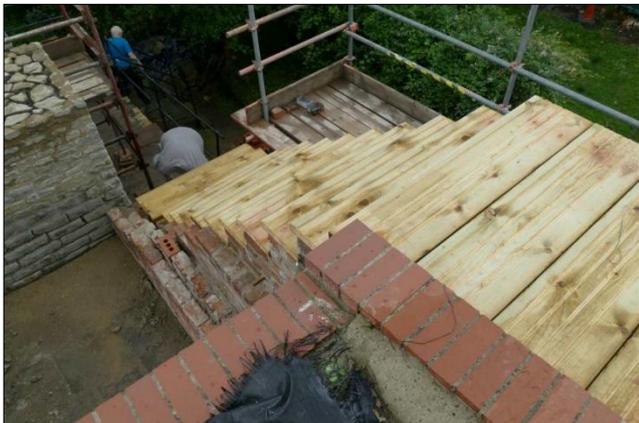
Photo 3 – ... and with the wooden treads in place.

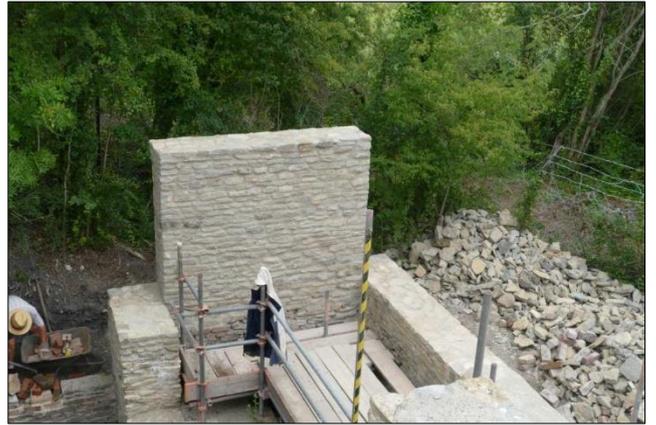
Photo 4 – The north-east wall of the Vertical Engine House, seen here from the top of the Old Pit heapstead, is now at its final height ...

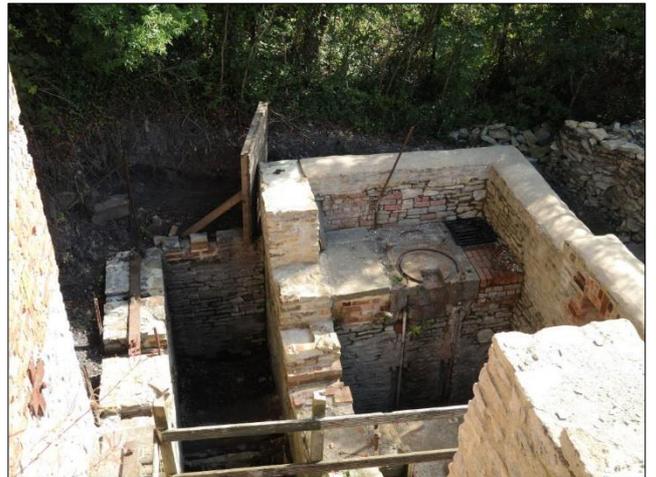
Photo 5 – ... and the same wall in August 2019.

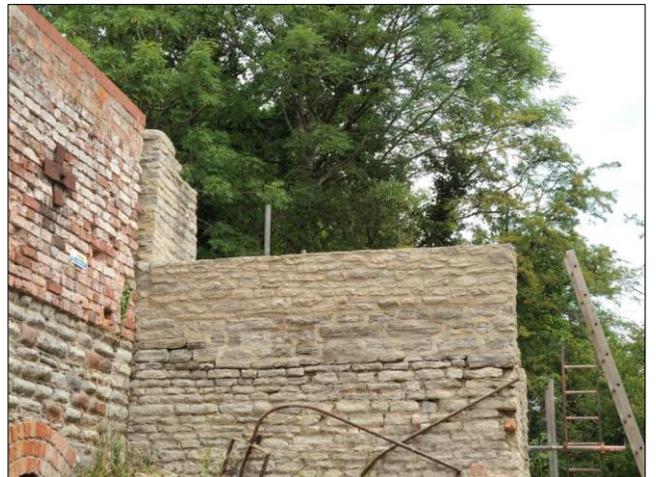
Photo 6 – The south-west wall of the Vertical Engine House has been raised to its final height, seen from the outside of the building.

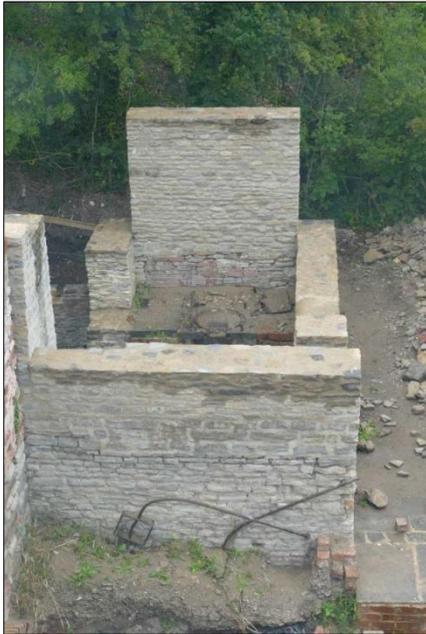
Photo 7 – The rebuilt walls of the Vertical Engine House, seen from the scaffolding around the bob wall of the Cornish Engine House.

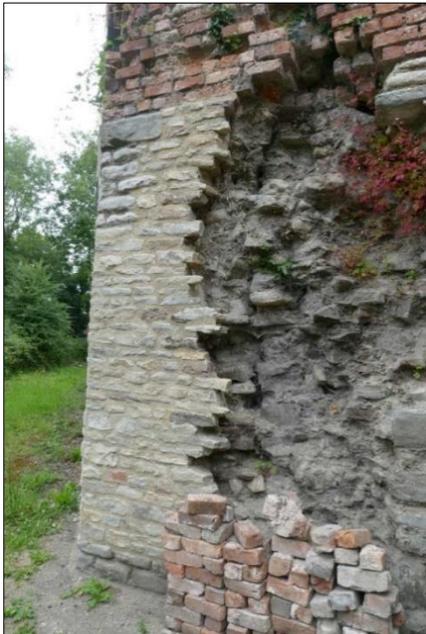
Photo 8 – The masons completed the rebuild of the western corner of the Old Pit heapstead. Photo 13 in the previous newsletter, N° 27, shows the same area during the rebuild.

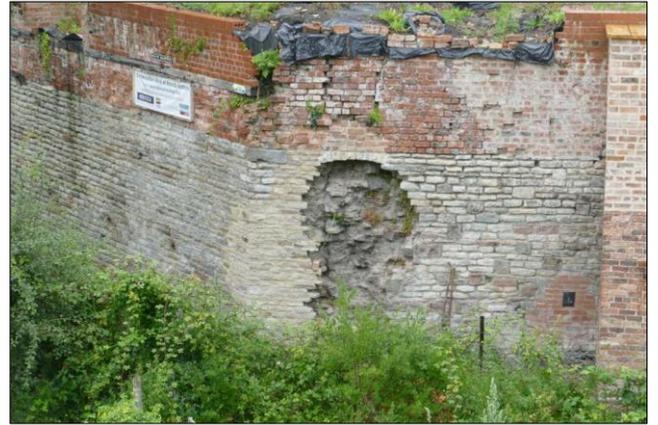
Photo 9 – Hamish built a masonry arch that connected the two parts of the stone facing. He also rebuilt some of the brickwork immediately above it, improving the stability of the rest of the wall.

only what is necessary for the long-term conservation of the structures. After the builders finished Hamish connected the two parts of the stone facing on the south-west wall of the Old Pit heapstead with a stone arch and filled in the area above it with bricks (photo [9](#)). This will give support to the brick facing at the top of this wall. The arch at the entrance to the East Flue has been rebuilt (photo [14](#)), as has the retaining wall that runs outside the south-west wall of the Vertical Engine House. The top of the bob wall of the Cornish Engine House is being rebuilt (photo [17](#)) so that the stone pivot slabs could be reinstalled. The platform outside the south-west wall of the Cornish Engine House now has a paved top (photo right), using flagstones bought with a grant from the South Gloucestershire Council. A stone with a hole drilled up from the underneath had sat for many years on the platform outside the south-west wall of the Cornish Engine House (photo [18](#)). It was not possible to incorporate it into the new layout so had to be removed. A second hole was discovered when it was examined after removal (photo [19](#)), and the measurements taken suggest that the block was a section of a Dramway sleeper that had been put to a new use. The concrete roof over the fan ducts now extends as far as the wall of the New Pit shaft (photo [20](#)) and the vandal-damaged section of the existing roof has been repaired. The area above the New Pit passage has been waterproofed to stop rain soaking through to the arched brick roof of the New Pit passage and causing spalling in frosty weather. A waterproof liner has been laid at the base of the winding ramp and two surrounding areas and then covered with concrete (photo [22](#)). Rain now drains from all three areas to the base of the winding ramp (photo [23](#)) and from there to the floor of the passage. We have still to devise a way of directing the water away from the passage. The original layout to the top of the Horizontal Engine House walls had weathered since the work was completed in 2014, so a course of coping bricks has now been laid around the perimeter. Photo [24](#) was taken at an early stage, when a stone bridge had been laid across the drainage gap at the northern corner to act as a support, while photo [25](#) shows the completed brickwork laid across the bridge. At the time of writing the masons were laying the coping bricks along the top of the south-east wall of the New Pit heapstead, replacing the ones vandalised earlier in the year. And talking of vandals, work should start shortly on the new boundary fences.

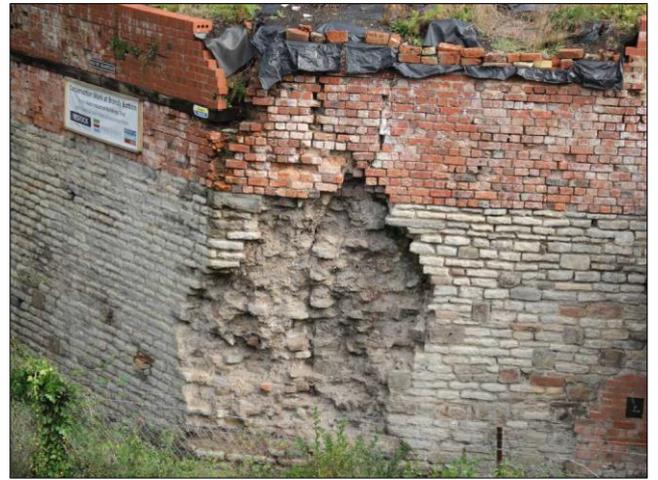
Photo 10 – The original state of the corner in October 2019.

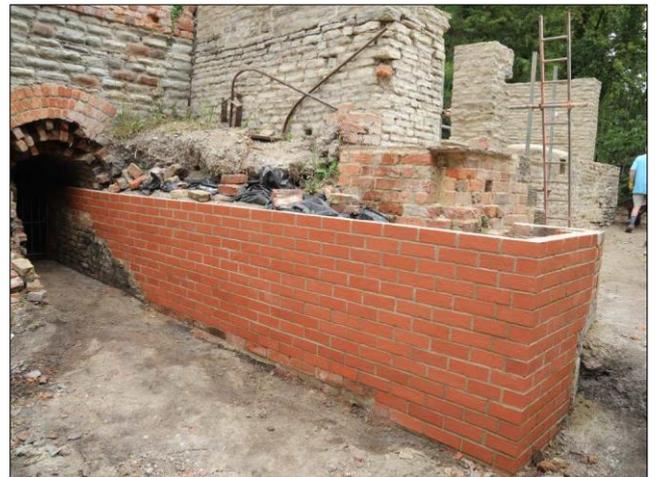
Photo 11 – The rebuilt wall outside the exit of the East Flue in June 2020 ...

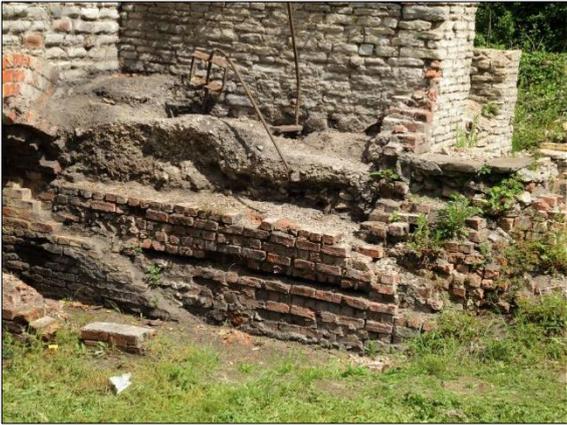
Photo 12 – ... and the same area in 2015.

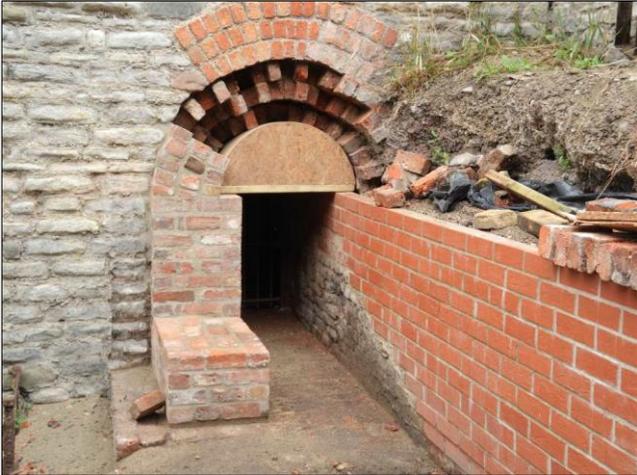
Photo 13 – The brick arch at the end of the East Flue during the rebuild ...

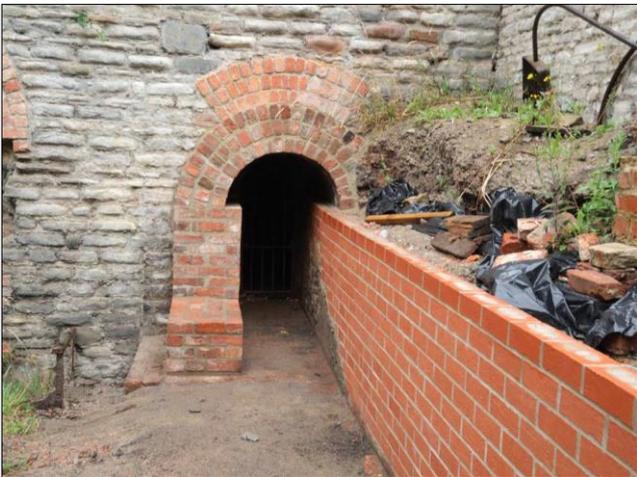
Photo 14 – ... and when completed.

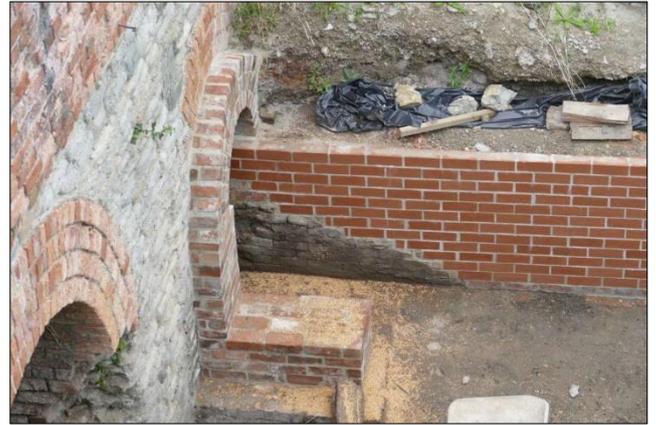
Photo 15 – This view of the brick arch was taken from the scaffolding around the bob wall. It clearly shows the join between the original and new brickwork, and how the bricks of the arch now extend beyond the face of the heapstead wall.

The scaffolding around the bob wall of the Cornish Engine House presented an opportunity to see if there were any unusual views of the site, and also to take some reference photos of the inside of that building and the tops of its walls. Photo [15](#) is one of these photos, while some of the others are photos [45](#) to [48](#).

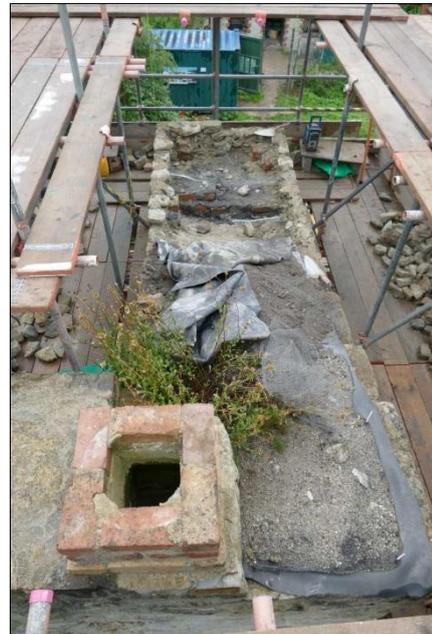
Photo 16 – The top of the bob wall of the Cornish Engine House from the north-east in early July ...

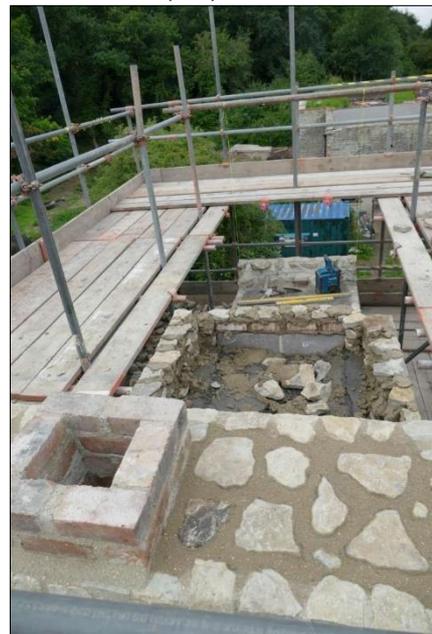
Photo 17 – ... and mid-July.

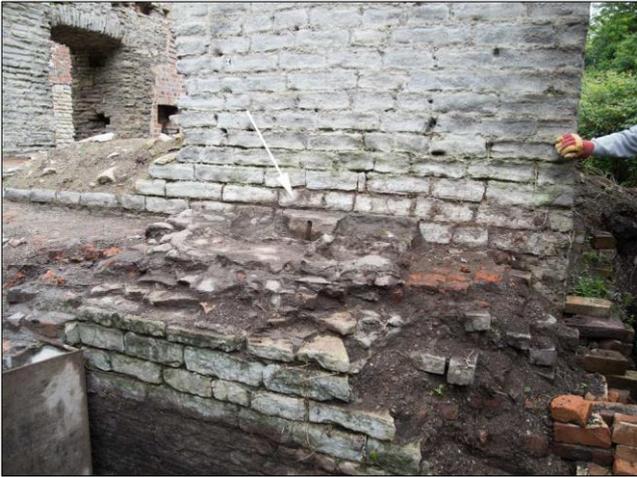
Photo 18 – The platform outside the south-west wall of the Cornish Engine House in July 2017. The arrow points to a stone that had a hole drilled upwards – see comments on p.2.

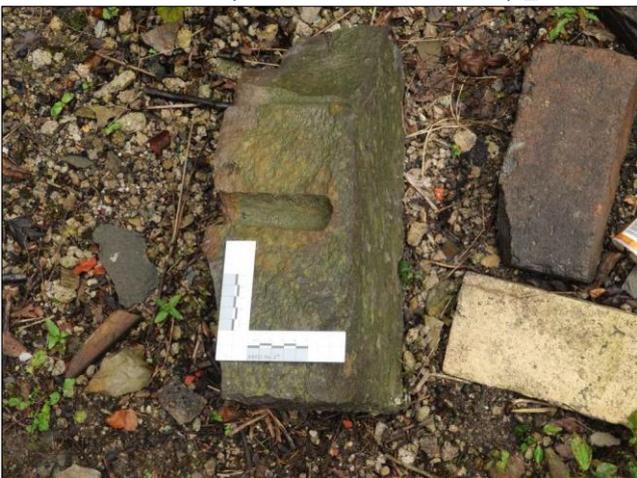
Photo 19 – The stone seen in the previous photo after its removal in July 2020 (5 cm x 5 cm scale).

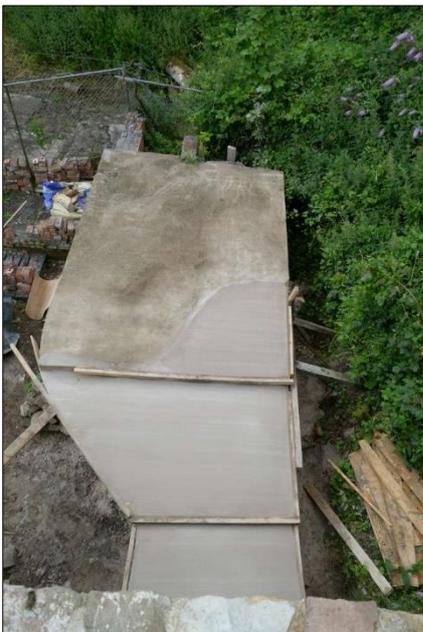
Photo 20 – The newly cast roof of the fan ducts, seen here from the top of the New Pit heapstead, now extends from the fan housing, situated at the top of the photo, to the wall of the shaft. The camera angle gives the impression that there is a considerable difference in height between the top and bottom sections, though photo 21 shows that this is not the case.

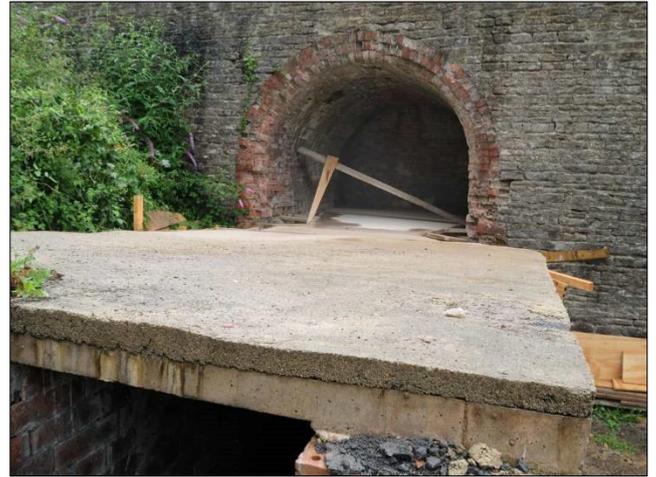
Photo 21 – View of the new roof from the fan end of the ducts with the shuttering still in place. This angle shows that the roof is at almost the same level throughout.

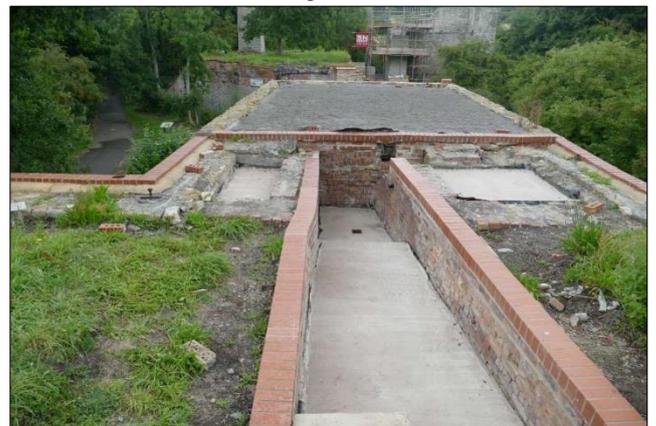
Photo 22 – The winding ramp of the New Pit heapstead after a waterproof membrane covered by concrete was laid in July 2020. (See comments on p.2)

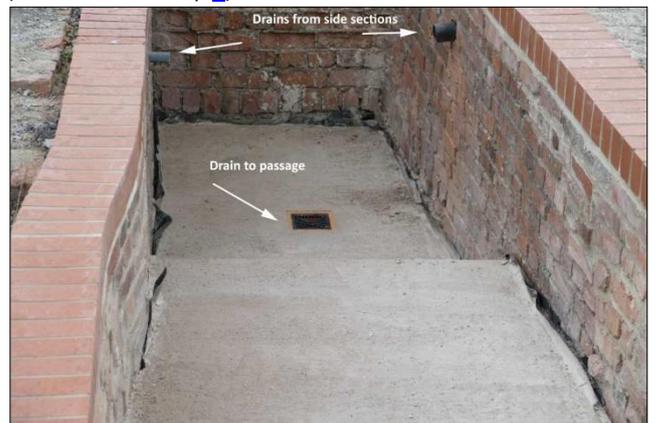
Photo 23 – View of the Horizontal Engine House end of the winding ramp, showing the arrangement of the drains.

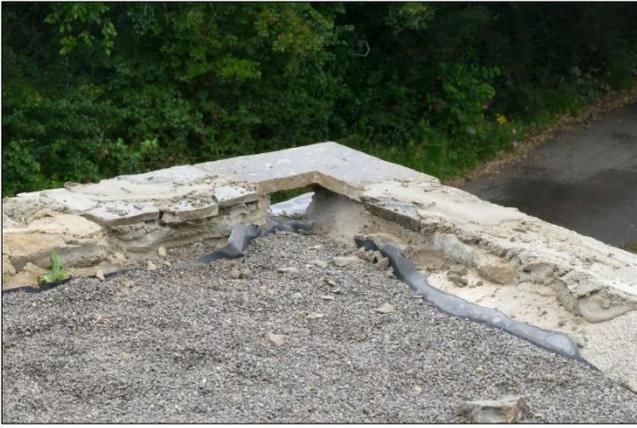
Photo 24 – A stone bridge has been laid as a support for the coping brick course over the drainage channel in the northern corner of the Horizontal Engine House roof ...

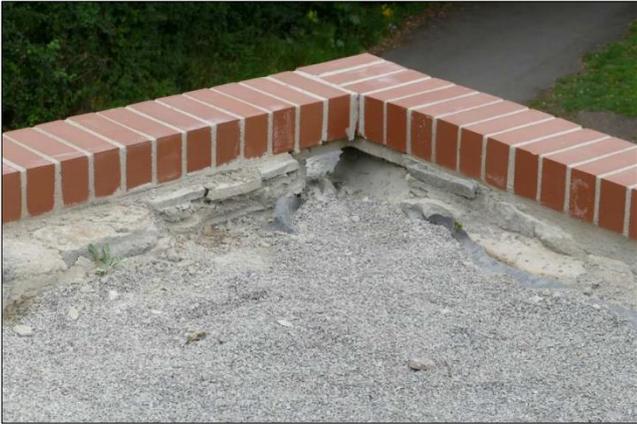
Photo 25 – ... and the same corner after the bricks have been laid.

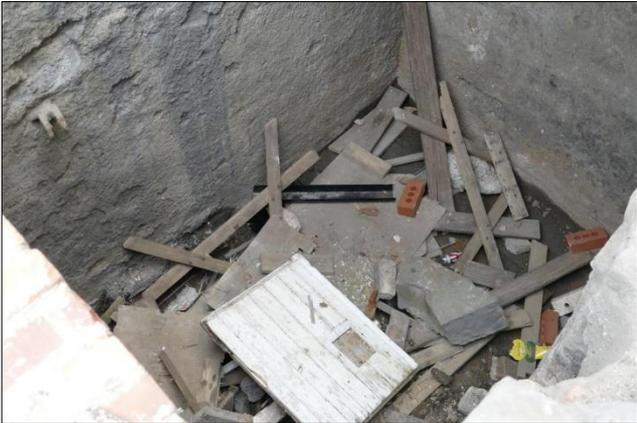
Photo 26 – Debris thrown into the condenser pit in the Cornish Engine House by vandals during lockdown. The dry weather had lowered the water table, making it easier to recover the items.

One of the first tasks for the volunteers in June was recovering the objects that vandals had thrown down the shaft outside the Vertical Engine House and the condenser pit in the Cornish Engine House. Photo [26](#) shows the mess at the bottom of the latter. As well as trashing parts of the site, we discovered that the vandals had removed the nameplates from the Old Boiler House, the Pumping Shaft, and the Vertical Engine House. The bricks that had been dislodged by the vandals have been cleaned for reuse at some time in the future, and some of the north-west wall of the New Pit heapstead ramp has been repointed.

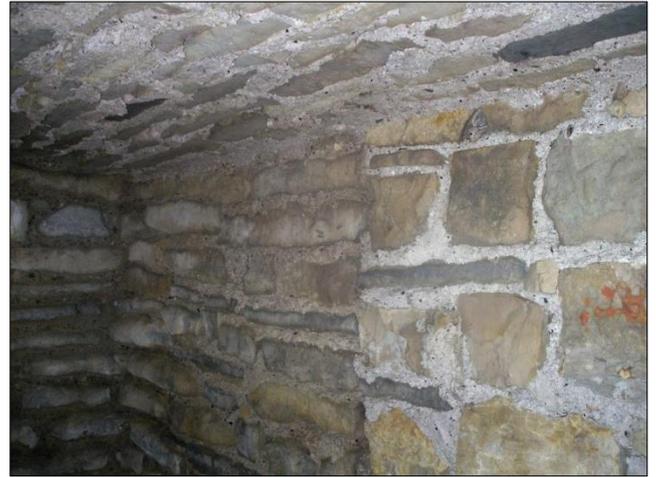
Photo 27 – View of the south-eastern wall of the chamber at the south-eastern end of the Cornish Engine House. The vertical break in the stone courses does not run the full height of the wall.

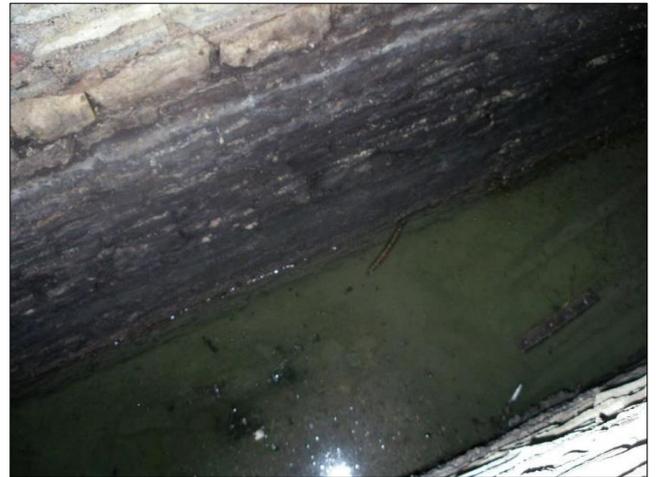
Photo 28 – Another view of the south-eastern wall of the chamber, looking downwards to the water level. This photo was taken during dry weather, and the dark area on the wall shows the range of water levels. The bright area at the bottom of the photo is the reflection of the flash.

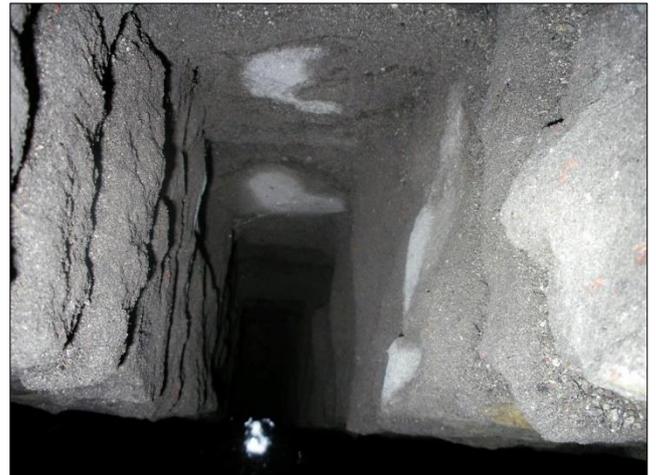
Photo 29 – Looking down the masonry slot on the north-west side of the chamber. The engine bed itself is located above the top of the photo. The bright area at the bottom is the reflection from the flash.

The holding down bolt on the north-west side would appear to have been mounted in the condenser pit while the masonry slot seen in photo could be associated with the bolt on the south-east side. If there is no access to the underneath of 3 of the 4 bolts, then how are they tightened? As is always the case at Brandy Bottom, every answer comes with a new set of questions attached.

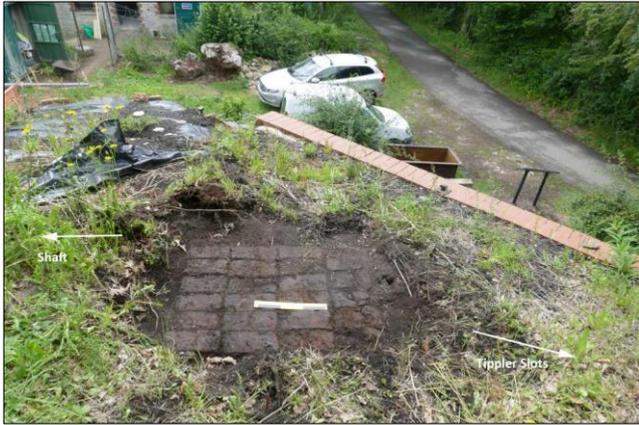
Photo 30 – Brick “path” found on the top of the Old Pit heapstead in June 2020 ... (30 cm scale on bricks)

Clearance work has not resumed in the condenser pit of the Cornish Engine House as it was felt that it was too cramped for keeping a safe spacing between volunteers. Attention turned instead to the top of the Old Pit heapstead. In June this uncovered a single layer of bricks (photo [30](#)) at the south-west end. During the following work parties the excavated area was extended to the east (photo [32](#)), uncovering the almost 4 feet deep metal-rimmed hole seen in photo [33](#). Also found were the row of metal fastenings seen in photo [34](#). The latter are loose, so may have been attached to a length of wood that has rotted away. Work in this area is still underway, so the significance of the finds has not yet been fully assessed. At the same time another group started working at the batch end of the heapstead, where earlier work had uncovered the remains of a building. There are the footings of a wall with what looks like a doorway at the south-eastern end of the area (photo [36](#)). Running at right angles to those footings towards the batch are the footings of another wall (photo [37](#)). A small salt-glazed jar was found toward the batch end (photo [38](#)). Exploration around what appeared at first glance to be a fallen wall revealed what could be a door with some associated pieces of wood (photo [40](#)), and a stretch of brick flooring (photo [41](#)). Work here is also still in progress, but hopefully there will be more information about both these discoveries in the next newsletter.

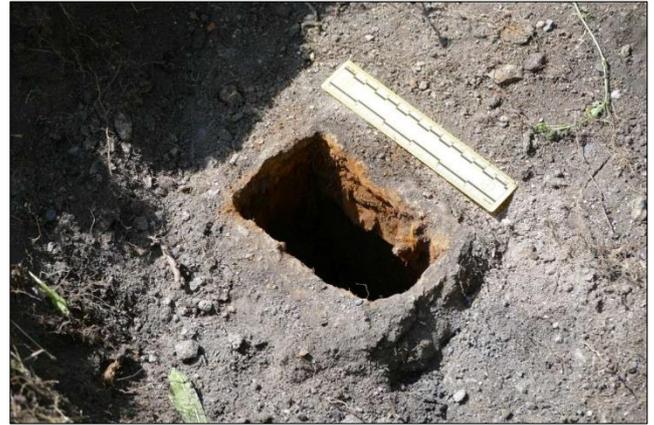
Photo 33 – Close-up of the metal lined hole seen in the centre foreground of photo [32](#) in front of the kneeling figure on the left. The hole is over 4 feet deep. (15 cm scale)

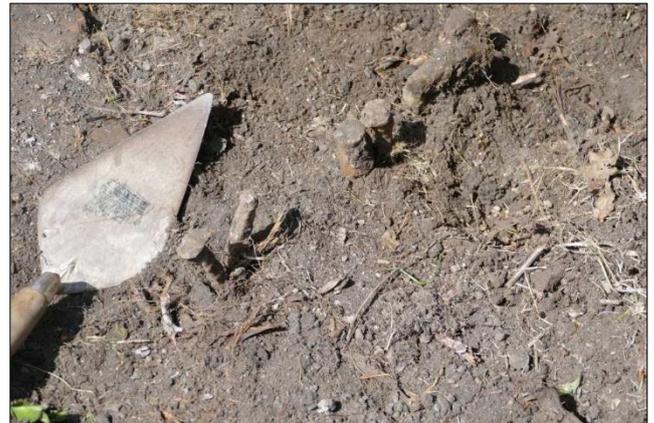
Photo 34 – Close-up of the row of metal fittings. The trowel can be used to locate their position in photo [32](#).

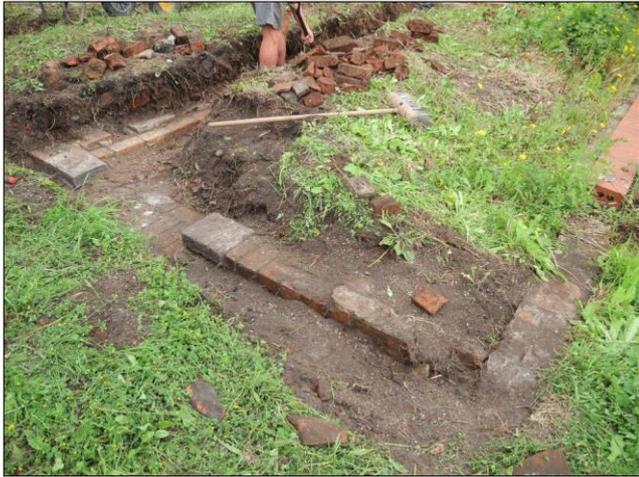
Photo 36 – Foundations for a building uncovered at the batch end of the Old Pit heapstead. There appears to be a door at the left-hand end of the footings.

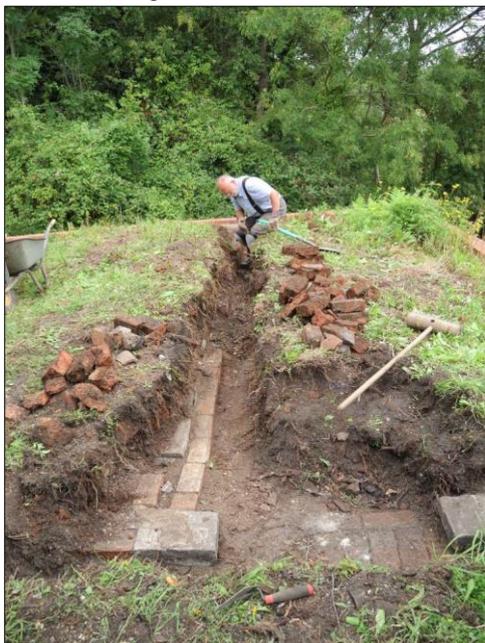
Photo 37 – The footings of another wall were uncovered running at right angles to the first. This trench was enlarged to discover the end near where Ken is working.

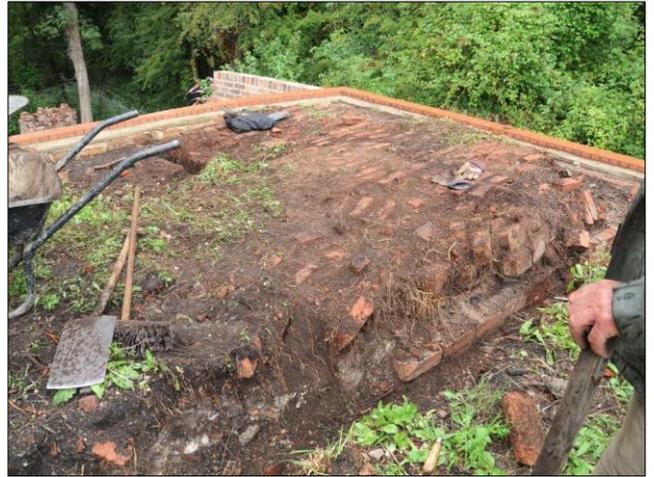
Photo 39 – This confused mass of bricks is located between the wall footings seen in photo [37](#) and the wall above the Old Boiler House (top left of photo).

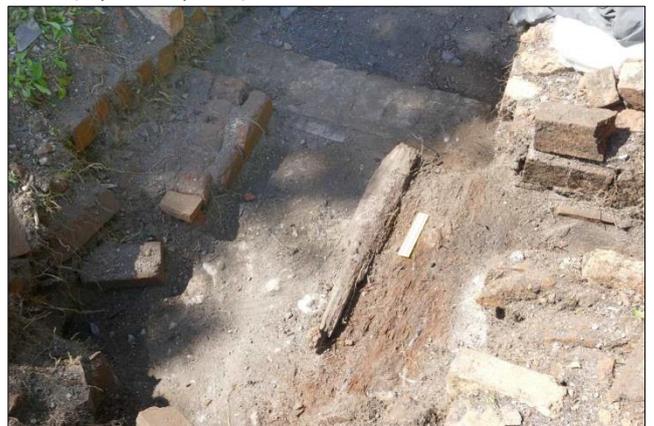
Photo 40 – The remains of what may be a door to the building, opening out onto a walkway running between the building and the Old Boiler House. (The left-hand figure in photo [43](#) is working on this area) (15 cm scale)

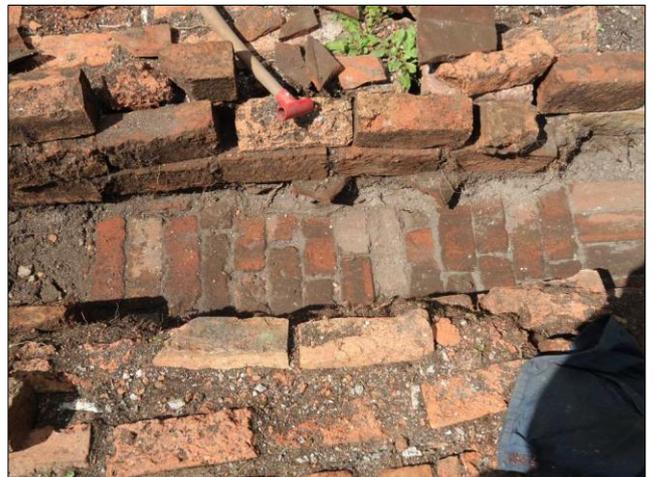
Photo 41 – A section of brick flooring was uncovered in the north of the area, where the figure at the rear of photo [43](#) is working.

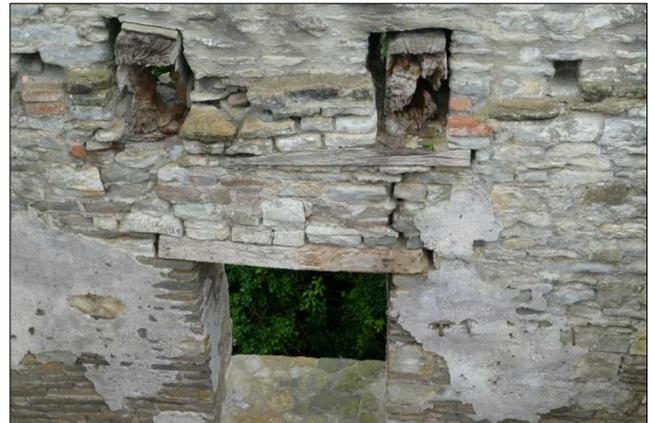
Photo 46 – ... and a close-up of the area around the remains of the wooden beams. There are smaller sockets for subsidiary beams on either side of the main sockets.
