FRIENDS OF BRANDY BOTTOM COLLIERY, PUCKLECHURCH

Newsletter N^o 4, August 2014

Progress: May – August 2014

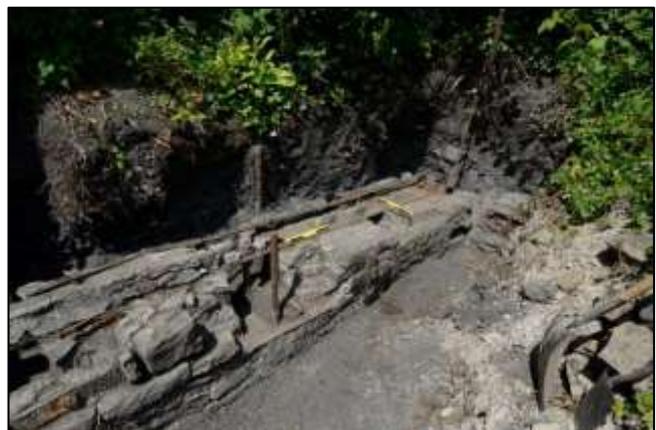
Work continued in the northern part of the Vertical Engine House. The tops of the north-west and north-east walls have been uncovered, and the bottom established at the southern end of the winding drum pit. This end of the pit has been cleared as far as a set of holding down bolts, and there was a thick layer of grease beside one of them (just to the left of the kneeling figure in photo 1). The photo to the right shows the north-western wall and photo 2 the north-eastern one. The indications are that we have uncovered the

original tops of the walls. The slots in the walls in photo 2 may have held the floor joists.

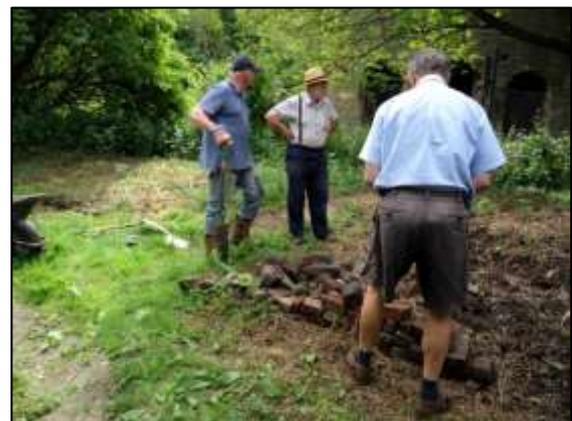
Photo 4 – Starting to clear a passage between the two enclosures for the arrival of the container.

There was a general clear up of vegetation around the site in July and August, both to clear an area for a storage container and also as part of a general tidy-up. An area between the two enclosures was cleared and roughly levelled for the container, and brick pillars built to support it (photo 5). Clearing the bushes from the slope above the entrance to the Pumping Shaft passage uncovered the remains of some steps, or rather the remains of the inside supports for some steps (photo above right). The outside supports must have crumbled away over time, taking away the treads. The close up seen in photo 6 gives an idea of the size of these supports.

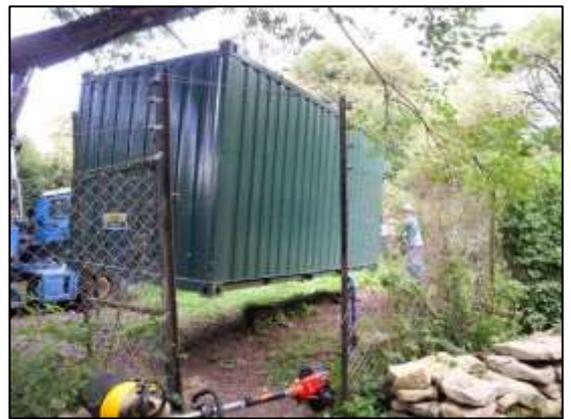
Photo 9 - Craning the storage container into position.

The storage container arrived on 20th August. Photo 9 shows it being craned into place and 10 shows it in its new location. There was also an unusual visitor – a Harris hawk (photo right, and photo 11). It was being flown by the Cory falconer to scare off the seagulls from the nearby tip. While the falconer was talking to us, the seagulls had spotted that the hawk was not flying and could be seen sneaking back at low level. The hawk

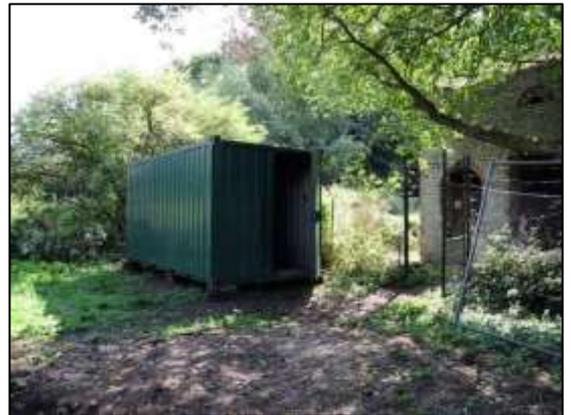
Photo 10 – The storage container in place.
