FRIENDS OF BRANDY BOTTOM COLLIERY, PUCKLECHURCH

Newsletter N^o 5, November 2014

Progress: September-November 2014

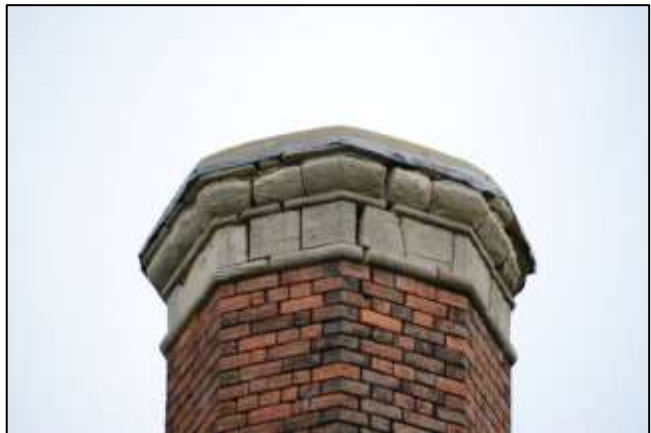
The masons returned in September and completed work on the top of the chimney. The top course of badly eroded ornamental stonework was removed and replaced with a concrete ring that was cast in-situ. This will increase the stability of the top as the ring is bolted to the stonework below. The inside of the top section of the chimney was repointed at the same time. The photo on the right shows the top of the chimney from the south after the repairs, while for

comparison photo 1 was taken from almost the same viewpoint in March 2014. The masons have still to complete repointing the outside of the top. Some photos of both the site and the surrounding countryside (photos 4-6, 17) were taken while the masons were still at work and able to give easier access to the top. Most of the surrounding countryside is relatively featureless, but the top of the Parkfield chimney can just be made out hidden among the trees. That photo has not been included as the chimney is a tiny speck even on an enlarged copy of the photo. It was not possible at the time to take photos looking down on Vertical Engine House and the Old Boiler House, due to freshly-laid mortar on the top of the chimney. Photo 3 was taken before the concrete ring was cast, and gives an idea of the width of the masonry at the top.

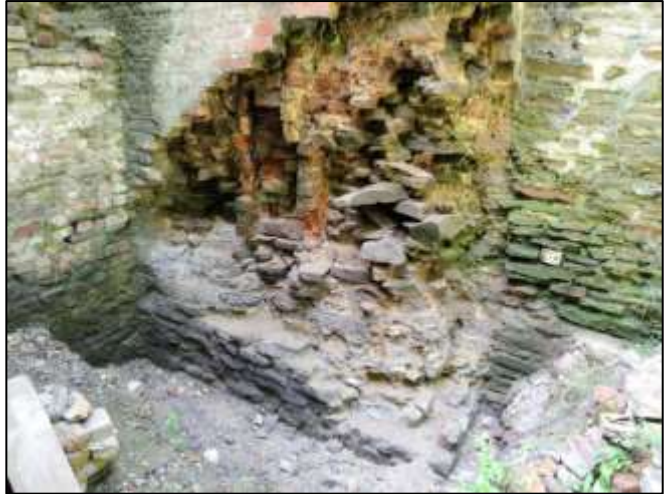
A start was made in October on the rebuilding of the base of the chimney in the Old Boiler House. At some time in the past, probably when the boilers were moved to the other side of the chimney, the flue to the chimney had been bricked up. Poor foundations had led to the collapse of the brickwork over time. The wagon plate, shown in the first FoBB Newsletter, was found here during exploratory trenching in 2013. The photo to the right shows the state of the base of the chimney before rebuilding started. By the end of October

the rebuild had reached the bottom of the flue, which is the vertical slot seen in the middle of the picture. A close-up of the flue can be seen in photo 7. It will be kept as a feature in the rebuild, which uses bricks recovered from the spoil in the floor of the Old Boiler House.

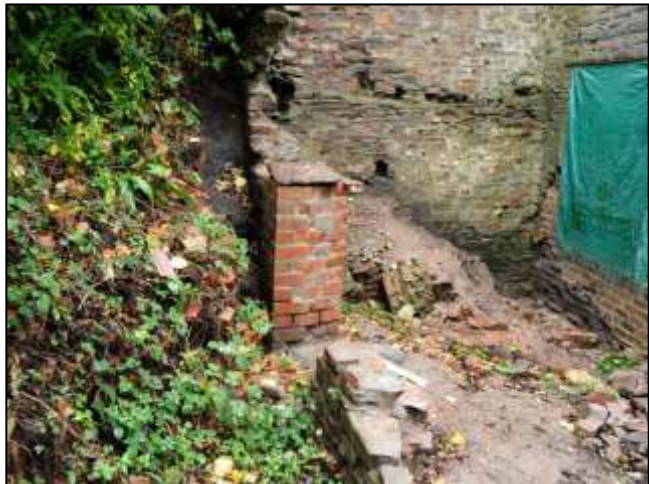
Part of the end of the north-east wall of the Old Boiler House was also rebuilt. This section was on the eastern side of what was probably a window opening, and the end of the partially rebuilt section can be seen in the centre of the photo on the right. The rebuild also used bricks recovered from the floor of the Old Boiler House. There is still some repointing to be done to the original bricks at the base of the wall, and the rebuilt section has still to be capped with some of the large Pennant stones recovered from the site in Pucklechurch.

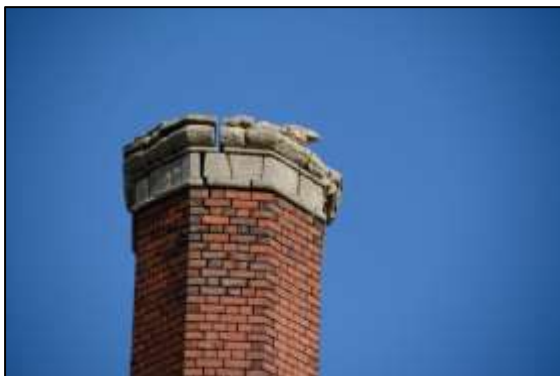
Photo 1 – View of the top of the chimney in March 2014. This was taken from about the same spot as the one of the finished top, seen on the first page.

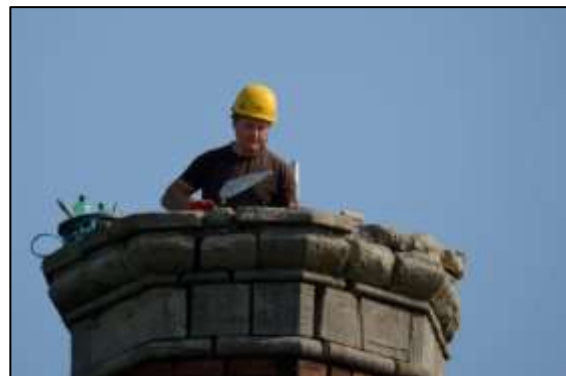
Photo 2 – One of the masons at work on the top of the chimney.

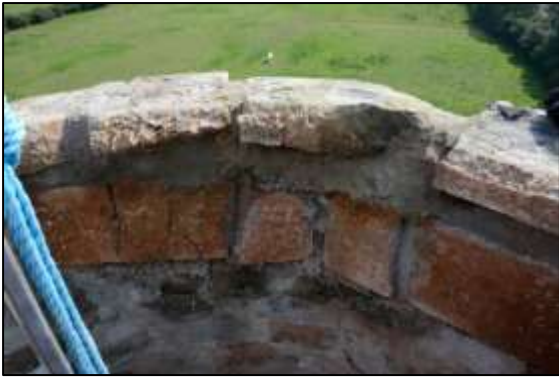
Photo 3 – Close-up of the top of the chimney during the rebuild, before the concrete ring was cast.

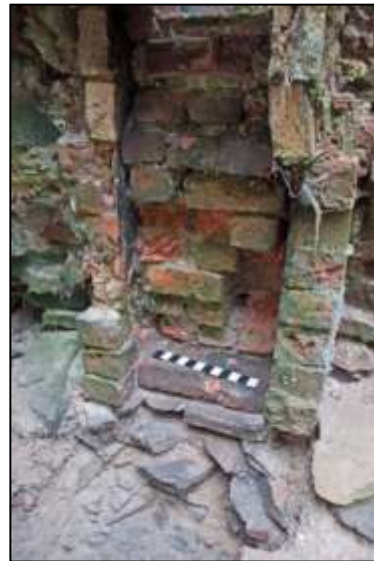
Photo 7 – Close-up of the bricked-up flue to the chimney in the Old Boiler House.

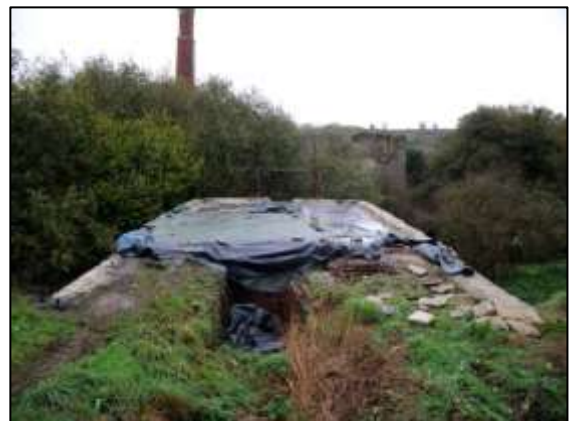
Photo 8 – Reconstruction work on the roof of the Horizontal Engine House underway at last.

The masons returned at the end of October to work on the roof of the Horizontal Engine House. By early November they had built up the top of the walls so that there is an enclosed space to hold the waterproof membrane. This can be seen in photo 8 after what had been a rainy night, but there is still some work to be done before the final waterproof membrane is laid. The sheets that can be seen in the photo are only an intermediate layer. The waterproof membrane will be covered with a protective layer of fine gravel. Photo 9 is a telephoto close-up of the eastern corner of the roof.

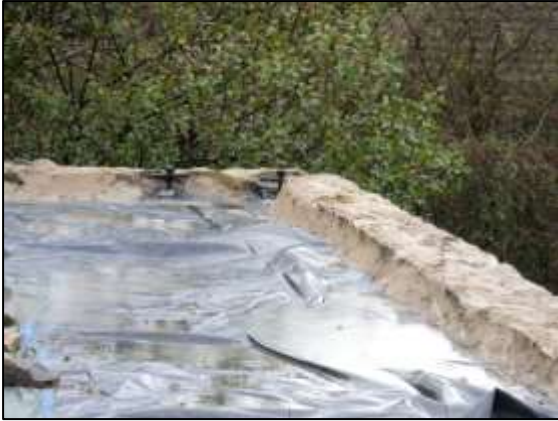
Photo 9 – Close-up of the eastern corner of the Horizontal Engine House roof, showing the rebuilt walls and an intermediate membrane in place.

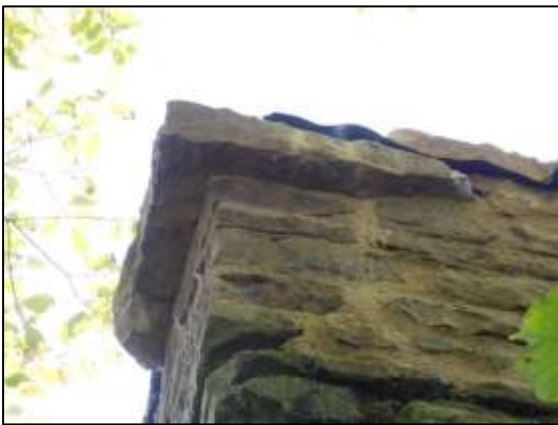
Photo 10 – Close-up of the northern corner of the Horizontal Engine House, showing the stonework placed to channel water draining from the roof away from the walls below.

Photo 10 is a close-up from below of the northern corner, showing the stones that have been placed to throw rainwater draining from the roof away from the wall below. The masons are due to finish work on the roof by the middle of November, assuming that there is a let-up in the current rainy weather.

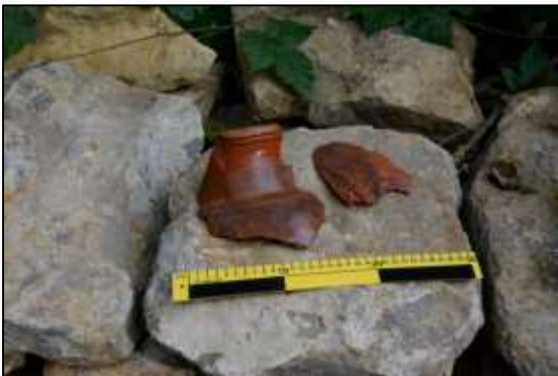
Photo – 11 Fragments of a large pot with a glazed interior, found in the winding drum pit, Vertical Engine House.

Excavation of the winding drum pit in the Vertical Engine House continued. The original bottom has been reached at both ends, but the centre, currently used for wheelbarrow access, has still to be cleared. While the south-western end was paved with flagstones, the bottom at the north-eastern end was a layer of oil-soaked spoil. Among the few notable finds were the remains of a window frame found in the north-east end. It was buried under some sizeable pieces of building stone, suggesting that the wall had collapsed around it. Two fragments of a large pot with a glazed interior (photo 11) were also found at this end.

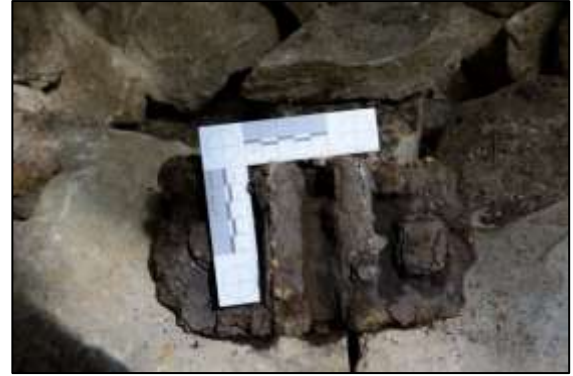
Photo 12 – Light rail chair found at base of north-west wall of the New Pit heapstead.

More of the path along the base of the north-west wall of the New Pit heapstead has been cleared, uncovering the two railway chairs seen in photos 12 and 13. While the one in photo 13 was probably used for the mainline railway, the other would have been used with the lighter rails found on the Dramway or on the mine's internal tram lines. Deciding which requires further research.

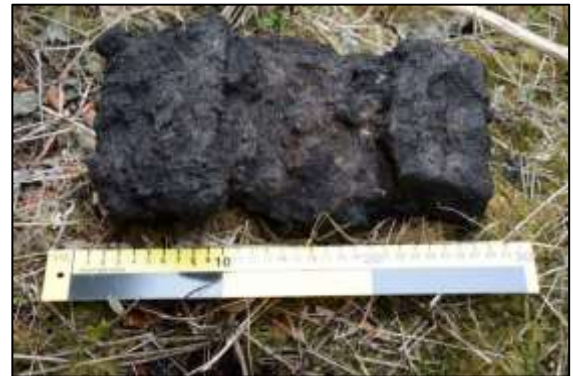
Photo 13 – Rail chair found at base of north-west wall of the New Pit heapstead.

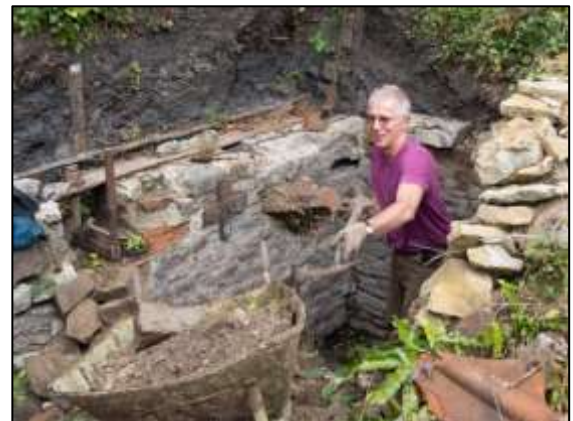
Photo 14 – The dirt is sent flying out of the winding drum pit in the Vertical Engine House.

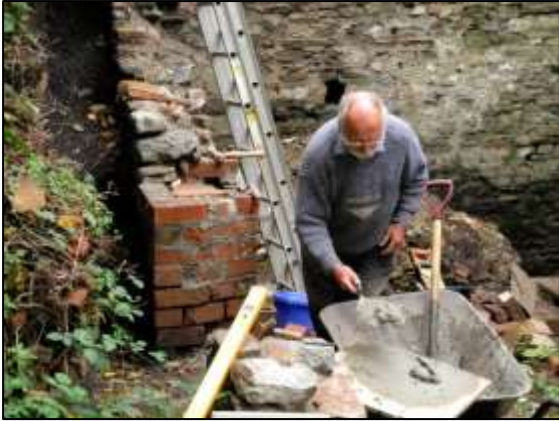
Photo 15 – Rebuilding the corner by the window in the Old Boiler House.

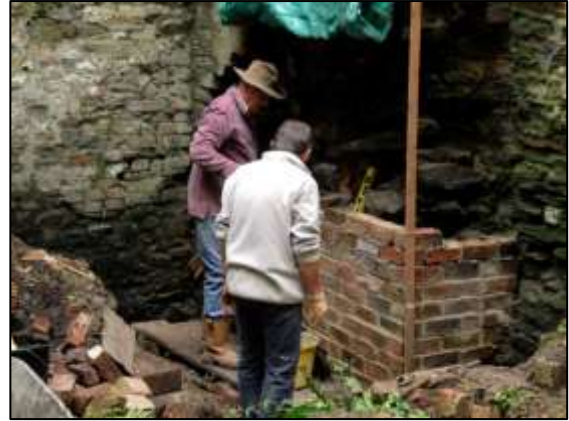
Photo 16 – Rebuilding the base of the chimney in the Old Boiler House.
