FRIENDS OF BRANDY BOTTOM COLLIERY, PUCKLECHURCH

Newsletter N° 15, May 2017

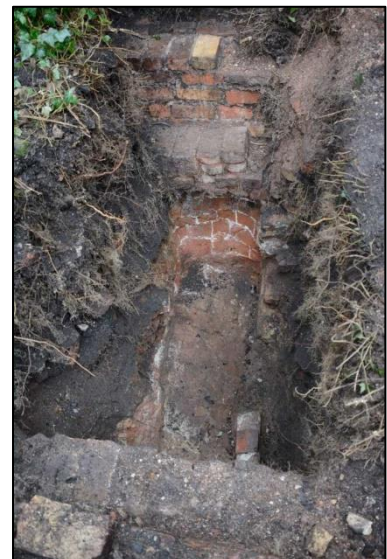
Further excavation work in February around the foundations for the egg-ended boiler uncovered the remains of the firebox (photo right). The light coloured brick, seen at the top of the photo and in close-up in photo 1, bears the makers name 'Johnson Andrew & Co' with a crown as an emblem. So far we have not been able to discover more about its maker. Hidden in the spoil were the pottery fragments seen in photos 2 and 3. The piece seen in photo 2 is part of an ornate item, as the surface is indented below the white markings that run diagonally across the piece.

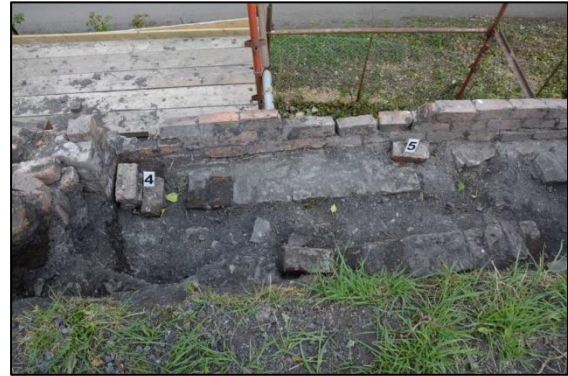
This year we intend to rebuild the tops of the walls of the New Pit heapstead to protect the walls against frost damage. The tops were cleared of spoil in the early part of the year so that detailed specifications could be drawn up for the rebuilding contract. This has highlighted some differences in construction between the north-west wall of the New Pit heapstead and its Old Pit equivalent. The adjacent photo shows part of the north-west wall of the New Pit heapstead. There appears to be a later

brick wall (beside the '5' in the photo) built across the face of what may have been a tippler slot, a feature which was not found on the Old Pit tippler slots. Photo 10 shows the section to the left of the '4' in the above photo, and there the construction is the same as that of the Old Pit slots.

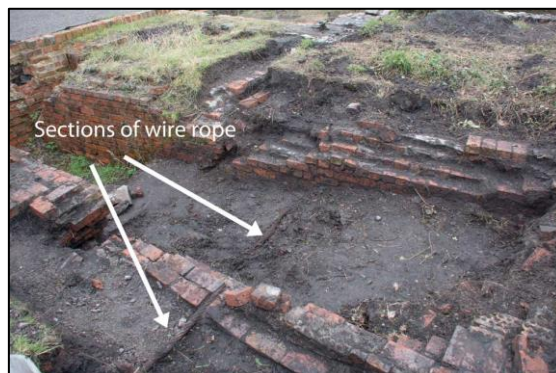
Spoil was removed from the winding ramp on the top of the New Pit heapstead. Stretched across the middle was a length of wire rope, which had originally been connected to another length on the outside of the north-west wall (photo right). The length outside the wall was formed into a loop that was connected to an anchorage point. Photo 19 shows the whole of the rope/anchorage in-situ, seen from the winding ramp end. In it, '1' marks the point where the wire rope was clamped back on itself and '2' where the loop is attached to the bolt. '4' marks the plate at the end of the bolt, which appeared to have been braced against some timber. Photo 20 shows the two pieces after lifting from the trench. The spoil removal revealed the asymmetric layout of the walls of the ramp, and photo 21 shows that the gap narrows towards the Horizontal Engine House. The right hand wall in the photo points towards the centre of the brick arch, while the left hand one points towards the edge of the arch. This suggests that the layout was changed at some time from the original twin cage to a single cage operation.

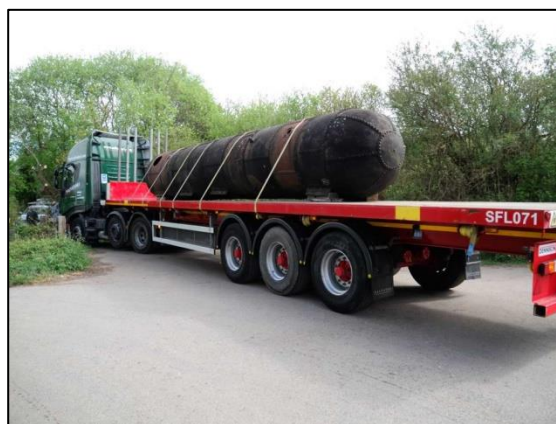
Photo 4 – Egg-ended boiler waiting to make its approach to Brandy Bottom ...

clearing the place in the 1960s. A replacement has been purchased from a collector in Kent, and it was delivered on an articulated lorry in April (photo 4). The driver was very skilful, as they invariably are, in manoeuvring his long vehicle off the cycle path, between the two fenced areas and the storage container and then alongside the temporary storage bank (photo 6). The intention is to put the boiler onto its original foundations outside the south-east wall of the Cornish Engine House, once that area has been cleared, so that it can represent some of the missing machinery.

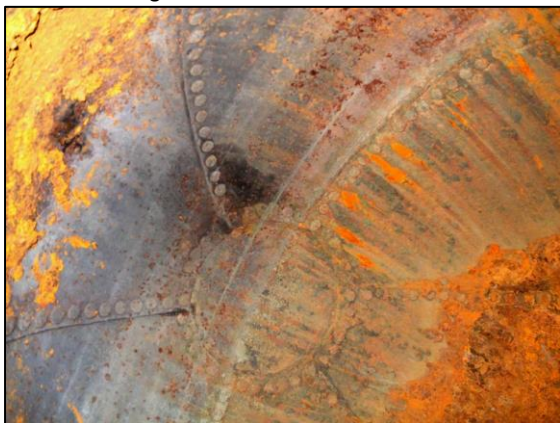
Photo 8 – The inside of one end of the boiler.

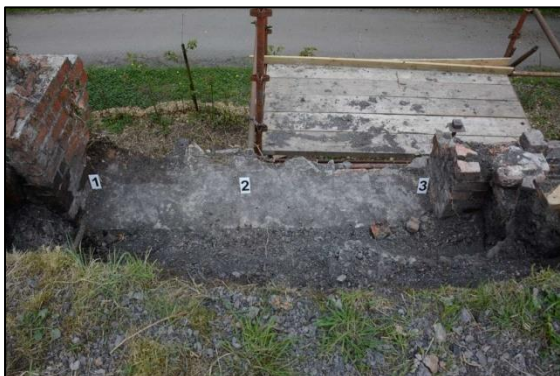
Photo 10 – Part of the top of the north-west wall of the New Pit heapstead, seen from above.

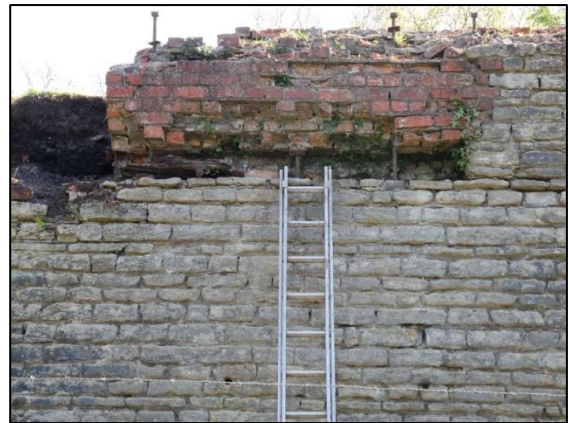
Photo 11 – Slot in north-west wall of the New Pit heapstead after the removal of the encroaching ivy. The left hand end of the brick section can be seen adjacent to the '1' marker in the previous photo.

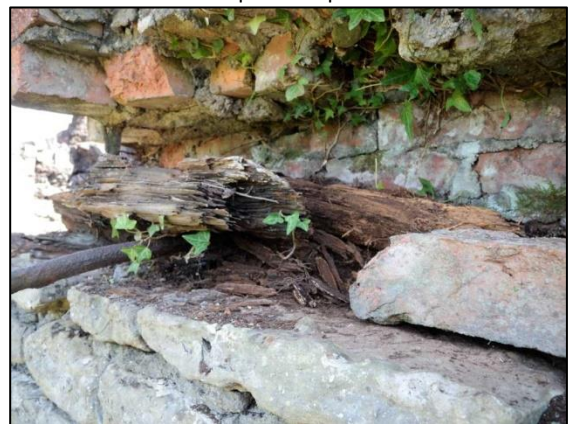
Photo 12 – The inside of the left hand end of the slot, containing a fragment of the original wooden beam.

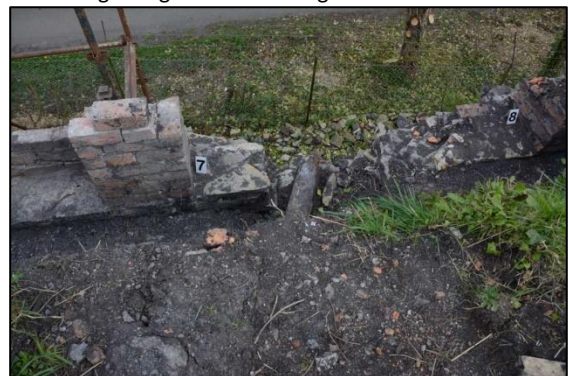
Photo 13 – The northern end of the north-west wall of the New Pit heapstead, with the remains of the drain pipe in the middle of the photo. (See comments on page 2)

More has been found out about the pipe located at the top of this wall, whose discovery was reported in the last newsletter and which can be seen from above in photo 13. We now know that it runs from the shaft and would have connected with the section of pipe found at ground level in 2014. That in turn appears to be connected with the nearest culvert feeding the pond, suggesting that the pipe drained water away from the top of the shaft.

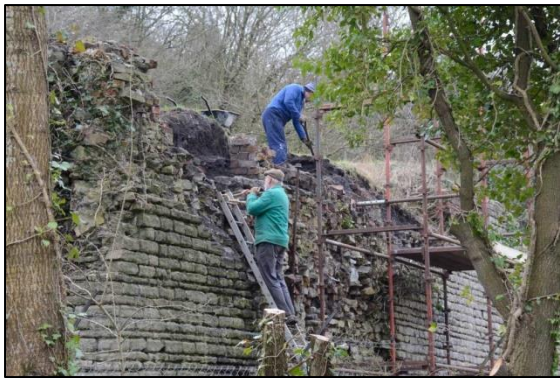
Photo 14 – The length and direction of the drain pipe in the north-west wall of the New Pit heapstead is probed, while spoil clearance continues above.

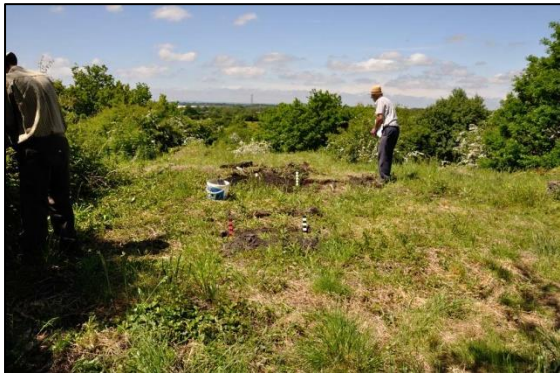
Photo 15 – Exploration work in July 2013 uncovered the foundations at the south-eastern end of the building that stood at the top of the New Pit heapstead ramp.

Examination of the 1947 and 1955 aerial photos of the site showed that there was a building at the top of the New Pit heapstead ramp. The 1947 photo shows a chimney on the south-western side of the roof, while the building is roofless in the 1955 one. The latter does indicate that there was a doorway at the eastern corner, something that was confirmed when the bottoms of the walls were uncovered in 2013 (photo 15). The interior was left undisturbed, and the presence of a brick floor was only discovered this year when the north-west end was cleared of spoil as part of the heapstead wall clearance (photos: right with 30 cm scales; 16 to 18). As can be seen from photo 17, the floor in the western corner of the building has subsided in the region around the '1' and '2'. However there is a definite plinth in another area, marked by '5' in the photo on the right and in photo 18. The brick floor has now been covered up again to protect it while the masons are working on the adjacent

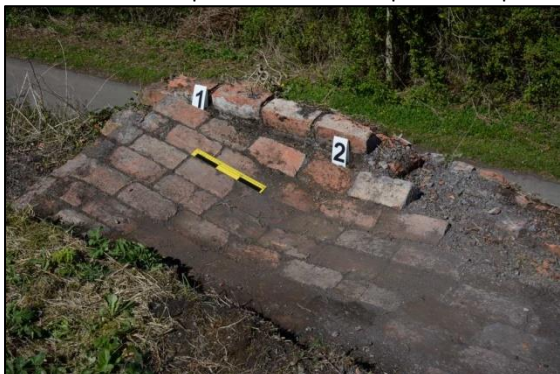
Photo 16 – Close-up of the western corner of the building after spoil removal. (30 cm scale)

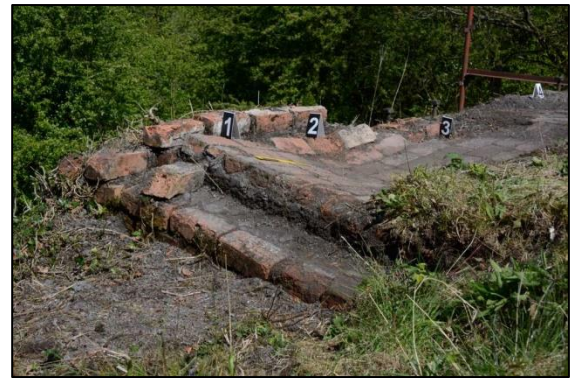
Photo 17 – The same corner as in photo 16, but from a different angle that shows the subsidence in the area around the '2' more clearly.

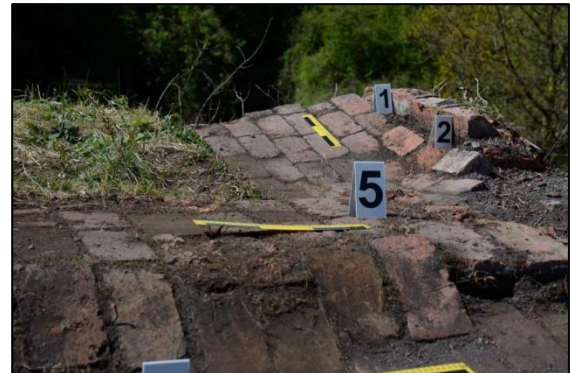
Photo 18 – Looking towards the western corner (marked by '1' and '2', with the raised plinth (marked '5') in the foreground. (30 cm scales)

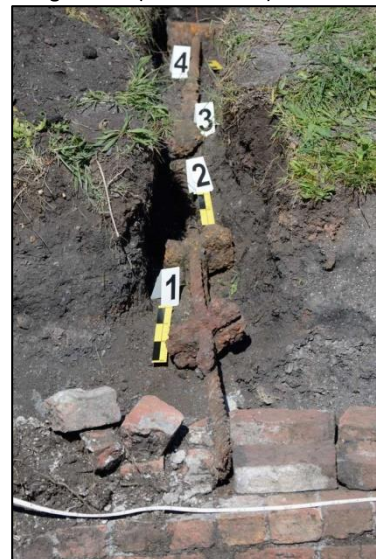
Photo 19 – The wire rope and anchorage point in-situ to the north-west of the winding ramp, New Pit heapstead. (30 cm scales)

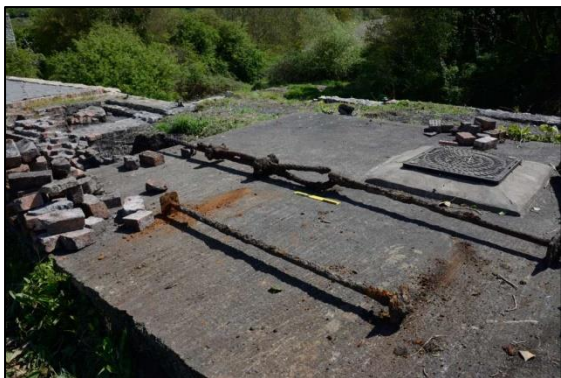
Photo 20 – The wire rope and anchorage point, seen in the middle of the photo, after removal from the trench. (30 cm scale below the loop in the wire)

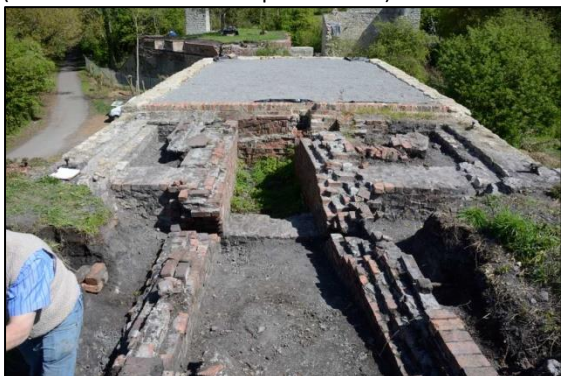
Photo 21 – The partially uncovered winding ramp of the New Pit heapstead. The gap between the walls narrows towards the Horizontal Engine House.

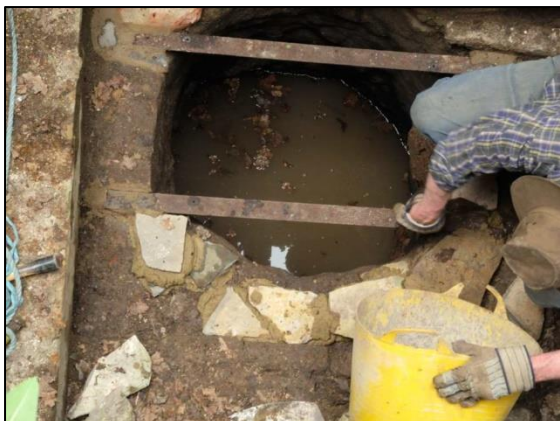
Photo 26 – Building the supporting framework for the sump cover in the Vertical Engine House ...

As the bulk of the pre-conservation work has been finished on the New Pit side, attention has returned to the Vertical Engine House. A protective cover is in the process of being fixed over the sump in the engine bay (photos 26 and 27), and more spoil was removed from under the engine bed.

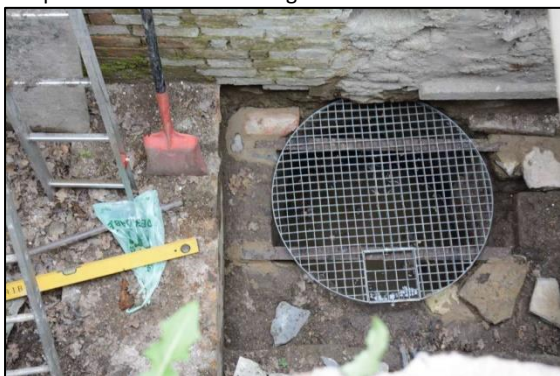
Photo 27 – ... and the cover is temporarily put in place to check the fit.
