FRIENDS OF BRANDY BOTTOM COLLIERY, PUCKLECHURCH

Newsletter N^o 20, August 2018

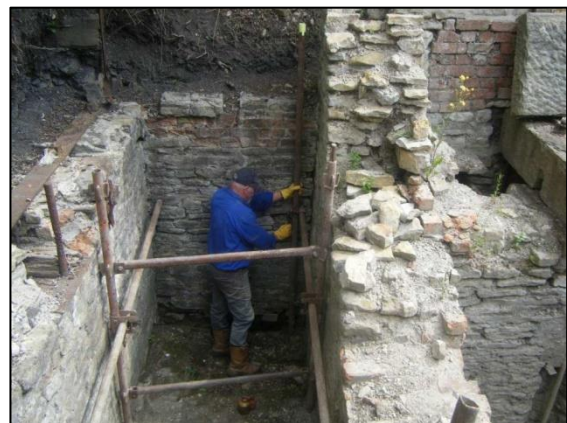
Scaffolding was erected in the winding drum pit of the Vertical Engine House to allow conservation work to start (photo right, © M Taylor). Photo 2 shows the north-eastern end of the wall between the winding drum pit and the engine bay before work started. The rough edges of the wall just to the right of the volunteer's head will be rebuilt to stop further weathering. The channel seen in the middle of photo 3 is positioned above the remains of the riser found in the winding drum pit in 2015 (photo 4). In that photo what appear to be the walls of the riser are in fact thick deposits of scale. The riser itself had probably been made of wood, which has decayed over time to leave just the scale in place. An edge view of a piece of scale (photo 5) shows that it had built up in irregular layers. The area around the window in the south-east wall has been rebuilt (photos 6-9), apart from replacing the original stone sill that had been vandalised. The majority of the outside of that wall has been repointed.

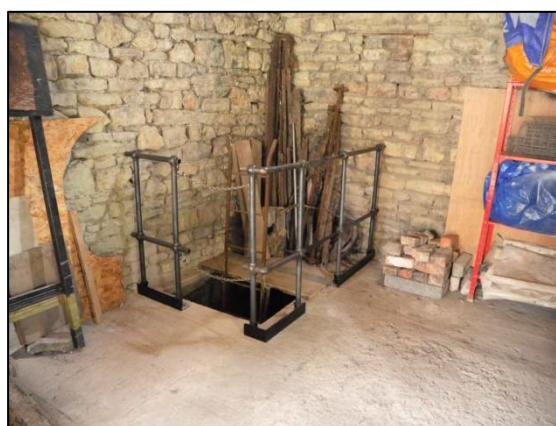
A safety barrier has been built around the new entrance to the undercroft of the Horizontal Engine House. The photo on the right shows the completed barrier, while photo 23 was taken during the build.

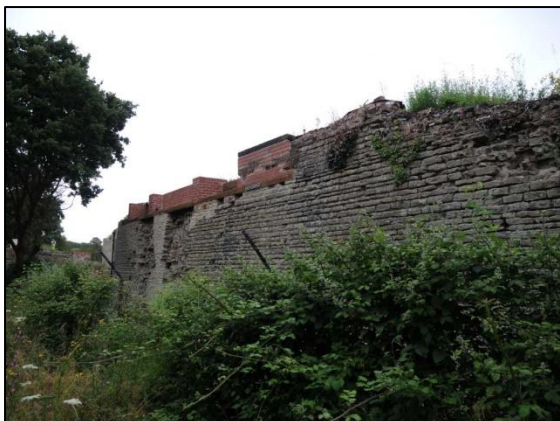
Photo 1 – North-west wall of New Pit heapstead after the removal of the scaffolding.

Drain holes have now been drilled through the walls of the New Pit tippler slots, allowing the scaffolding that has been covering much of the north-west walls of the heapstead to be finally taken down. A view of the rebuilt north-west wall of the heapstead can be seen in photo 1, taken from the cycle path. Two identifying signs, similar in style to those used in the Old Pit, have been fixed to the wall of the heapstead and the recently reconstructed tippler slots.

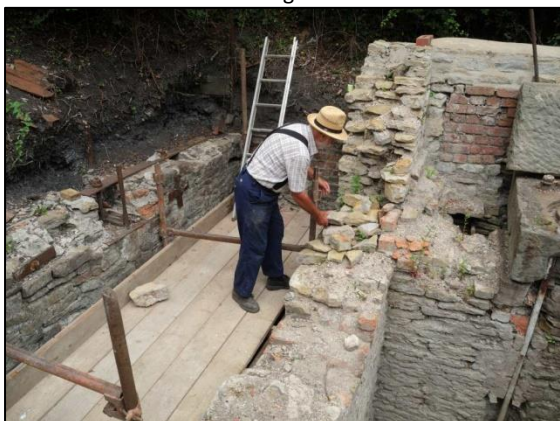
Photo 2 – Getting ready to rebuild the wall between the winding drum pit and the engine bay in the vertical Engine House.

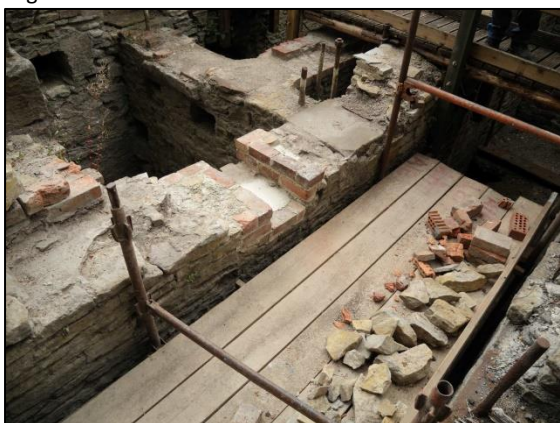
Photo 3 – The wall between the winding drum pit and the engine bay after the channel between the two had been rebuilt.

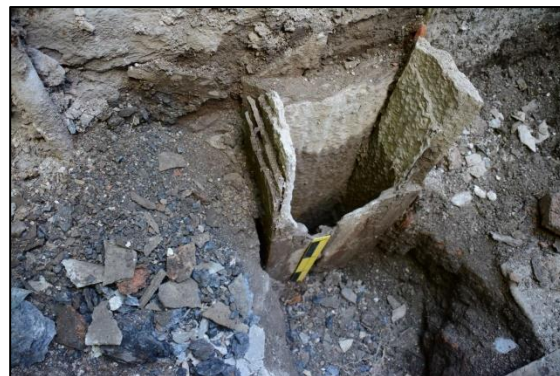
Photo 4 – Photo of scale deposited around the walls of a riser in the winding drum pit, Vertical Engine House, taken in 2015 as the spoil was being removed.

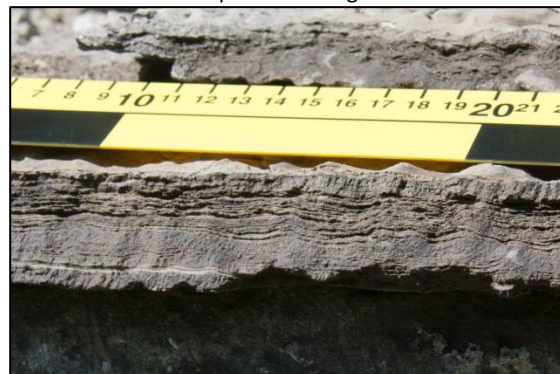
Photo 5 – Close-up of the edge of a sample of the scale seen in photo 4, which has been deposited over time in irregular layers.

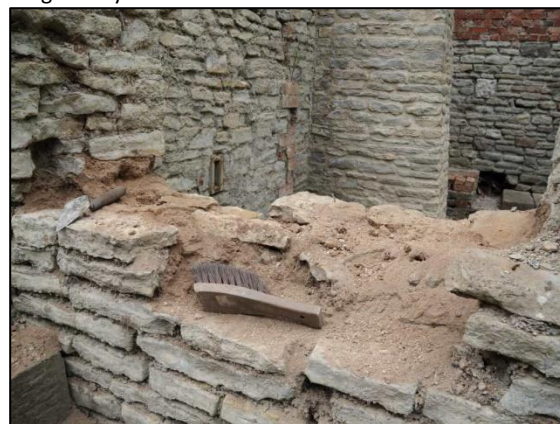
Photo 6 – The stonework around the window opening in the south-east wall of the Vertical Engine House before work started ...

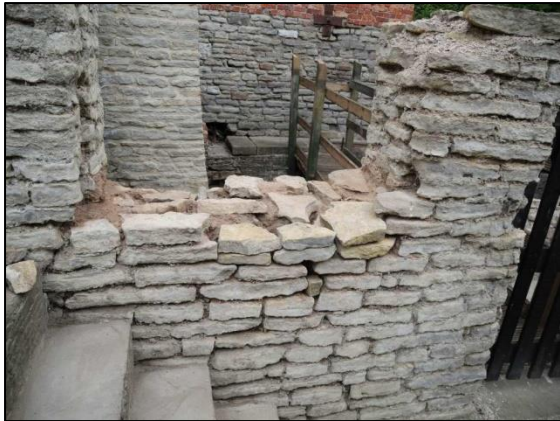
Photo 7 – ...after the loose mortar was cleared away ready for rebuilding ...

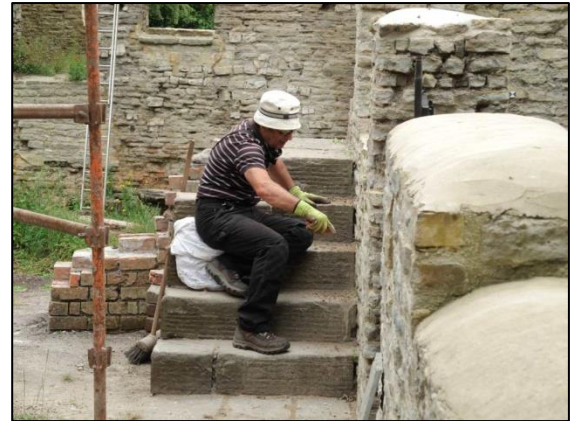
Photo 10 – Preparing the area seen in photo 7 for repointing.

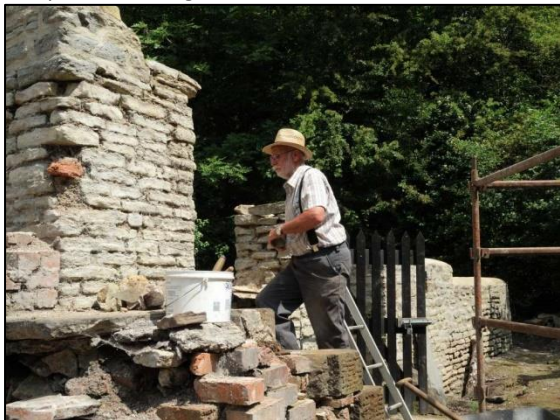
Photo 8 – ... Rebuilding in progress ...

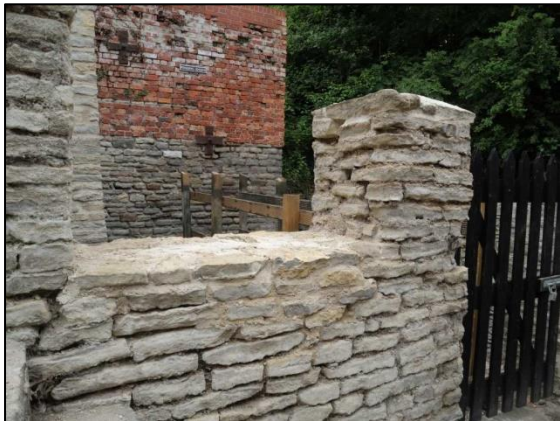
Photo 9 – ... and the almost finished result – a stone sill has still to be fabricated and laid. The area has been repointed after the photo was taken.

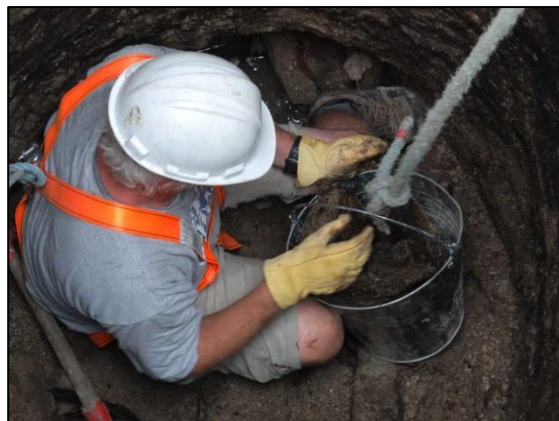
Photo 17 – Excavating spoil from the bottom of the shaft outside the entrance to the Vertical Engine House ...

Excavation of the brick-lined shaft outside the south-east wall of the Vertical Engine House resumed. This feature had been first discovered in 2013, but at that time had only been excavated to a depth of about 3 feet and its purpose was unknown. As the water table was reached at about 12 foot, a conduit appeared on the northern side. This conduit can be seen in the middle of photo 18, and we have established that it is linked to the well in the engine bay of the Vertical Engine House. That is known to be connected to the pond lying to the north-west of the cycle path. The connection was established by the low tech method of dropping a stone into one pool of water and checking the other for the resulting disturbance. It is possible that the brick-lined shaft was part of the water supply to the boilers. The recent drop in water levels allowed more spoil to be removed from the shaft in the Old Pit alcove. This uncovered two conduits, one heading north-westwards under the heapstead and the other heading into the New Boiler area. The former can be seen towards the top left of photo 21, while the other is underwater at the base of the opposite wall. Somewhere in all this maze of conduits will be the connection with the pond.

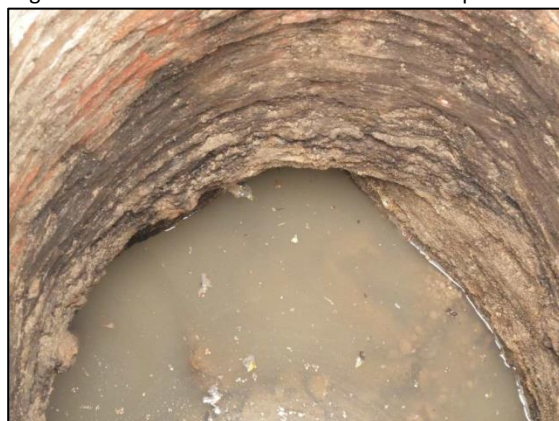
Photo 19 – ... the water-logged base of the shaft at the end of the work party ...

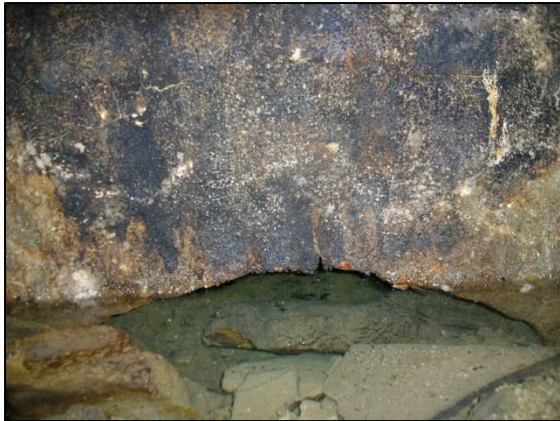
Photo 20 – ... A view of the same area as photo 19, taken from the bottom of the shaft at the start of the following work party. Note the clarity of the water. (© K Kemp)

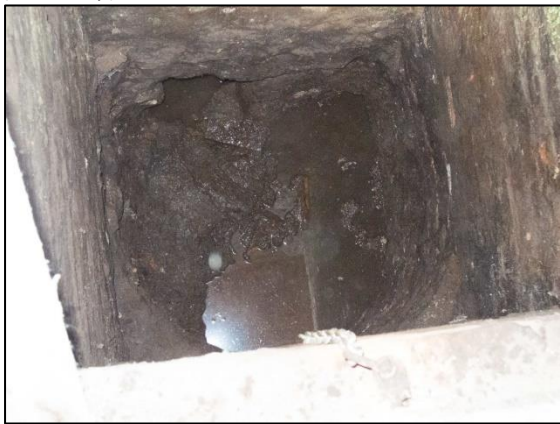
Photo 21 – The recently deepened bottom of the well in the Old Pit alcove. The conduit seen towards the top left of the photo goes under the heapstead.

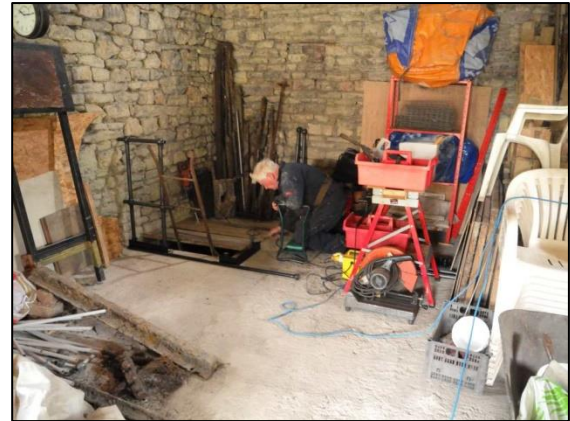
Photo 23 – Building the safety barrier around the new entrance to the under croft of the Horizontal Engine House.
