# FRIENDS OF BRANDY BOTTOM COLLIERY, PUCKLECHURCH

Newsletter N<sup>o</sup> 21, November 2018

## Progress: August – November 2018

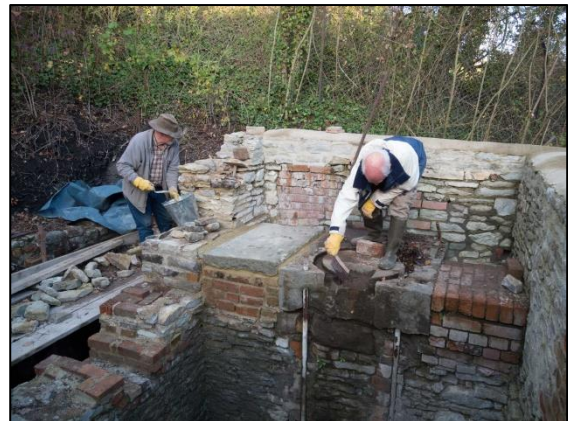
There has also been progress in conserving the area around the steps outside the entrance to the Vertical Engine House. As can be seen from photo 6, the mortar had weathered away, and the stone slab at the top of the stairs was unsupported at its left hand end. The photo on the right shows the progress made by mid-November. At the end of

that work party the stone slabs, seen here in temporary positions at the top of the photo, were re-laid on top of the flat platform. An attempt was also made to find the eastern end of the flue bricks, as this might give us clues about the position of the boilers. We did not find the end, just a tantalising sight of some more bricks (photo 9). We also found what is thought to be a metal pipe support, seen in photo 10, in this area. Work had to be stopped as the excavations got in the way of the movement of people and wheel barrows going to and from the Vertical Engine House.

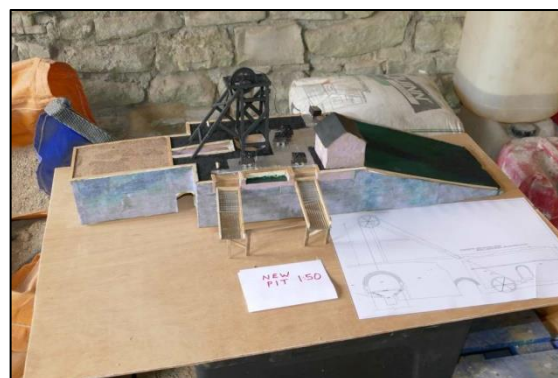
One of the new items on display over the weekend in the temporary visitor centre, so new that it had not been fully finished, was Hamish Orr-Ewing's 1:50 scale model of the New Pit (photo right). It represents what the New Pit might have looked like in its heyday, complete with headgear, loading screens and loaded 'coal' skips on the top of the heapstead – it survived being played with as a toy by some of the younger visitors. The three 'Local Industrial Heritage' boards, which were produced

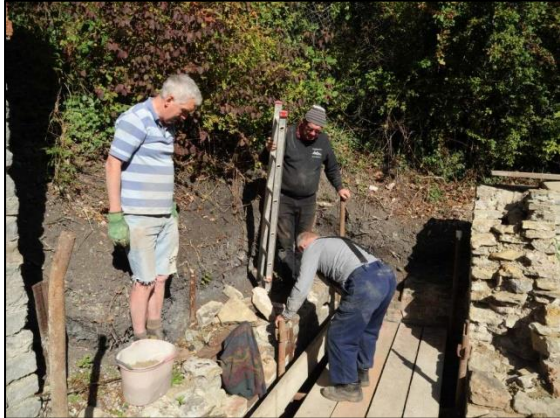
Photo 1 – Working on the scaffolding across the top of the winding drum pit, Vertical Engine House.

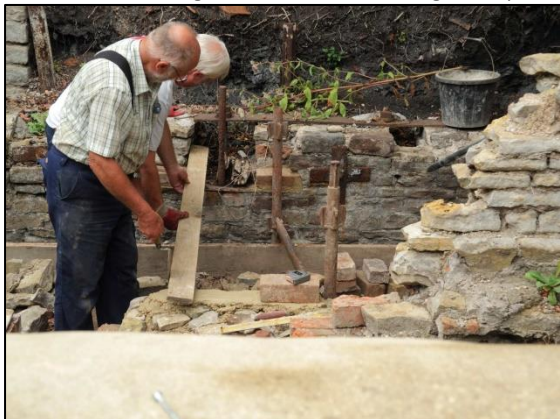
Photo 3 – ... During the rebuild, the edge of the rebuilt beam slot in the south-eastern wall was aligned with that of the existing slot in the north-western wall.

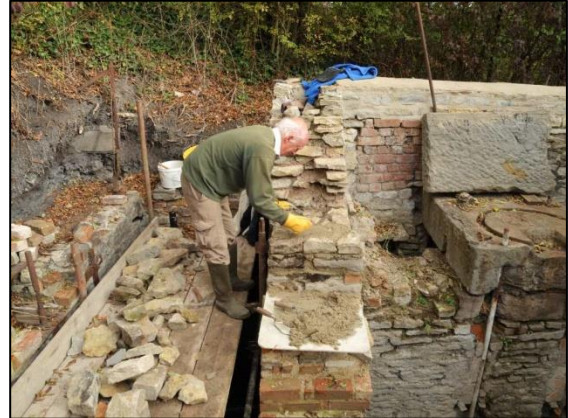
Photo 4 – Rebuilding the wall between the winding drum pit (on the left) and the engine bed in the Vertical Engine House.

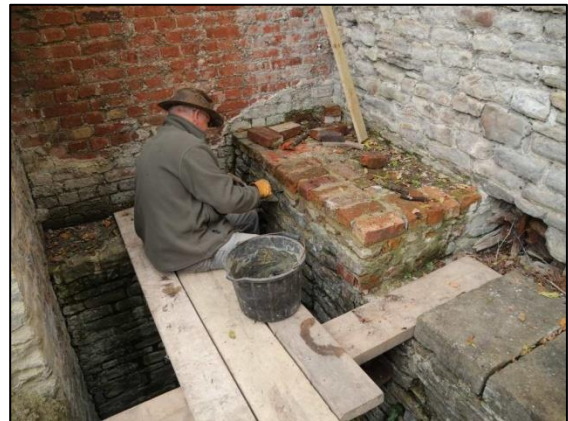
Photo 5 – Missing bricks have been replaced on the platform in the western corner of the Vertical Engine House.

Work continued on rebuilding the tops of the walls of the winding drum pit in the Vertical Engine House. This has been spread out throughout the quarter, with a break for a site tidy-up before the Heritage Open Days weekend. The main aims are to seal the walls against water penetration and any resulting frost damage, and to repair damaged or missing walls where it is obvious what is missing, using matching salvaged material. The photo on the right shows the progress made at the north-eastern end of the building by mid-November. A large slab of stone, seen lying against the far wall in photo 4, has been returned to its position in the gap on the north side of the engine bed. Photos 1 to 4 were taken at various times during the quarter. The bricks that were missing from the edge of the platform in the western corner of the winding drum pit have been replaced (photo 5).

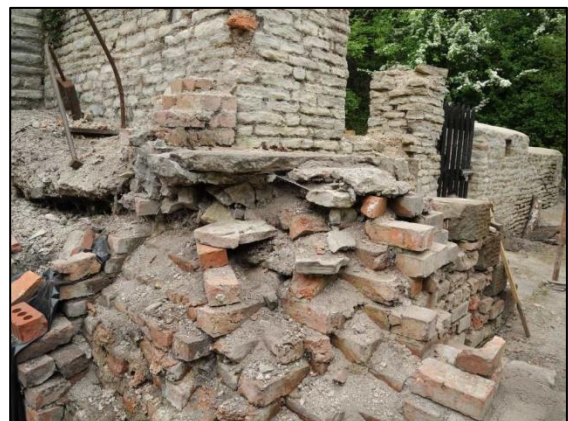
Photo 6 – The brickwork at the end of the East Flue and the steps outside the entrance to the Vertical Engine House in May 2018.

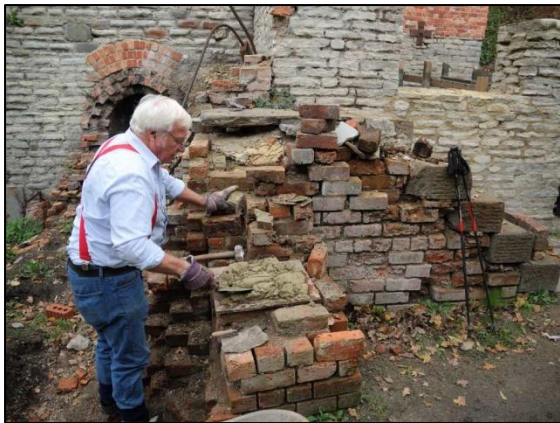
Photo 7 – Rebuilding in progress of the brickwork under the steps outside the entrance to the Vertical Engine House.

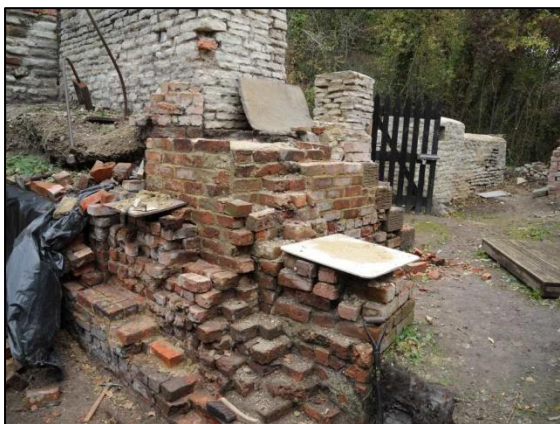
Photo 8 – Another view of the same area, taken in early November.

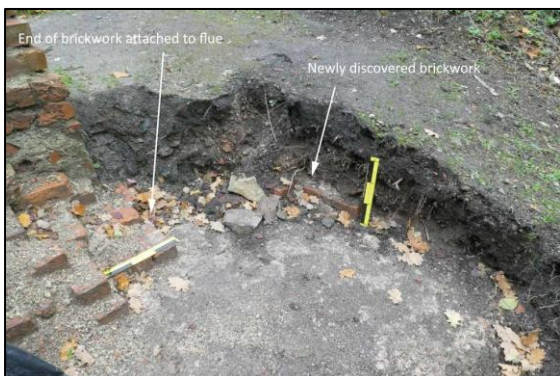
Photo 9 – View of the excavated area at the end of the East Flue. The left hand arrow marks the end of the brickwork attached to the flue, while the right hand one shows the start of the newly discovered brickwork. There are signs that the bricks were originally laid across the gap. The flat surface in the foreground is the base of the flue. (30 cm scales)

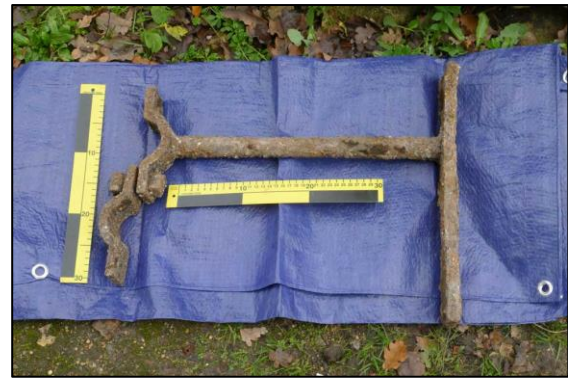
Photo 10 – Iron pipe support, found at the south-eastern end of the East Flue. The central rod is 16" long, and the clamp on the left could accommodate a 2" diameter pipe when fully closed. (30 cm scales)

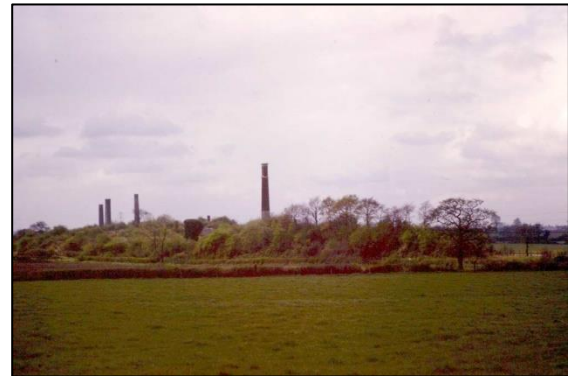
Photo 11 – The Brandy Bottom chimney can be seen in the centre of the photo, with those of the Shortwood brickworks are on the left. (© R Stiles, 1977)

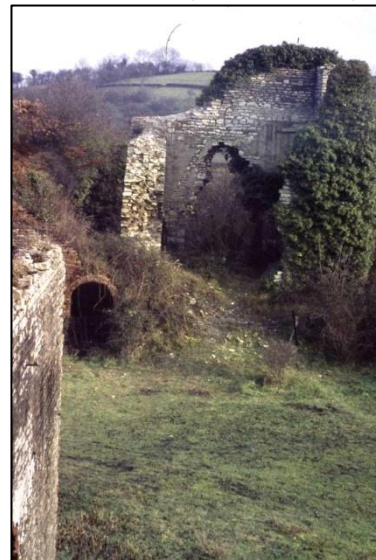
Photo 12 – The Cornish Engine House from the top of the New Pit heapstead. (© R Stiles, 1977)

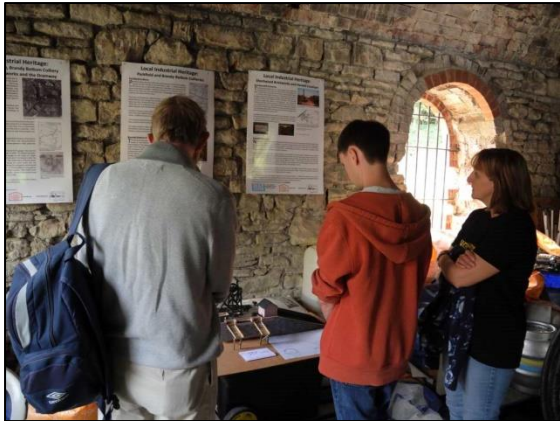
Photo 19 – Visitors on the Heritage Open Days weekend looking at H Orr-Ewing's 1:50 scale model of the New Pit heapstead. (See photo on top of page 3) The three 'Local Industrial Heritage' display panels can be seen on the wall behind the visitors.

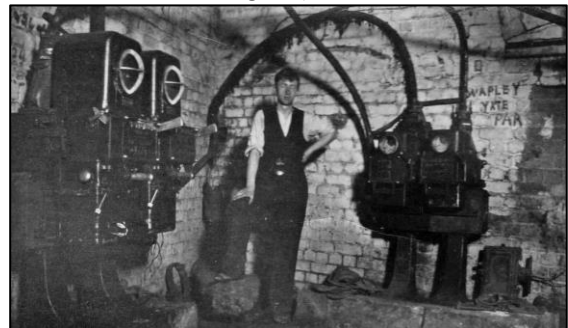
Photo 24 – Underground worker in an electrical switch room at Parkfield. (Photo from the K Gardner collection and caption based on the work of D P Lindegaard)

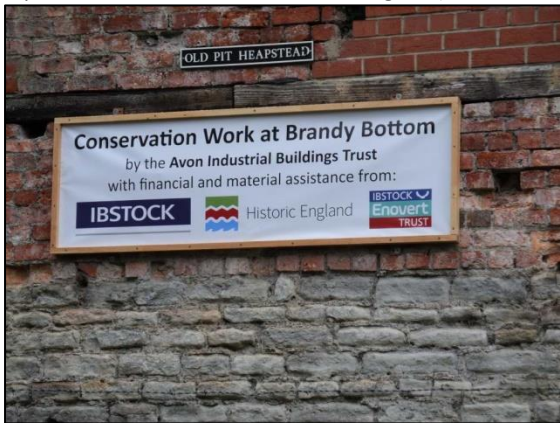
Photo 26 – One of the sponsors' banners has been fixed permanently to the Old Pit heapstead, so that it can be seen by passers-by at all times.

One of our banners, acknowledging the financial and material assistance given to the project by Historic England, Ibstock and the Ibstock Enover Trust, has been permanently fixed to the wall of the Old Pit heapstead (photo 26). It can now be seen by passers-by at all times.

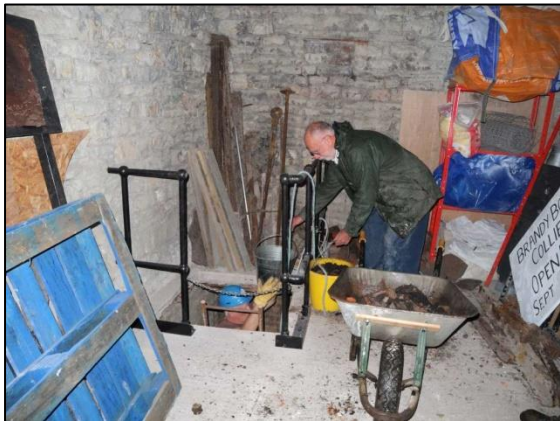
Photo 27 – Spoil being removed from the undercroft of the Horizontal Engine House.

It was raining on the first work party in October, something that is not a good idea if you plan to continue the rebuild of the masonry of the East Flue or the Vertical Engine House. Instead work started on clearing the rubble from the area under the concrete floor of the Horizontal Engine House. It was one of those tasks that had been 'saved for a rainy day' as it was under cover, though the diggers in the undercroft found it was warm work. The south-west end was cleared down to a brick floor (photo on top of next page), and a start was made on clearing the oil/grease-soaked debris from the central aisle. It is thought that the oil/grease came from a combination of the oil used for lubricating the machinery and the grease used on the winding ropes. Some more views of

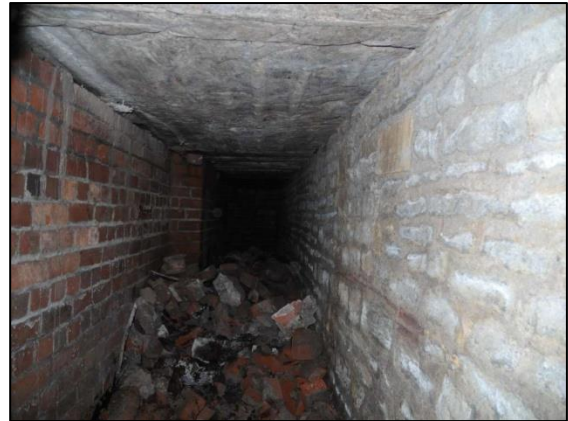
Photo 28 – View along the south-eastern side of the undercroft, showing the pile of bricks that will have to be removed.

the area can be seen in photos 28 to 30. The bricks are being recovered and stockpiled for future use. They included a number of bull-nosed bricks and also two tapered firebricks. One is marked 'Rufford Stourbridge' (photo 32), while the other one has a 'B' (photo 33). We have found a number of 'Rufford' bricks elsewhere in the site, but this is the first brick marked with a 'B'. Some bricks marked with 'Bovey' have been found in the past, so it is possible that the latest brick carries a variation of their mark. Further progress with clearing the undercroft will depend on the arrival of rainy days, as there is still plenty of work to be done elsewhere. Nobody is looking forward to removing and cleaning the large numbers of bricks that have been dumped in there.

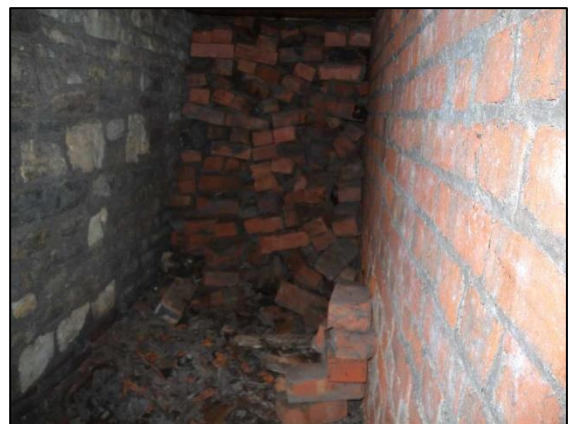
Photo 29 – Bricks stacked up on the north-west side of the undercroft. Judging by the view from the other end of the undercroft, they appear to be stacked against a pillar.

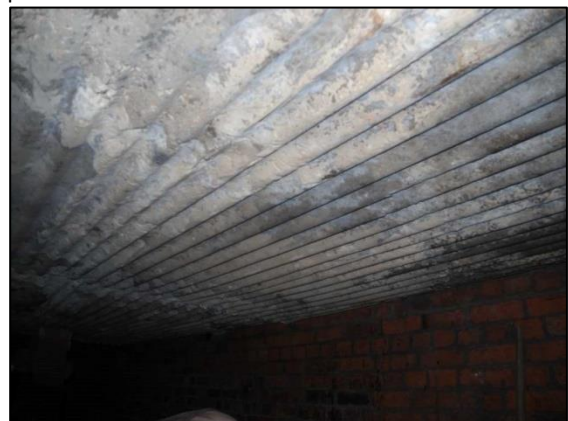
Photo 30 – The underside of the false floor of the Horizontal Engine House, taken at the south-western end of the central bay of the undercroft.

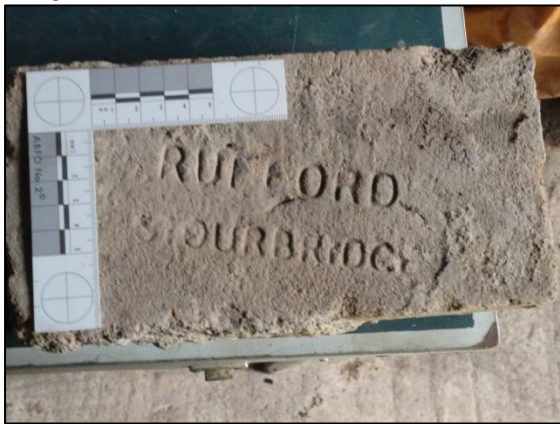
Photo 32 – Tapered firebrick, found in the under croft of the Horizontal Engine House, with the maker's mark 'Rufford Stourbridge' stamped onto one face. A similarly marked brick was found in the Vertical Engine House in 2016. The other tapered firebricks found, with the exception of the one seen below, have not been marked with a maker's name.

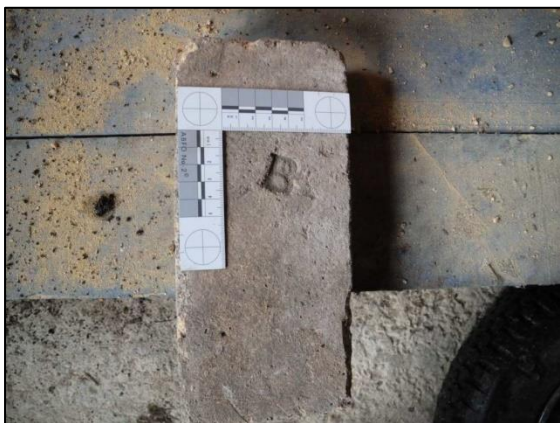
Photo 33 – Tapered arch firebrick, found in the under croft of the Horizontal Engine House, with the maker's mark 'B' stamped onto one face.
