Friends of Brandy Bottom Colliery Pucklechurch

Newsletter N° 37, February 2024

Progress: May 2023 – February 2024

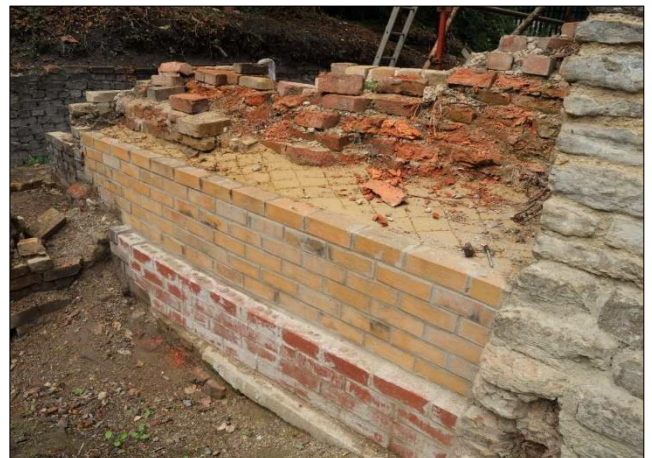
Photo 2 – The completed repairs to the bottom section of the wall seen in photo 26 of the previous newsletter (N° 36).

The initial stage of rebuilding the brickwork at the north-east end of the Egg-ended Boiler settings was completed, as can be seen from photo [2](#) on the right.

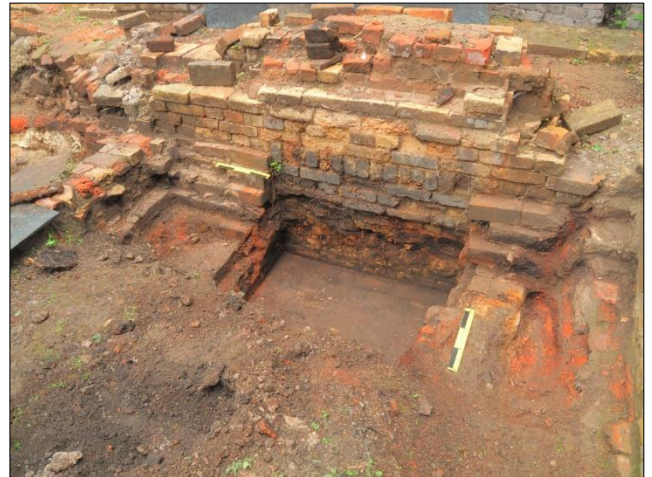
Photo3 – The south-eastern end of the Lancashire Boiler setting furthest from the Cornish Engine House (See comments about the brick floor on p.[2](#)). (30 cm yellow/black scales)

The bricks in the floors of the two boiler setting are laid in different orientations – those in the setting adjacent to the Cornish Engine House are laid across the line of the boiler (photo [3](#)) while those in the other setting run along the line of the boiler (photo [22](#)). Both Steve H and Derek have visited the Lancashire boiler set-up at the Crofton Pumping Station and brought back photos of the layout there to help with our understanding of the Brandy Bottom layout.

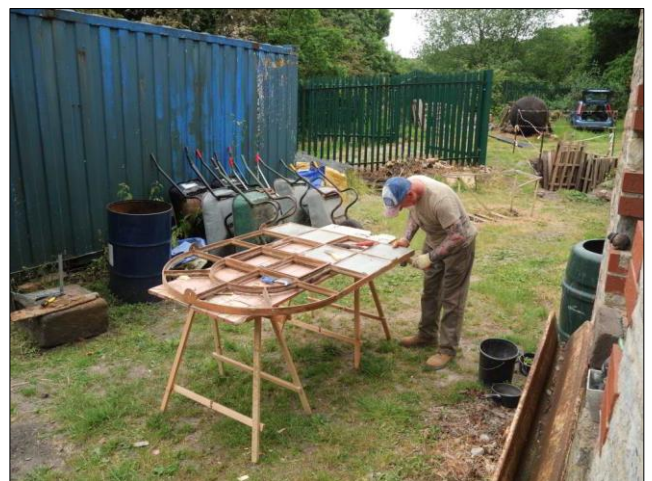
Photo 4 – John cleaning one of the cast iron window frames that will be fitted into the window openings of the Horizontal Engine House.

John has spent several work parties cleaning the cast iron window frames that Hamish obtained (photo [4](#) right), often working in isolation from the rest of the crew. His attempts to recover some of the glass panes have been frustrated by the ancient rock-hard putty. The plan is to fit these frames, with Perspex as the glazing, to the windows of the Horizontal Engine House. This might make the HEH slightly less draughty during winter lunch breaks, when everybody sits well wrapped up to eat their 'pieces' and there are cries of "will somebody close the windows."

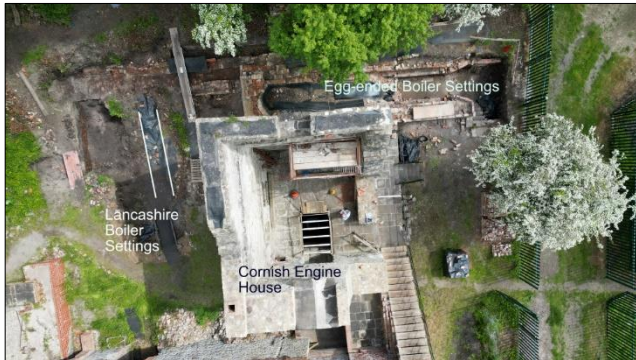
Photo 10 – Annotated aerial photo of the Cornish Engine House (middle), Egg-ended Boiler settings (top right) and Lancashire Boiler settings (left), taken in May 2023. (Drone photo © Toby Hore, 2023)

Derek arranged for a drone survey of the top of the walls of the Cornish Engine House in May. The survey was used to plan what needed to be done to the tops of the walls, something that could not be done from ground level. One of the survey views is shown as photo [10](#). This has been annotated to show the positions of the Egg-ended Boiler settings, and those of the Lancashire Boilers. A scaffolding tower was built in June on the outside of the south-east wall of the Horizontal Engine House (photos [12](#) and [13](#)), in addition to the tower on the inside of the wall. This has allowed some fallen stones above the window to be replaced. In addition, voids in the wall have been pressure grouted to increase the stability of the structure. The extent of the damage on the outside of the wall can be seen in photo [14](#), while

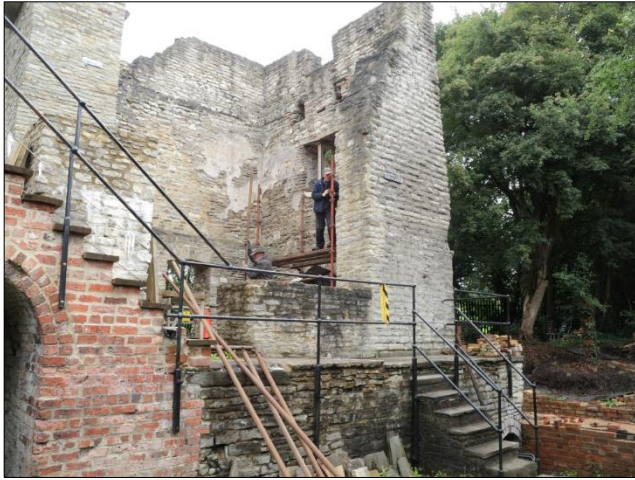
Photo 15 – ... and the same area after repairs were finished.

photo [15](#) is a view of the same area after the repairs were completed. The inside tower was dismantled at the beginning of August (photo [16](#)), while the outside one was left up until after the HODs.

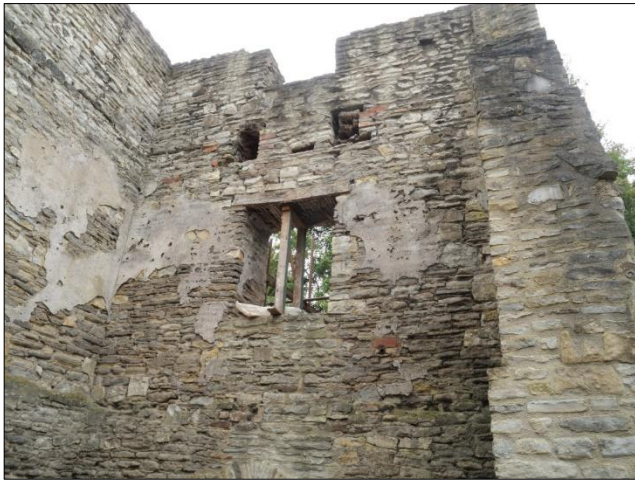
Photo 17 – The inside of the south-east wall of the Cornish Engine House after repairs were completed.

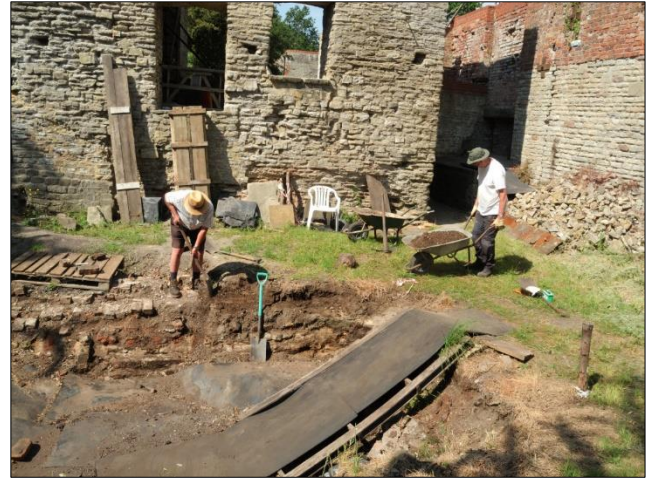
Photo 18 – View of the excavations in the New Boiler area. The photo was taken in July from the top of the Old Pit heapstead, with the north-east wall of the Cornish Engine House on the right.

The volunteer gang moved into the New Boiler area in June (photo [1](#)), hitherto the preserve of Tim and his sons. More of the two brick bases of the boiler settings have been uncovered (photo [18](#)) together with an open area to the north-east (photo [23](#)). The latter had a layer of dark material covering the floor (photo [25](#)), thought to be compacted coal dust. Many of the clay and fire bricks in this area are badly decomposed and conservation work started after the HODs. Photo [31](#) shows Ken and Mick at work on the Lancashire Boiler settings nearest the Cornish Engine House in November, while Hamish is working on the settings furthest away in photo [32](#), and Steve H is working on the Egg-ended Boiler settings in photo [33](#). Photos [35](#) to [40](#) were taken between November 2023 and January 2024 and show work in progress in both the New Boiler area and the Egg-ended Boiler settings. Photo [42](#) was taken in January and shows the rebuilt brickwork of the Lancashire Boilers' settings covered up against the winter weather.

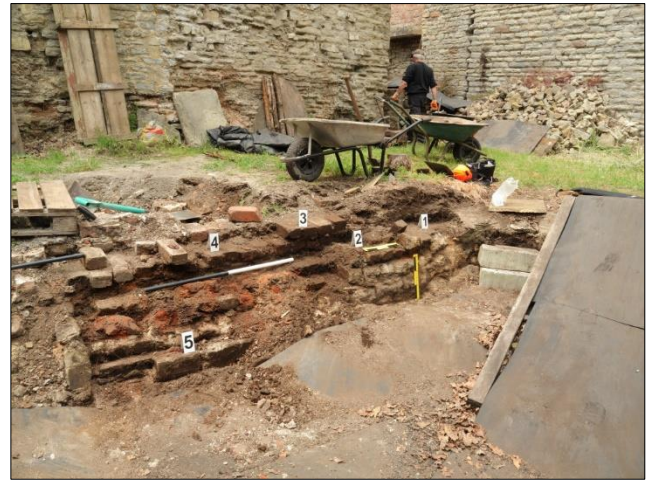
Photo 20 – The number tents do not signify any particular areas of interest, but act as a key to other photos taken of the area. (1 m black/white ranging pole, 30 cm yellow/black scales)

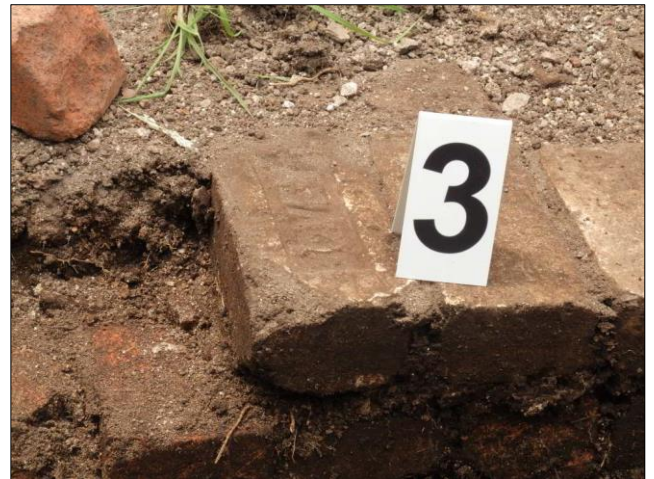
Photo 21 – One of several Bovey firebricks found when clearing the area seen in the photo above.

The investigation into the maker of the firebrick seen in photo 19 of the last newsletter (N°36) continues. The best lead so far has been an advertisement in volume 15 (1866) of the splendidly named *Journal of Gas Lighting, Water Supply and Sanitary Improvement*. In it, E Baker and Co are offering firebricks, gas retorts, garden edgings and ornate house bricks from premises in London's Paddington. The address suggests it is a storage depot for a Stourbridge factory and the last line is: "Shipments at the shortest notice."

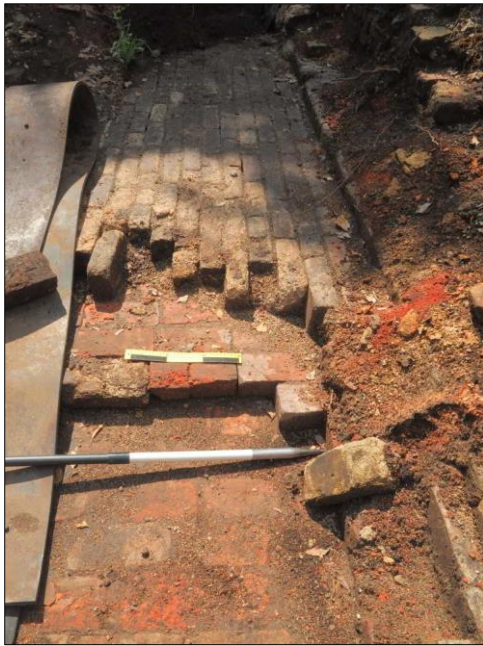
Photo 22 – Brick floor of the boiler setting furthest away from the Cornish Engine House. The brick courses in this setting run along the length of the setting (See comment on p.2). (1 m black/white ranging pole, 30 cm yellow/black scale)

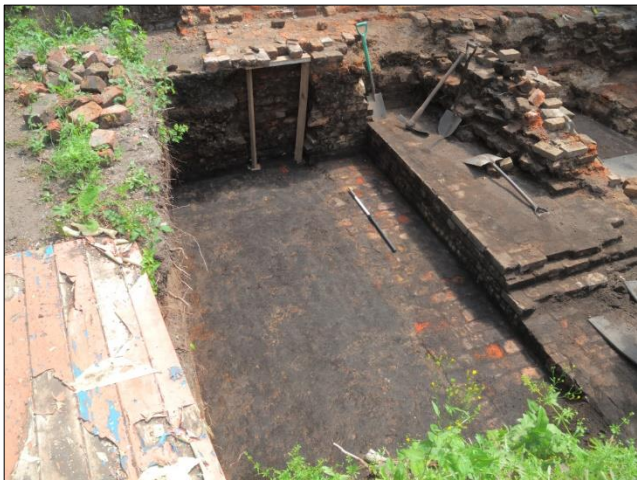
Photo 23 – Partially excavated bay to the north-east of the boiler settings. This is where the firebars seen in photo 27 were found.

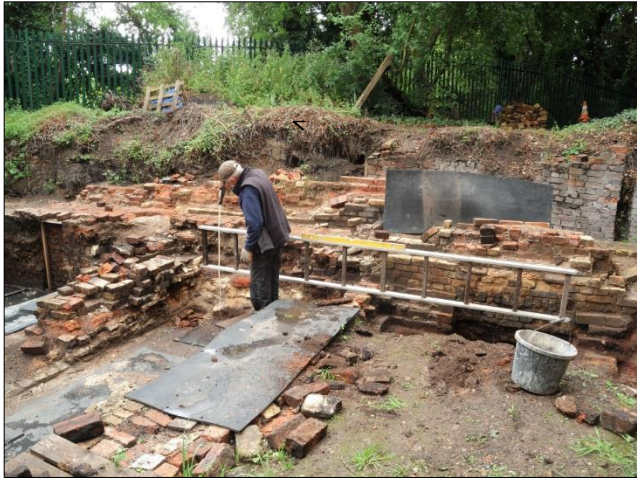
Photo 28 – Marek measuring the difference in heights between the two brick boiler bases in the New Boiler area. He is using as a reference point the top of a ladder, which was levelled with the aid of the yellow spirit level seen just behind him.

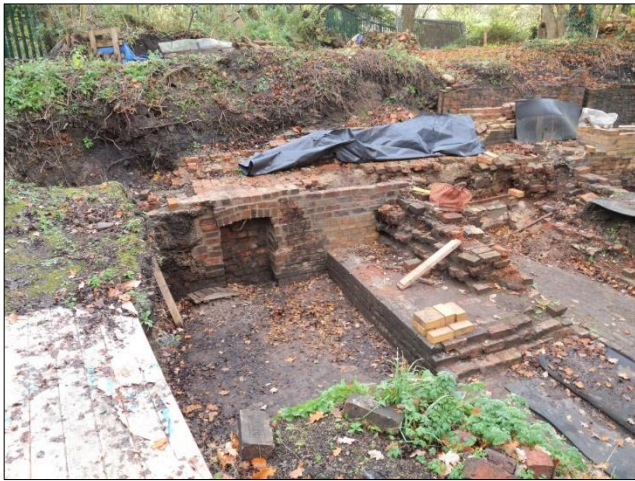
Photo 41 – The brickwork at the eastern end of the Lancashire Boiler settings during the rebuild (Note the rebuilt brick arch over the recess in the wall at the back left) ...

Photo 40 – Pete W and Steve H backfilling the newly built brickwork on the south-west end of the Egg-ended Boiler settings with concrete.

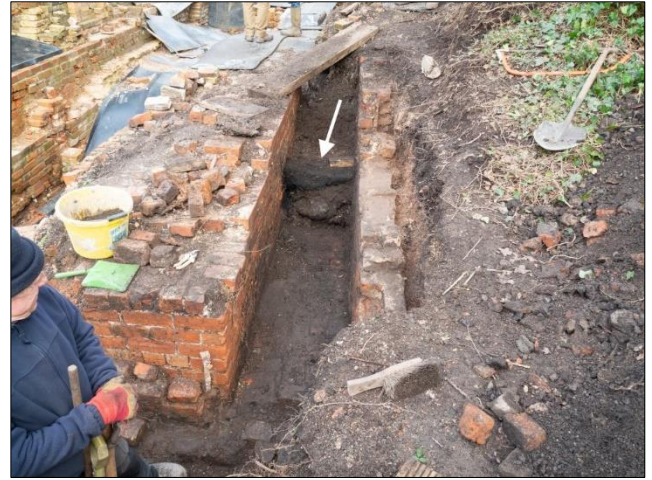
Photo 43 – A layer of dark material, possibly compacted coal dust, was found in the flue to the east of the Egg-ended Boiler settings. Here its position is marked by an arrow, while there is a close-up in the following photo ([44](#)).

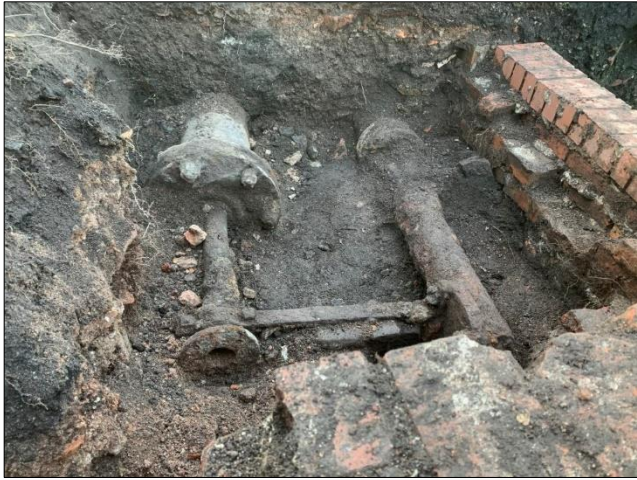
Photo 45 – The Egg-ended Boiler end of the two pipes connected to the sump by the gate to the New Pit yard. (See comments on [p.2](#)) This view was taken from the south-west... (Two 1 m black/white ranging poles)

Work has continued on the site's water distribution system. The area around the end of two metal pipes beside the Egg-ended Boiler has been excavated. These had been previously traced as running from the chamber near the New Pit vehicle entrance. Photo [45](#) shows the area after excavation, while photo 33 of Newsletter N° 36 was taken before work started. Photo [47](#) shows the position of the pipe end relative to the Egg-ended Boiler settings. We have not decided exactly what the function of the pipes was, but their position at one end beside the Egg-ended Boiler settings and the connection at the other to the drainage chamber suggest that they may have been used to drain or blow-down the boiler. There had been a lot of rain before the work party on 03 January, and the sound of running water was heard in the chamber by the New Pit vehicle gate. Another pipe was traced running from the chamber, this time along the path leading to the nearby tip (photo [50](#)). However, this was not the source of the sound as it ended in a disconnected pipe (photo [49](#)), and we did not discover where the sound was coming from. The purpose of the disconnected pipe is still one of the site's mysteries.

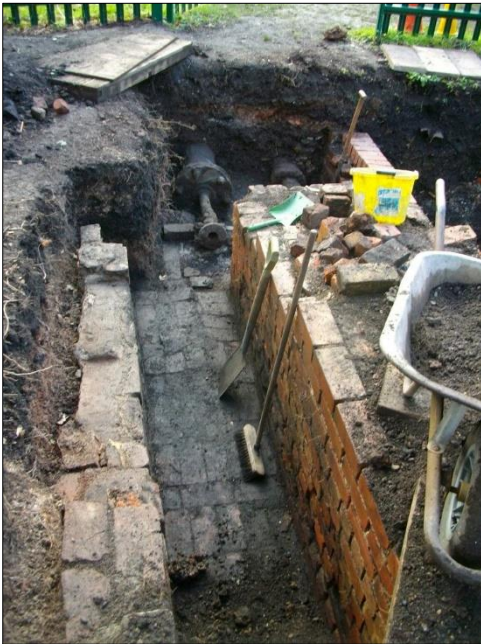
Photo 47 – The pipes shown in photo [45](#) can be seen at the top of the photo, just below the open gate. The settings of the Egg-ended boiler are out of sight on the right. (© K Kemp, 2024)

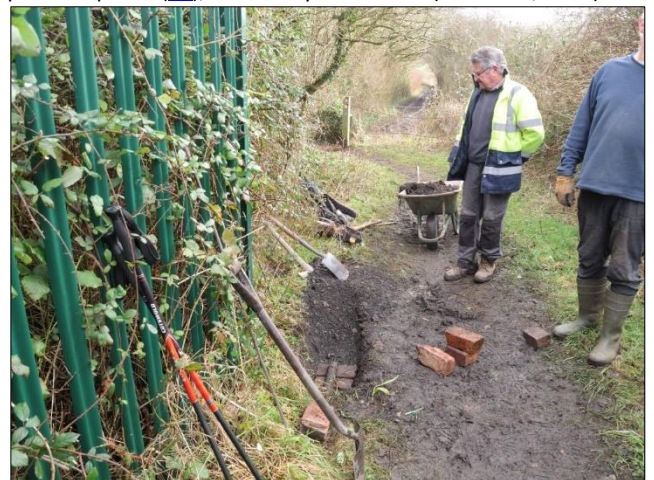
Photo 51 – Derek and Mick standing by the end of the pipe seen in photo [49](#).

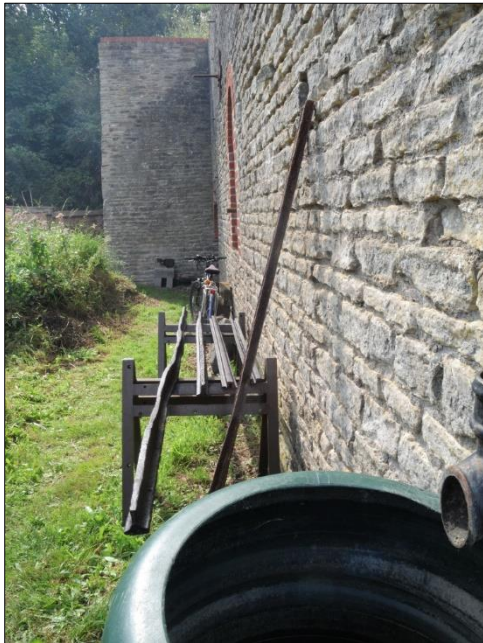
Photo 51 – The lengths of Dramway and Top Hat railway lines have been given a coating of WaxOil. The length of Dramway rail on the left is no longer straight. As the changes occur on the unsupported areas between the sleeper blocks, Hamish suggested that this was caused by a heavy load such as a loco.

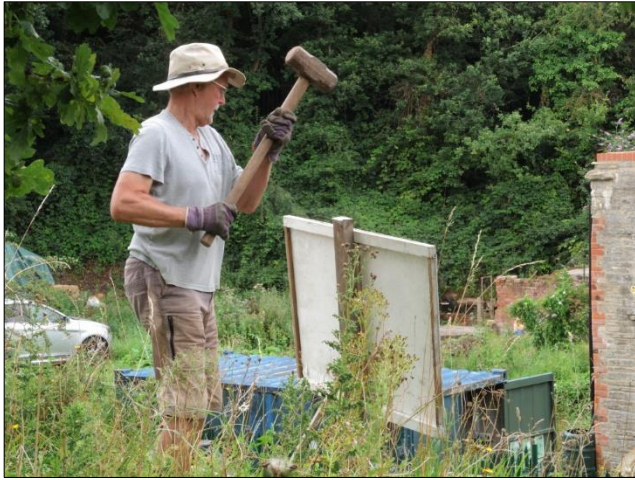
Photo 57 – Hamish working on repairs to the floor inside the Cornish Engine House (See comments on [p.2](#)). The red and the yellow traffic cones cover the two remaining engine holding down bolts ...

Several work parties in July and August concentrated on getting the site ready for the Heritage Open Days (HODs). Steve H and John worked on the treads of the steps leading from the top of the Old Pit heapstead to the platform outside the Cornish Engine House (photos [52](#) and [53](#)). Some of the treads were loose as the bricks holding the securing screws had split. These bricks have been replaced, and holes drilled into them to secure new screws. On others the mortar between the top two courses of bricks has had to be re-laid. Bob (photo [54](#)) and Ken worked on the ramp up the Old Pit heapstead ramp. The original steps cut into the earth have been replaced with a set of stone slabs resting on wooden risers. The latter have been inserted to retain the soil (photo [55](#)). Pete W put up a sign on the top of the Old Pit heapstead (photo [56](#)) advertising our part in the Heritage Open Days scheme. Hamish worked in the Cornish Engine House, rebuilding the area around the missing holding down bolt on the south-east side of the engine bed (photo [57](#)). He has replaced the tiles that were vandalised with spares that

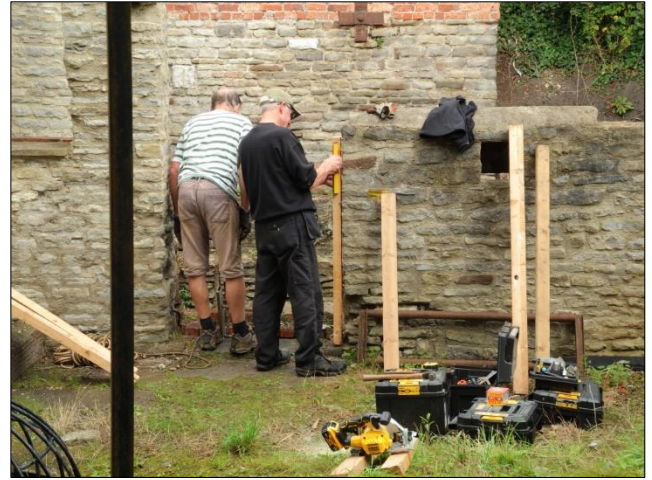
Photo 58 – ... and the same area ready for the HODs.

have been uncovered on site. Photo [58](#) shows this area after he had finished. Marek built a gate (photos [59](#) and [60](#)) to stop visitors falling into the Vertical Engine House, while John worked on marking the edges of drop off with warning tape (photos [61-63](#)).

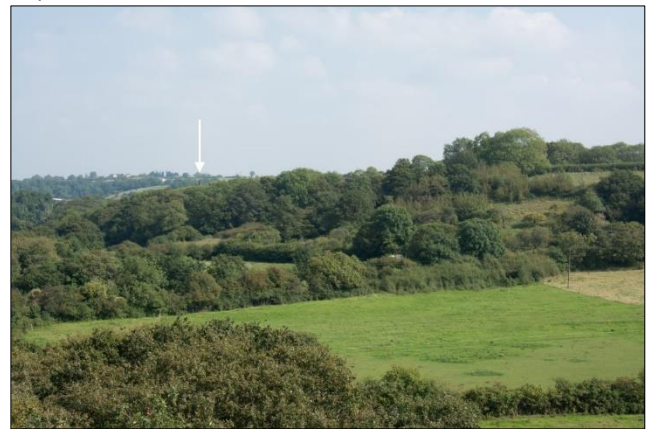
Photo 66 – 2014 view taken from the top of the chimney. Close examination of the original shows that the Parkfield chimney is just visible above the tree line. Its position has been marked with an arrow. (See comments on [p.3](#))

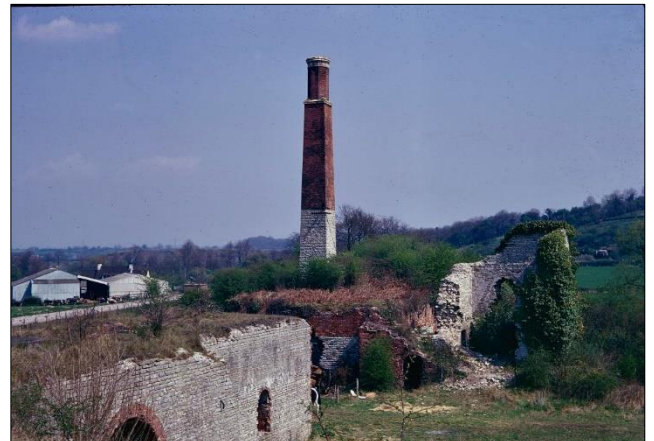
Photo 67 – 1973 photo of the Horizontal Engine House on the left, the chimney, and the Cornish Engine House on the right. (See comments on [p.3](#). ©Terry Evans, 1973)

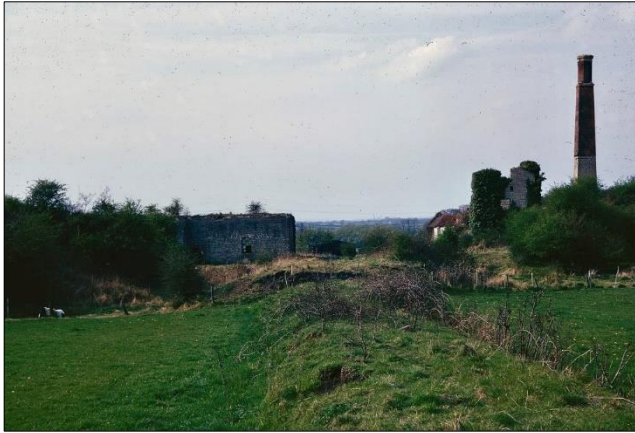
Photo 68 – Track bed of the light railway coming downhill towards Brandy Bottom. (See comments on p.3. ©Terry Evans, 1973)

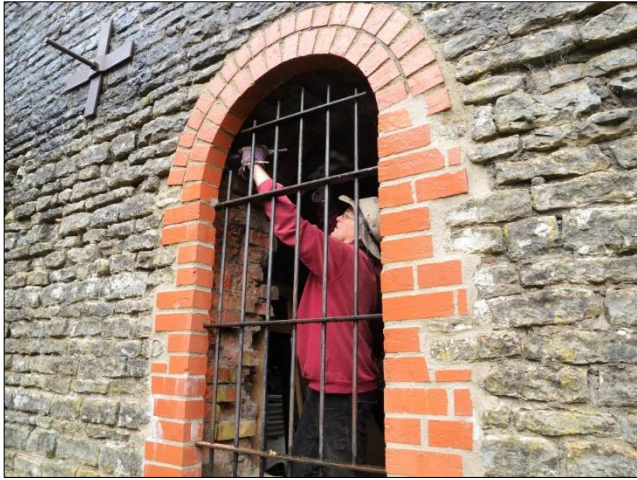
Photo 74 Pete W cuts a groove around the inside of one of the Horizontal Engine House windows, making it easier to fit the window frames.
