FRIENDS OF BRANDY BOTTOM COLLIERY, PUCKLECHURCH

Newsletter N^o 22, February 2019

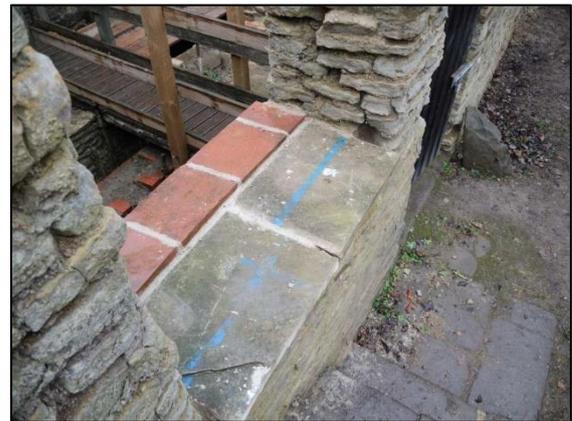
Repointing of the outside of the south-east wall of the Vertical Engine House continues, and a start has been made on repointing the eastern corner of the winding drum pit and the inside of the wall above the engine bed. However we have still to start on the major task of repointing the inside of the building. A path was cleared around the north-east end of the building to make it easier to get building materials to the winding drum pit. This has a secondary purpose of catching minor sloughs of materials from the batch before they fell into the drum pit. Most of the spoil removed along the line of the path was dark and full of coal, but a small section near the drum pit had been covered in a white layer of mortar (photo right, 30 cm scale).

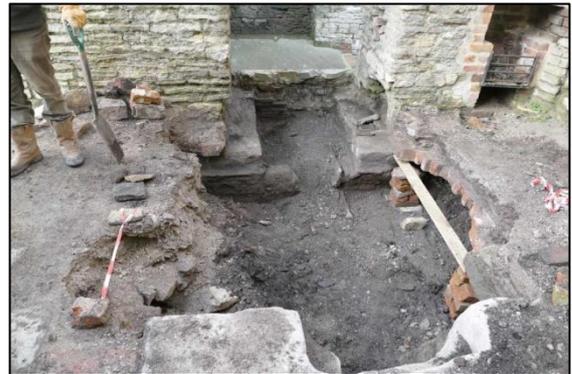
Spoil was also removed from the inside of the opening in the bob wall (photo right). Work here is still at an early stage, and the significance of the structures found has yet to be determined. For example there is a channel running towards the edge of the building, which can be seen to the left of the yellow/black 30 cm scale. (The light coloured stonework running across the photo marks the edge of the engine house. The Pumping Shaft capping and wall of the Old Pit heapstead, which can be seen in the background, are separated from the engine house by a passage.) Another structure whose purpose is as yet unknown is the semi-circular shaped groove found below the north-west edge of the engine bed (photo 15). Photo 16 shows the edge of the vault on the south-west side in the course of being excavated. This side is in a far worse condition than that of the vault on the north-east side. Here some

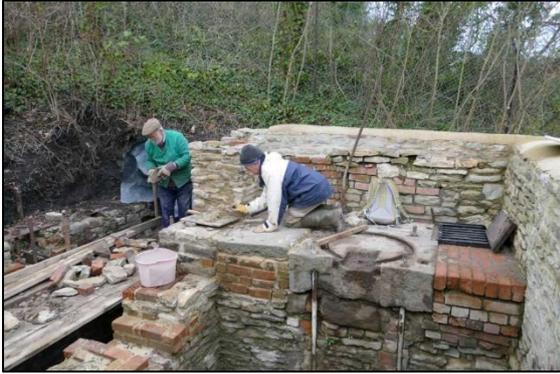
Photo 3 – Ken and Mick working on the northern corner of the Vertical Engine House. The winding drum pit is on the left.

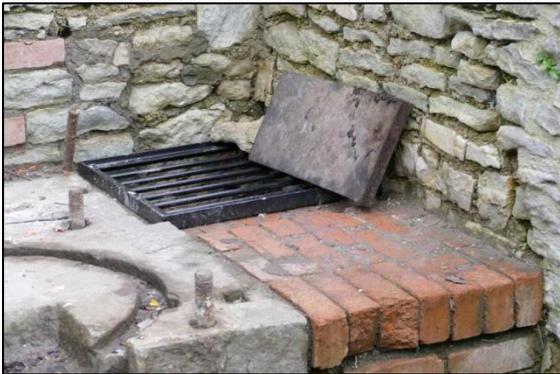
Photo 4 – The opening to the south-east of the engine bed of the Vertical Engine House has been closed with a metal grate – one of the many examples of Jeff’s metal working skills to be found on site.

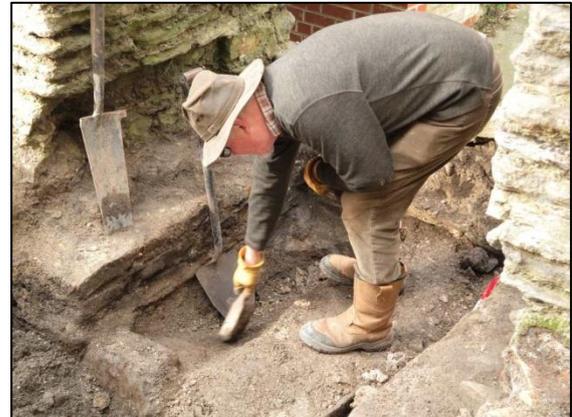
Photo 13 – Hamish working in the opening in the bob wall.

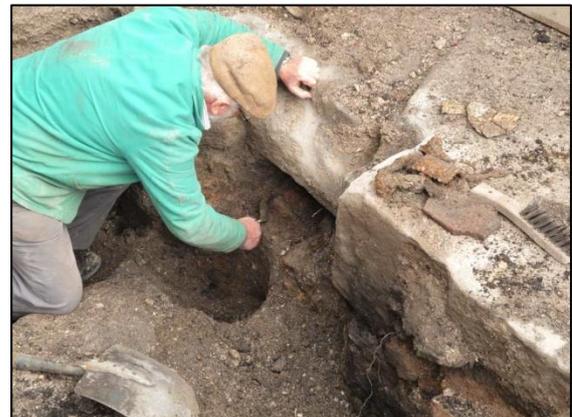
Photo 14 – Ken clearing spoil from along the north-western edge of the engine bed.

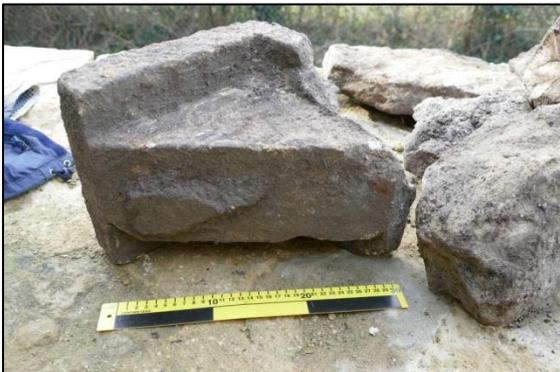
Photo 17 – This shaped stone (BB 090219-1) was found when removing the spoil from inside the Cornish Engine House. We have not yet worked out what it did. (30 cm scale)

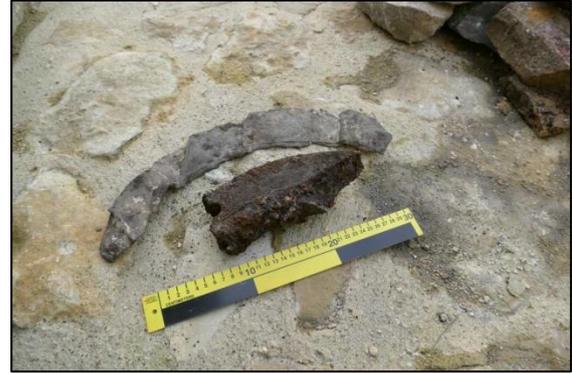
Photo 18 – These objects were also found in the excavated spoil. The bottom item appears to be part of a flange of a large diameter pipe (BB 130219-1), while the strip of lead above it may have been part of a gasket (BB 130219-2). (30 cm scale)
