FRIENDS OF BRANDY BOTTOM COLLIERY, PUCKLECHURCH

Newsletter N° 11, May 2016

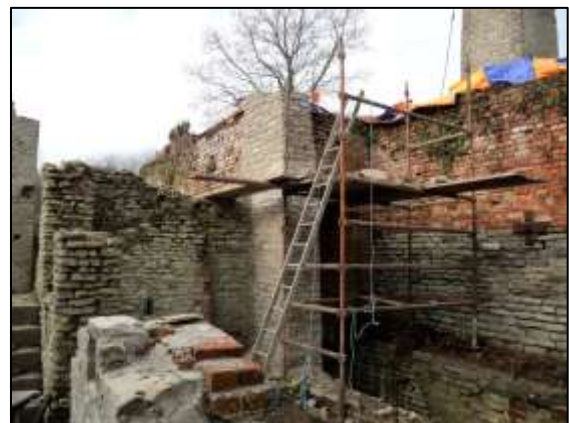
CWS Landscaping continued with their conservation work on the walls of the Old Pit and the fan ducts. The buttress in the Vertical Engine House was completed by the end of February (photo right). It was built to support an overhanging section of masonry at the top of the wall, which had previously been held in place by ivy. Photo 1, taken from a slightly different angle, shows the gap between the original stonework of the south-west

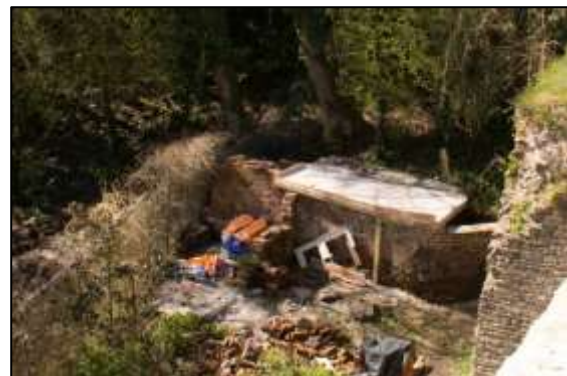
In the area of the Pumping Shaft, part of the inside of the passage, the masonry supporting the capping of the shaft itself, and the wall and platform above it have been rebuilt. The photo to the right shows the area after the rebuilding was finished, while the original state can be seen in photo 12. Photo 13 is a close-up, showing the parlous state of the masonry below the concrete capping with all of the front face missing, while photo 15 was taken after the rebuild. When the masons removed the flagstones from the platform above the passage, prior to relaying them after the adjacent wall was rebuilt, they uncovered a stone-lined shaft (photo 19). Its position is marked in photo 18, and its purpose is one of the many things that have still to be determined. In photo 20, taken from the Cornish Engine House end, the wall has been rebuilt and the flagstones have been re-laid, however the area around the stone-lined shaft has still to be finished.

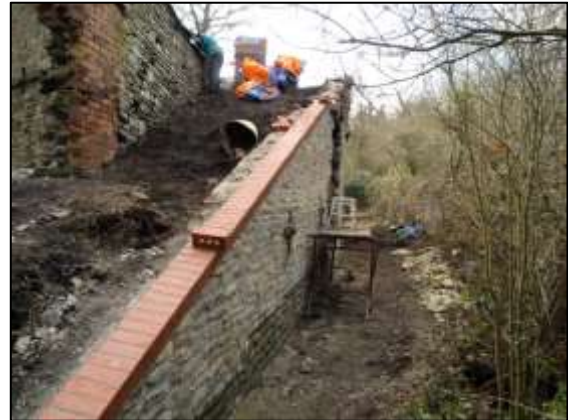
The tops of the fan duct walls have been built up and capped, and the northern duct has been given a cast concrete roof. The photo on the right was

taken from the top of the Horizontal Engine House in April, and shows the shuttering still in place around the newly-cast concrete roof. For comparison, photo 21 shows the ducts from the north before rebuilding, while photo 23 is a view from the top of the Horizontal Engine House after the duct walls had been rebuilt. The next photo, 24, was taken from the top of the New Pit heapstead before the new roof was cast, shows the layout of the ducts, fan housing and engine beds.

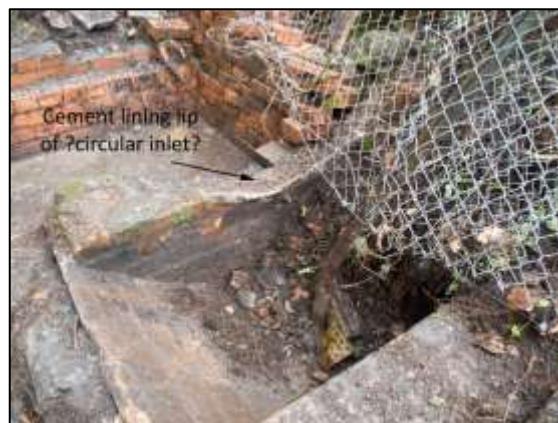
Work in the area of Fan Engine House has uncovered the base of the fan housing (photo right), confirming the comment made in the last newsletter (N^o 10). Unfortunately a post was driven into the middle when the site was fenced off, and this can be seen in the photo. The position of the fan housing is marked on photo 24. Based on design data on Sirocco fans taken from a 2000 book¹ on colliery ventilation, written by one of the April visitors, together with some site measurements, the diameter of the Brandy Bottom fan has been

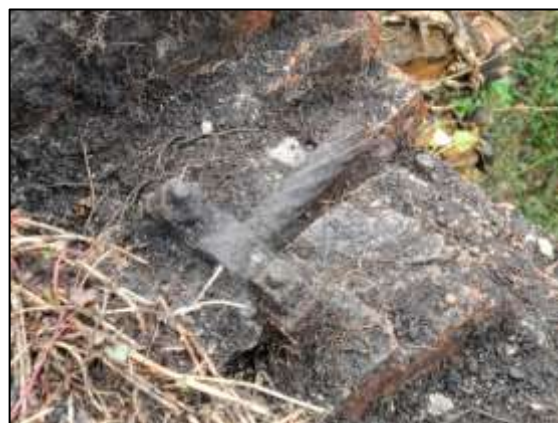
While clearing vegetation from the walls of the Old Pit heapstead, the masons uncovered two wire ropes set into the brick top of the southern end of the Old Pit heapstead. The eastern of these ropes can be seen in the photo on the right. Further investigations revealed that the ropes were anchored farther back from the edge (photo 47). The eastern rope was set in a block of concrete with the remains of a wooden beam behind it (photo 48), while the western rope was looped through an eye bolt (photo 49). The eastern anchor lies above an angled masonry slot at the bottom of the heapstead wall, which had been discovered in March 2014.

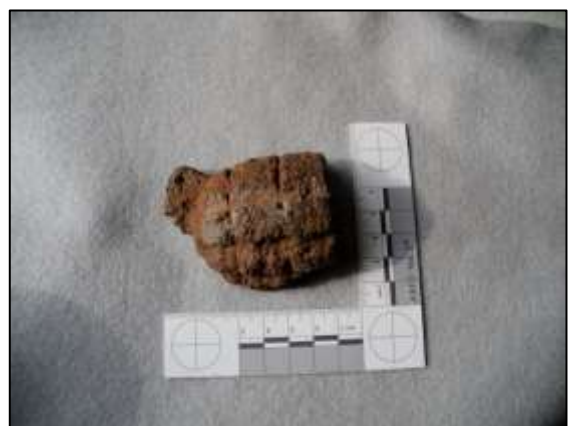
The cleaned-up half of the 8¾" diameter flanged wheel found in the tippler slot of the Old Pit heapstead can be seen in photo 57. It probably came from a coal tub, fits onto a square axle and has a ¼" flange on the outside edge that may be the result of wear. Another find, this time from the base of the Old Pit heapstead ramp, was a fragment of a hand grenade (photo right, 120316-1, 5 cm x 5 cm scale). How it got to Brandy Bottom is a

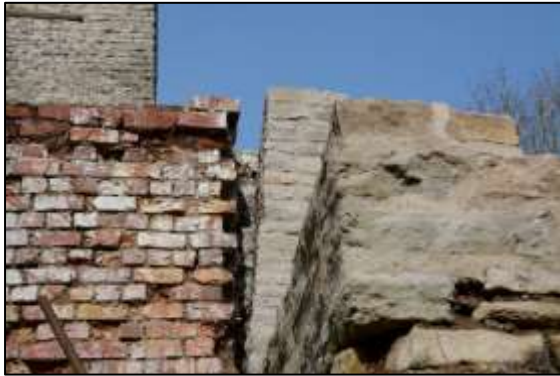
wall of the Vertical Engine House and the brick top of the Old Pit heapstead. The two walls were must have been built at different times as they were not keyed together. Photo 2 shows the inside of the south-east wall of the building around the fireplace after rebuilding and capping.

Photo 1 – Close-up of the top of the finished buttress in the Vertical Engine House, showing the gap between the original wall of the engine house and the brick top of the heapstead.

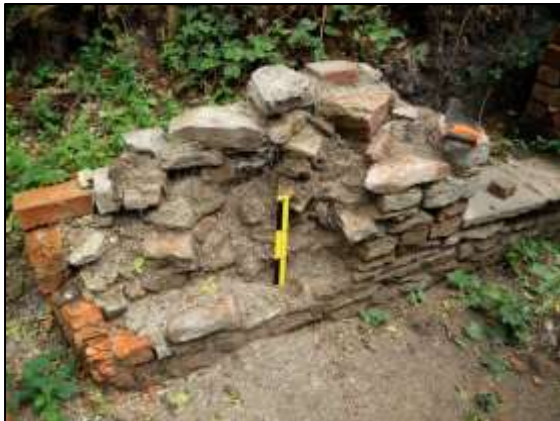
Photo 3 – Part of the north-east wall of the Old Boiler House in September 2014. The rebuilt section is marked as 'A' in photo 7. (30 cm scale)

The top of the north-west wall of the Old Boiler House has been patched and capped, and the northern corner of the building and part of the north-east wall have been rebuilt and capped. This has stabilised the wall fragments that were in danger of vanishing over time. Photo 7, which was taken from the top of the Old Pit heapstead, shows the area in mid-March after patching and/or rebuilding but before the wall capping was put in place. The state of the walls before the work started can be seen in photos 3 and 5, while 4 and 6 are the corresponding views of the rebuilt sections before they were capped. As can be seen in the photo on the right, there has been a change in the plans and the walls have been capped with cement and not bricks. This will make it easier to extend them upwards at a later date if required.

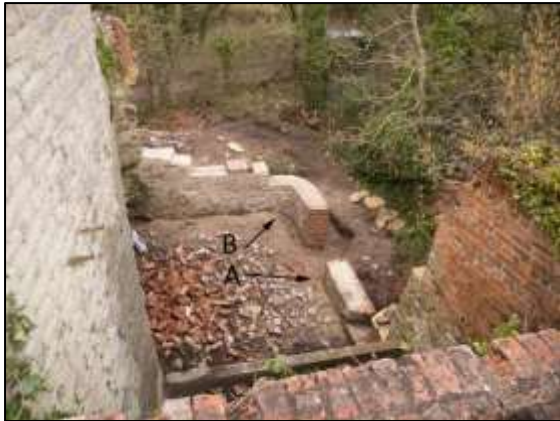
Photo 7 – The rebuilt north-western and north-eastern walls of the Old Boiler House in mid-March, seen from the Old Pit heapstead. The letters A marks the section of wall seen in photos 3 and 4, while B marks the section seen in 5 and 6.

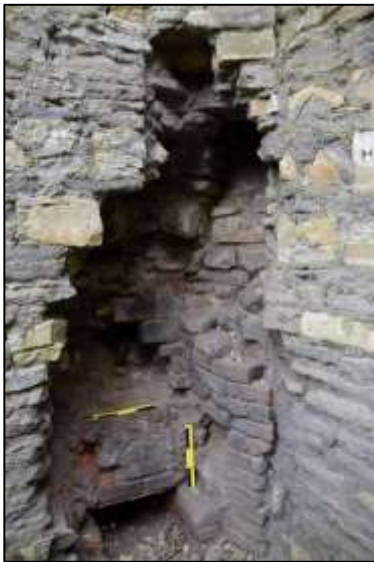
Photo 8 – Fireplace in northern corner of the Cornish Engine House before reconstruction ... (30 cm scales)

The fireplace in the northern corner of the Cornish Engine House has been rebuilt, and photos 8 and 9 are 'before and after' photos of that corner. The keystone of the arch above this fireplace has, like the one in the Vertical Engine House, been marked "AIBT 2016". Photo 9 was taken on a cold wet day in early March, hence the fire. The next two photos show the inside of the bob (north-western) wall of the engine house. The first, photo 10, was taken in July 2014 and shows how little of the left-hand end of the wall remained to support the weight of the masonry above the arch. The second, photo 11, shows the area after the supporting buttress was built.

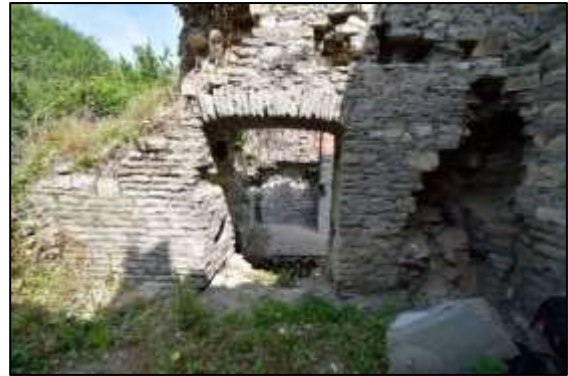
Photo 10 – Inside of the bob (north-western) wall of Cornish Engine House in July 2014 before reconstruction started ...

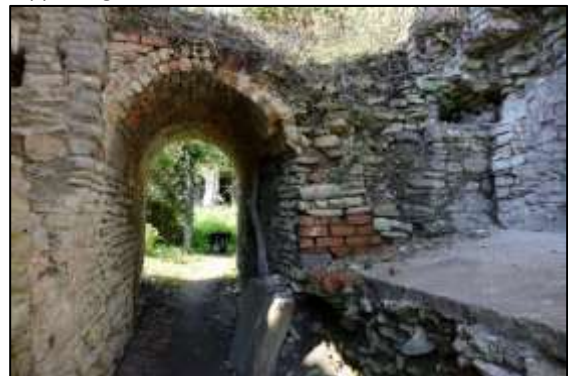
Photo 12 – The passage under the Pumping Shaft crossover in May 2014, with the shaft capping on the right.

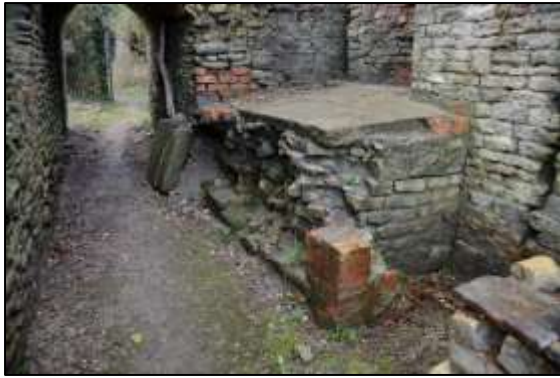
Photo 13 – This February 2014 photo shows the state of disrepair of the masonry walls below the capping of the Pumping Shaft.

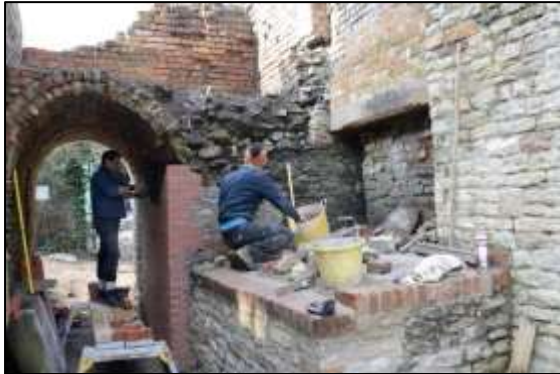
Photo 14 – Masons at work rebuilding the inside of the Pumping Shaft passage, and the wall above the shaft capping.

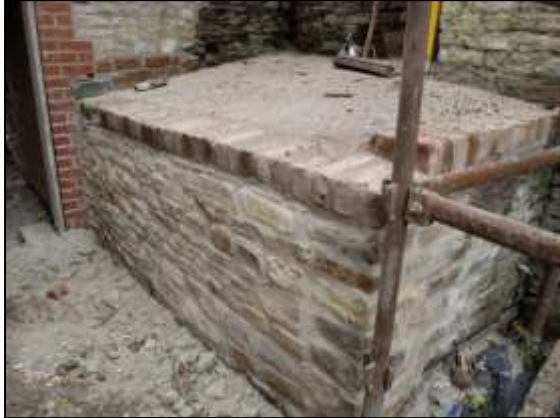
Photo 15 – The rebuilt base of the Pumping Shaft capping in March 2016.

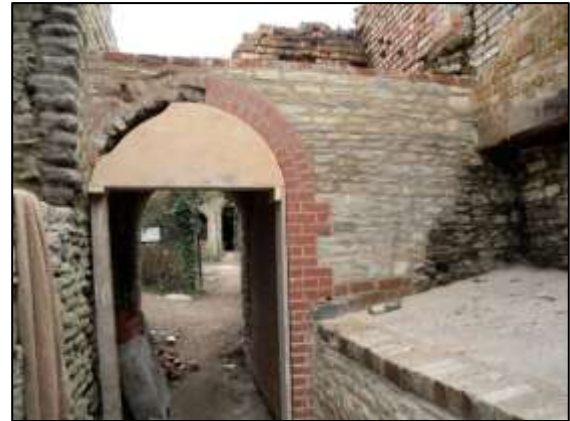
Photo 16 – Rebuilding of the wall above the Pumping Shaft and inside the adjacent passage in progress.

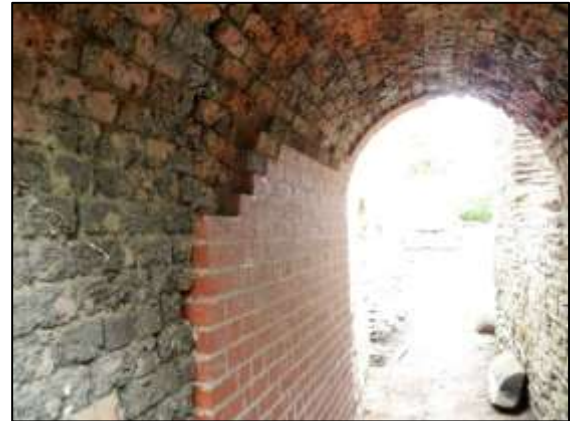
Photo 17 – Inside of the Pumping Shaft passage, showing the rebuilt section of wall on the left.

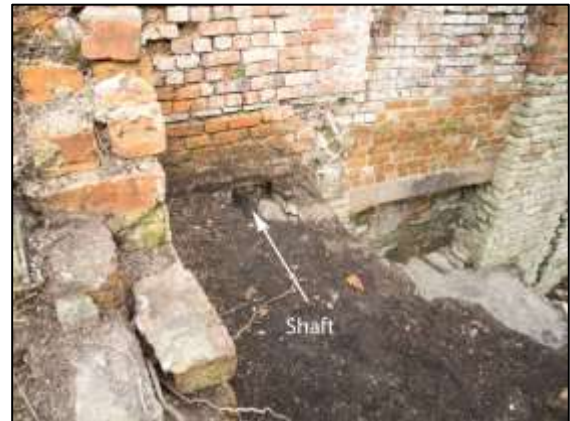
Photo 18 – View of the platform above the Pumping Shaft passage, after the flagstones had been removed during the rebuilding of the wall on the right of the photo. The position of the stone-lined shaft seen in the following photo has been marked.

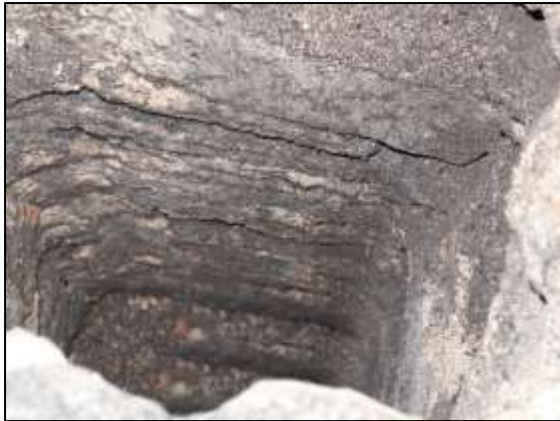
Photo 19 – The inside of the stone lined shaft located in the platform above the Pumping Shaft.

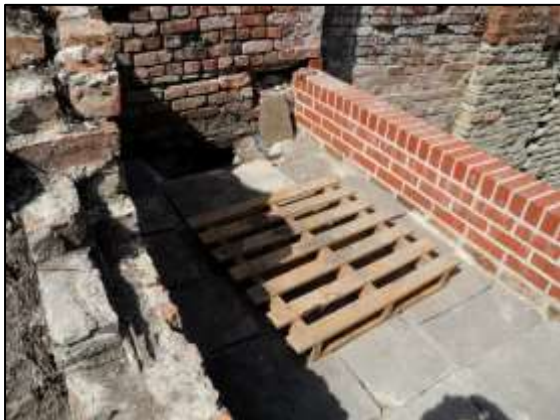
Photo 20 – The platform in May after the wall had been built up, and the flagstones re-laid. The area around the top of the shaft has still to be finished off and a grille installed.

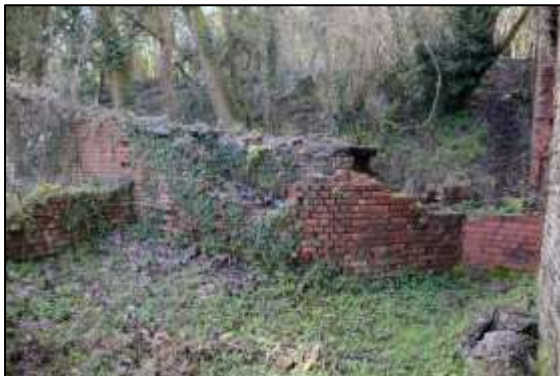
Photo 21 – The fan ducts in March 2014.

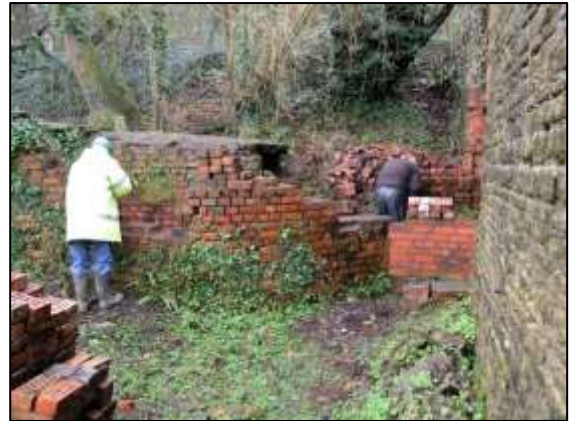
Photo 22 – Clearing around the fan ducts in January 2016 in preparation for the reconstruction of the duct walls.

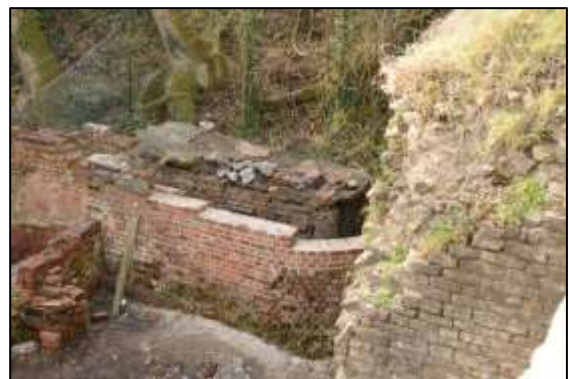
Photo 23 – View of the fan ducts in February from the top of the Horizontal Engine House.

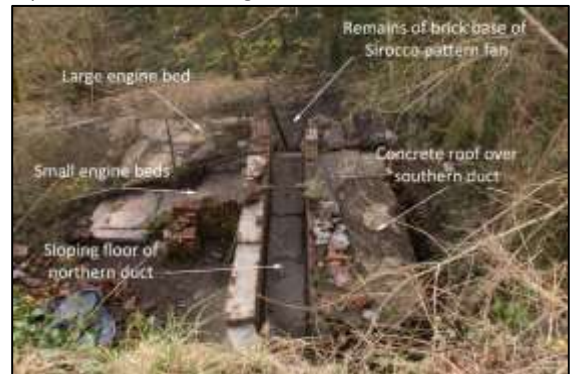
Photo 24 – View of the fan ducts from the top of the New Pit heapstead. Taken at the end of February, it shows the new brickwork on the top of the northern wall and the position of the fan housing. A close-up of the small engine beds was shown in the photo on page 7 of Newsletter N° 10.

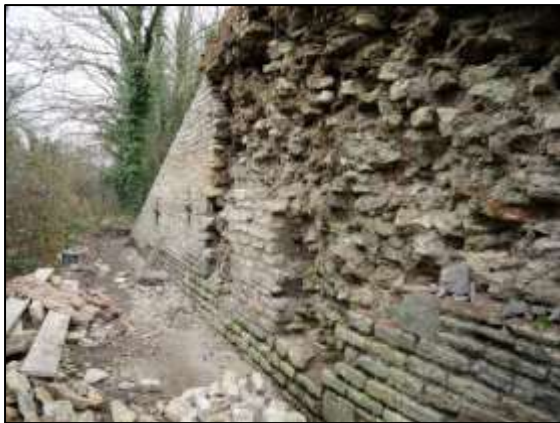
Photo 25 – A pillar is being built upwards to support the brick top of the north-western wall of the Old Pit heapstead.

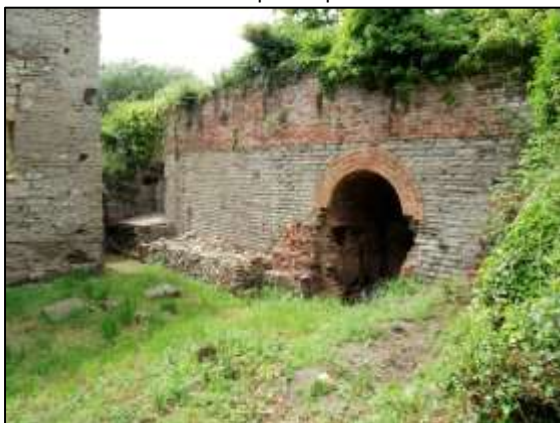
The tops of the Old Pit heapstead were cleared of vegetation and the brickwork built up where necessary to allow the walls to be capped. The visual effect of clearing the vegetation can be seen by comparing photos 27 and 29. These show the south-east wall of the heapstead in June 2013 and April 2016 respectively. Vegetation clearance uncovered the remains of two wire ropes clamped to the top of the south-western wall, and these are described on page 4. Rebuilding of the outer wall of the Old Pit heapstead ramp was completed and the top capped with bricks (photo right). Photos 30, 31, and 32 are 'before, during and after' views of the rebuild of the top of the wall above the Old Boiler House. Photo 33 shows the completed capping on the heapstead walls above the Vertical Engine House, while photo 34 is a view of that area from ground level.

Photo 27 – The south-eastern wall of the Old Pit heapstead in June 2013.

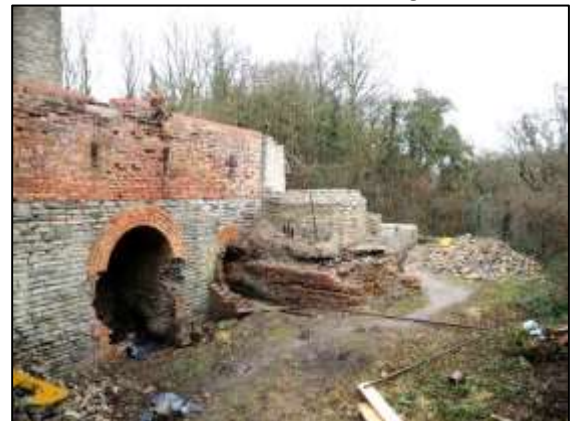
Photo 29 – ... and in April when the work was finished.

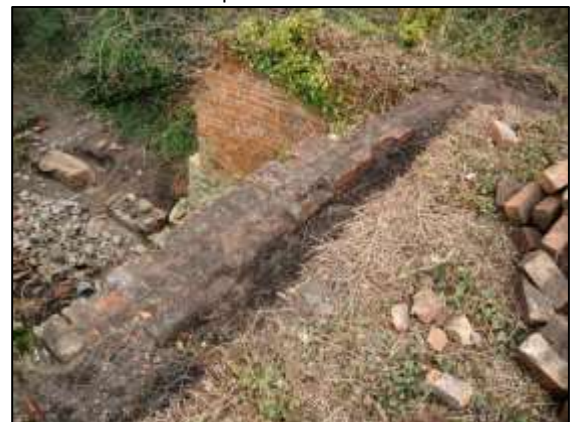
Photo 30 – A section of top of the wall of the Old Pit heapstead, located above the Old Boiler House, cleared of vegetation and ready for recapping ...

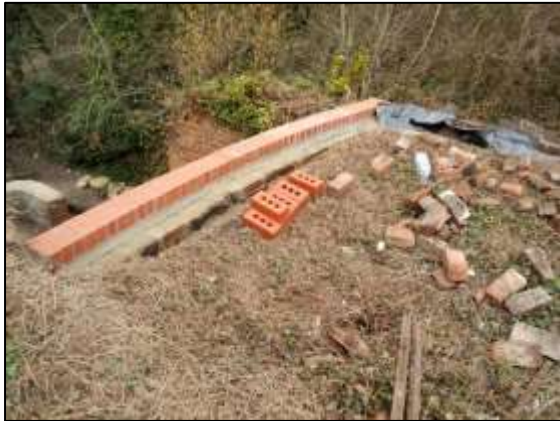
Photo 32 – ...and the completed capping in place.

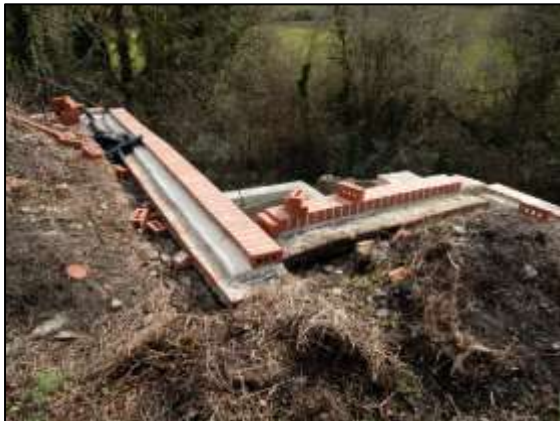
Photo 33 – Capping in place along the edge of the Old Pit heapstead wall above the Vertical Engine House.

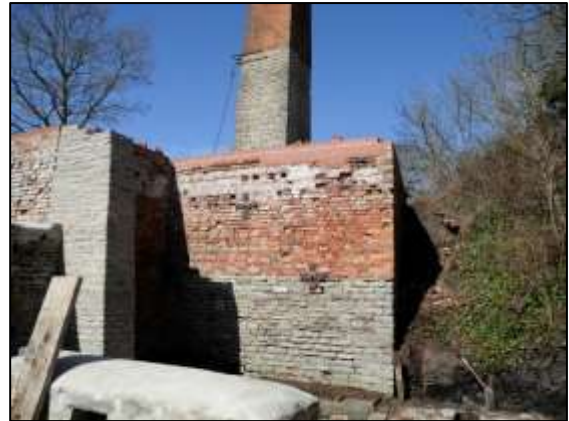
Photo 34 – The same stretch of wall seen in photo 33 seen from below.

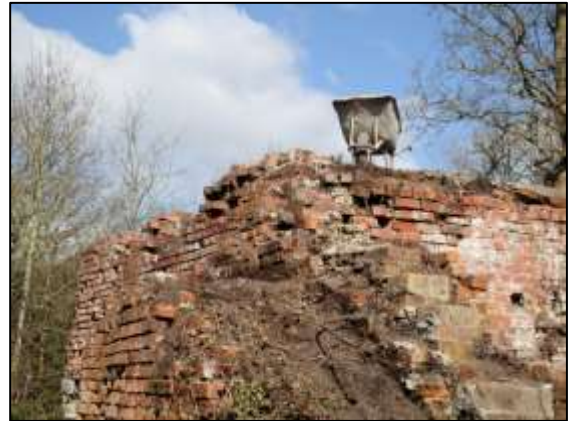
Photo 35 – The southern corner of the Old Pit heapstead in mid-March, before rebuilding started ...

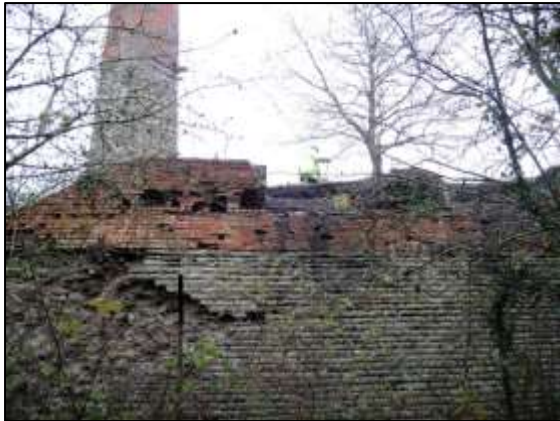
Photo 37 – North-west wall of Old Pit heapstead, with the northern tippler slot in the centre of the photo and the southern slot on the right hand edge.

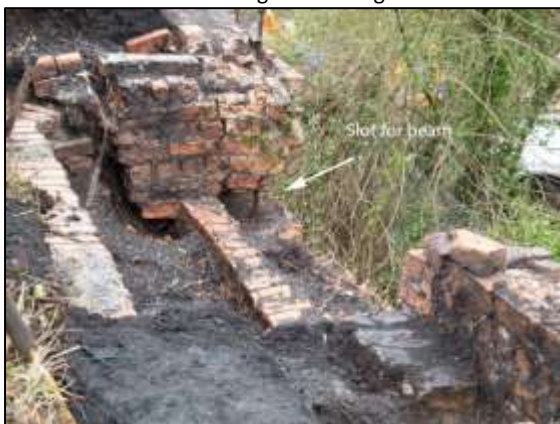
Clearing the vegetation from the top of the north-west wall of the Old Pit heapstead showed just how dilapidated the brickwork had become, with empty slots running along the length of the wall. Fragments of wood showed that these had once been filled with wooden beams. These had rotted away leaving the brickwork above the slots unsupported. This can clearly be seen in photo 38. Reclaimed sleepers have been inserted into the slots and the surrounding brickwork has been rebuilt. Photos 39 to 41 show various stages of the rebuild. Photo 42 shows the rebuilt southern tippler slot.

Photo 38 – The dilapidated state of the brickwork around the southern tippler slot before reconstruction started. The end of a slot which should have held a wooden beam can be seen in the centre of the picture.

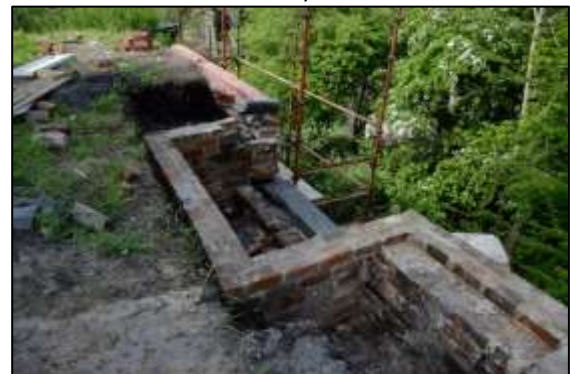
Photo 42 – The rebuilt southern tippler slot on 14 May.

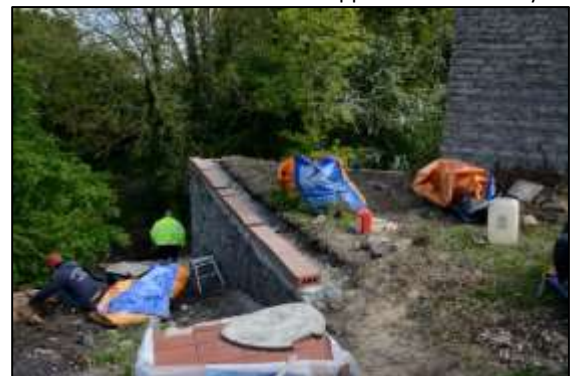
Photo 43 – The wall above the Old Pit heapstead ramp on 14 May after recapping was completed.

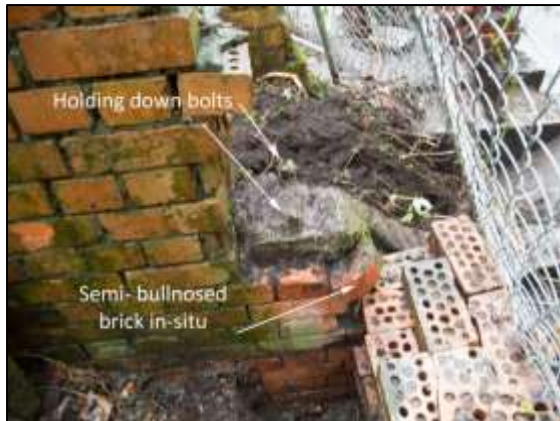
estimated at 45". This would give it an output of between 43 000 and 51 500 cubic feet/min. Cleaning up around the eastern end of the central wall of the ducts uncovered a pair of holding down bolts and a semi-bullnosed brick still in-situ (photo 44). The former would have been part of the fan bearing supports. The latter might have been part of the fan inlet and helped to guide the air flow into the fan. A cement track showing the swing of a damper in the northern duct can be seen in photo 45. This damper would normally be in a vertical position, directing the air leaving the fan up the exhaust to the atmosphere. On occasions it could be swung into a horizontal position, allowing the air to be forced down the shaft into the mine workings. A pit was discovered in the southern corner of the Fan Engine House (photo 46). Intriguingly, this was well built, has a ledge on two sides to support a trapdoor, has no apparent connection to any other structure, and has a pipe running through the middle. As to what it was for ... that stumped our visiting experts. However they were able to confirm from the layout of the fan that it normally extracted air from the mine.

Photo 44 – The holding down bolts, located at the eastern end of the fan ducts, are thought to be part of the supports for the fan bearing.

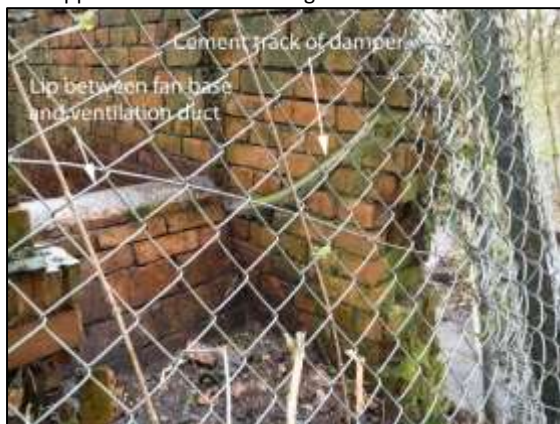
Photo 45 – The fan end of the northern duct, showing the cement track associated with the movement of the damper.

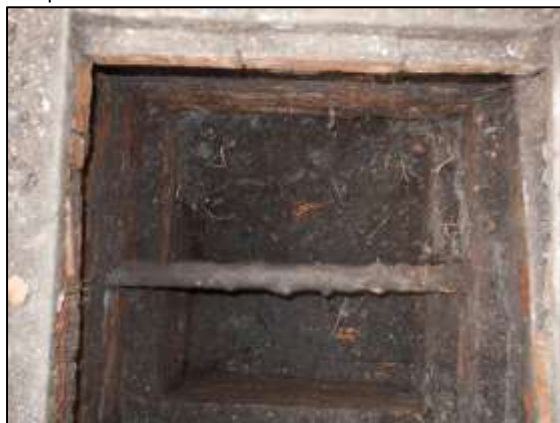
Photo 46 – Pit in the southern corner of the Fan Engine House.

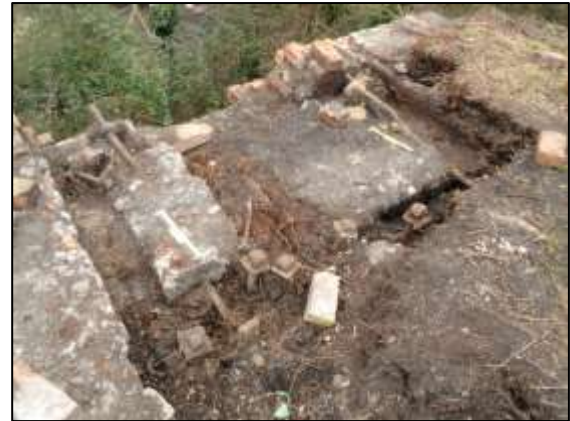
Photo 47 – Two wire ropes were uncovered at the south-west end of the Old Pit heapstead, clamped to the wall. The photo shows their anchorage points after the area was cleared of spoil, with the remains of a wooden beam running along the line of bolts. The anchorages can be seen in close-up in the next two photos. (30 cm scales)

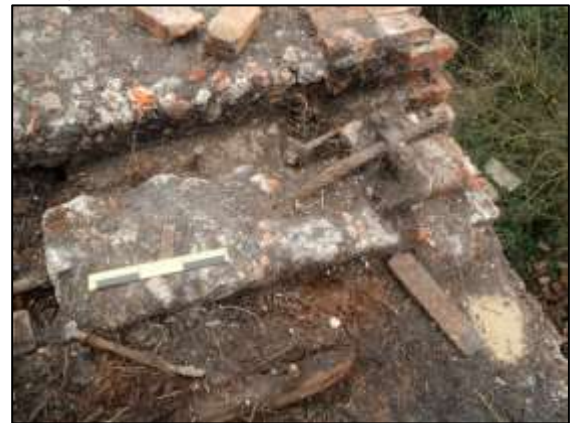
Photo 48 – The eastern rope has been bent back on itself and anchored in a block of concrete. The winding shaft lies out of view on the left of the photo. (30 cm scale)

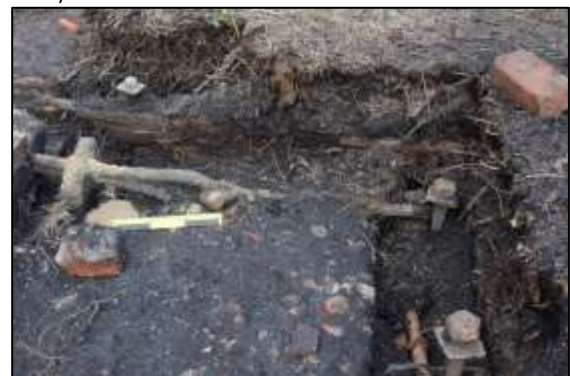
Photo 49 – While the western rope has been passed through an eye bolt whose inner end has yet to be uncovered. (30 cm scale)

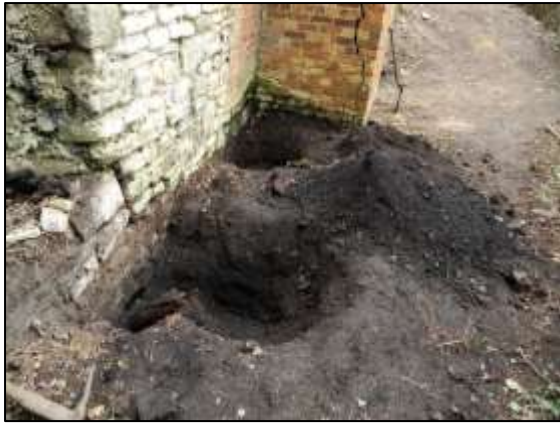
Investigations revealed a second slot at the base of the wall below the western anchor (photo 50). This still had a fragment of a wooden beam in place (photo 51). The ropes on top of the heapstead and the beams at the base appear to be part of a structure that can be seen running between the heapstead and the Horizontal Engine House in the 1881 and 1903 OS maps. It had been dismantled by the time of the survey for the 1915 map.

Photo 50 – The holes show where bracing beams had been positioned, thought to support the bridge seen in the 1881 map between the Old Pit heapstead and the Horizontal Engine House. A close-up of the timber in the nearest hole can be seen in the next photo. This area has been covered up again.

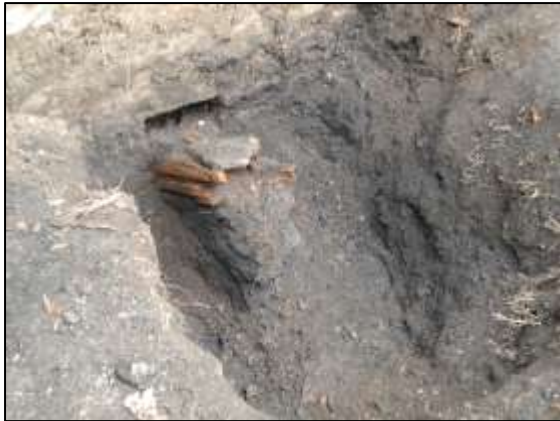
Photo 51 – Remains of timber bracing beam at base of southern wall of Old Pit heapstead.

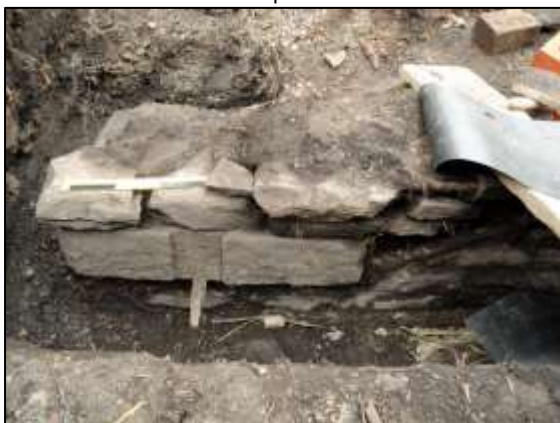
A large piece of Pennant stone was found at the bottom of the outer wall of the Old Pit heapstead ramp, with a groove cut into the north-western face (photo 52). Further excavation showed that there was no groove on the opposite face of the stone. This stone must have been recycled from elsewhere, as no one would cut an apparently unnecessary groove in a piece of Pennant without good reason. Or had the chiseller 'upset' the foreman and had been made to do penance?

Photo 52 – Close-up of the pennant stone at the base of the Old Pit heapstead ramp, showing the groove cut into the face. (30 cm scale)

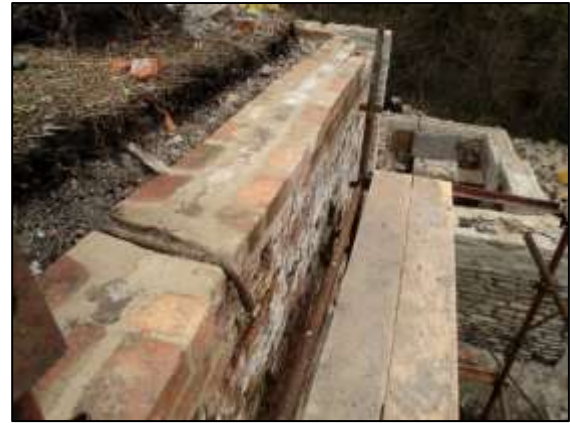
A length of metal conduit was uncovered by the masons on the top of the north-eastern wall of the Old Pit heapstead when they cleared the vegetation. This is of the type used for electric lighting, and can be seen in photo 53. So far only 2 feet of the conduit have been uncovered, but it appears to be heading in the direction of the chimney. As can be seen from photo 54, the wall capping has been re-built around the conduit.

Photo 53 – The top of the south-eastern wall of the Old Pit heapstead squared off ready for capping. This photo also shows the position of the conduit seen in the following photo.

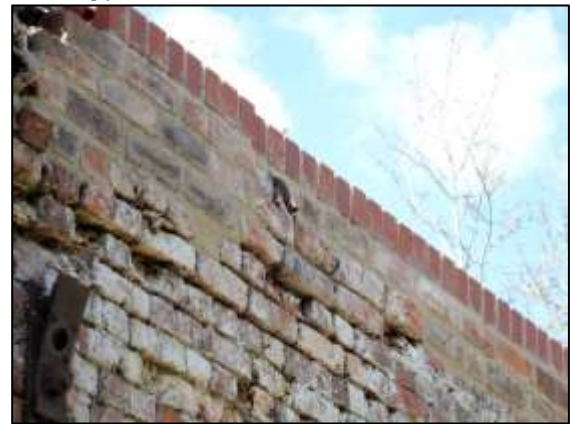
Photo 54 – The conduit poking out of the rebuilt wall.

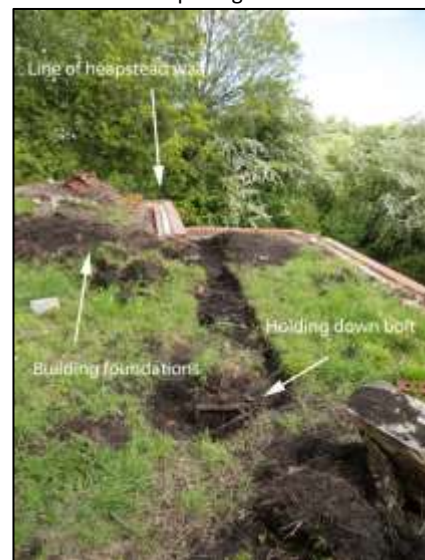
A holding down bolt was spotted in the grass of the Old Pit heapstead, along what is thought to be the original line of south-east wall (photo 55). A test trench dug at the north-eastern corner of the heapstead has uncovered what may be the foundations of a building (photo 56), which would correspond with one of the structures seen in the 1881 map. Work continues in this area.

Photo 55 – North-eastern corner of Old Pit heapstead, showing the position of the building foundations (photo 56) and holding down bolt mentioned on page 5.

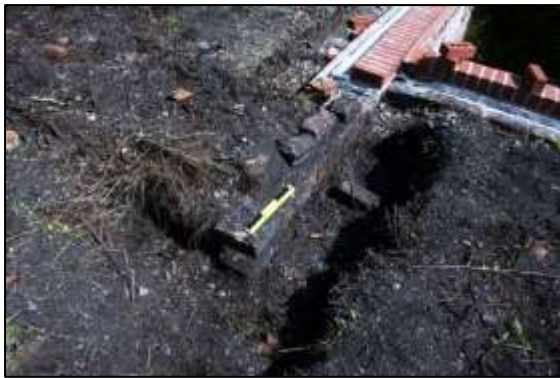
Photo 56 – The foundations of a building emerging from the spoil in the north-eastern corner of the Old Pit heapstead, above the Vertical Engine House. (30 cm scale)
