FRIENDS OF BRANDY BOTTOM COLLIERY, PUCKLECHURCH

Newsletter N° 10, February 2016

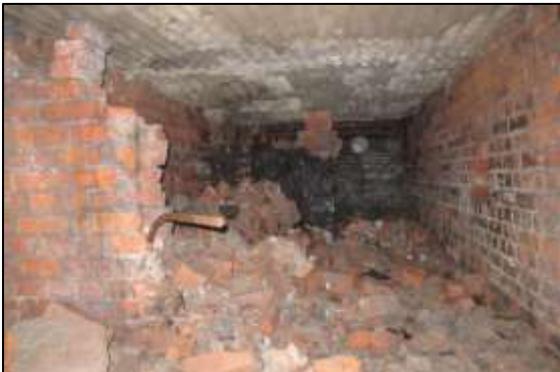
The Horizontal Engine House has a concrete floor that conceals the engine beds. Why and when it was laid is yet another of Brandy Bottom's mysteries. A SGMRG member with caving experience wriggled his way into the undercroft in September 2013, and took photographs and measurements. The photo on the right (© S Grudgings) shows the colliers' font in the northern corner, while photo 24 is a view along the undercroft towards the heapstead end. There is still a coating of grease from the ropes sticking to the wall.

Photo 24 – The undercroft of the Horizontal Engine House. There is still grease sticking to the far, heapstead end, wall. (© S Grudgings)

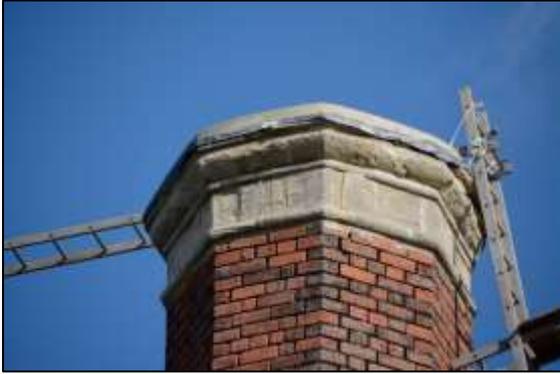
Photo 28 – ...and in February 2016 when the ornate stonework at the top was being repointed.

rebuilt, including the installation of the reinforced concrete ring which is bolted to the brickwork beneath it (photo 27). The fourth stage was to repoint the stonework at the top (photo 28), when it was noticed that the top 6 feet or so of brickwork also need repointing. That is scheduled for completion in February 2016.

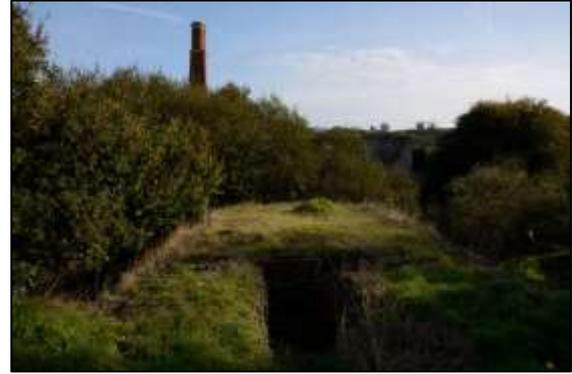
Photo 31 – The roof of the Horizontal Engine House after the removal of the vegetation but before final levelling...

A waterproof membrane was laid on the roof of the Horizontal Engine House in November 2014, again by CWS Landscaping. This has stopped water percolating down to the roof, where it caused spalling of the bricks in frosty weather (photo right), and formed puddles on the floor. Now the building is dry inside, it can be used for the storage of construction materials, and also provide a shelter for the volunteers should it rain during a work party. Photos 29-31 show various stages in the clearance of vegetation from the roof and photo 32 the membrane in place.

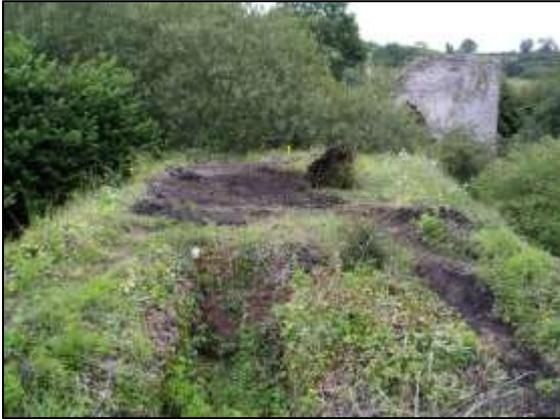
Photo 29 – A large hawthorn stump, and other vegetation, had to be removed from the roof of the Horizontal Engine House before the waterproof membrane could be laid...

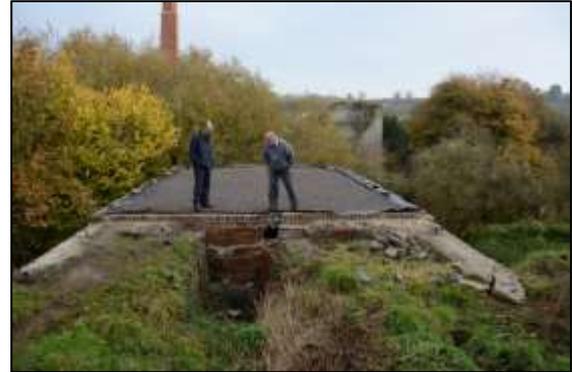
Photo 32 – ...and the finished membrane in place.

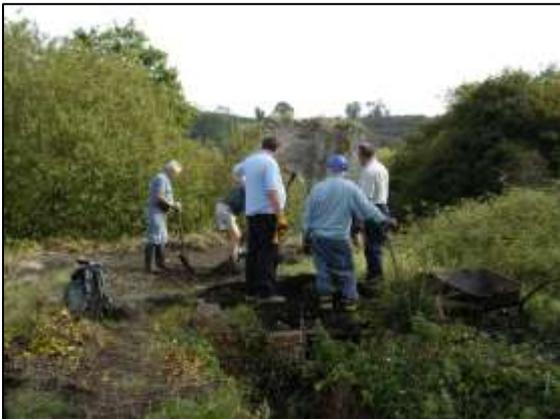
Photo 30 – ...and a work party sets to on clearing it.

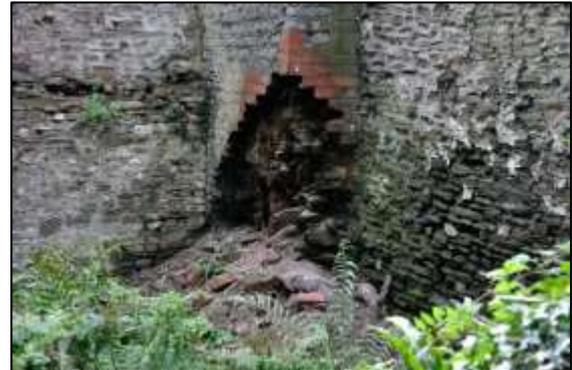
Photo 33 – Base of the chimney in the Old Boiler House in April 2014.

The volunteers rebuilt the base of the chimney in the Old Boiler House in 2014-15. Photo 33 shows the base of the chimney. In the close-up, photo 34, the remains of the flue to the chimney has been marked by an arrow. The presence of bricks around the edge of the area of missing masonry is evidence of an earlier rebuild. Photo 35 shows the completed rebuild, and photo 36 is a close-up of the rebuilt flue. The volunteers also rebuilt part of the north-east wall of the building, and braced it against the heapstead by installing a wooden beam between the two structures (photos 37-39).

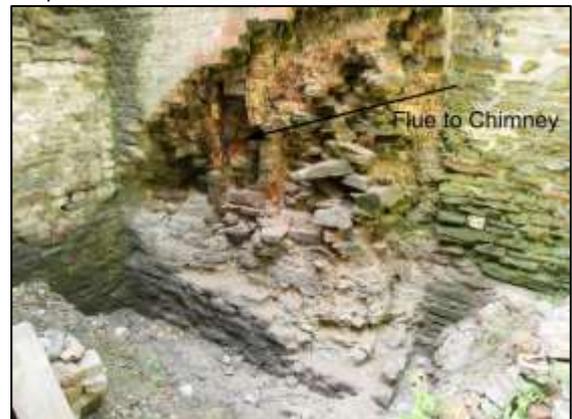
Photo 34 – Close-up of the base of the chimney in the Old Boiler House in May 2014...

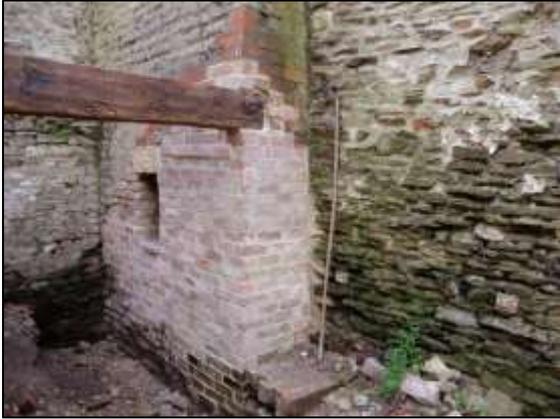
Photo 35 – ...and the finished result.

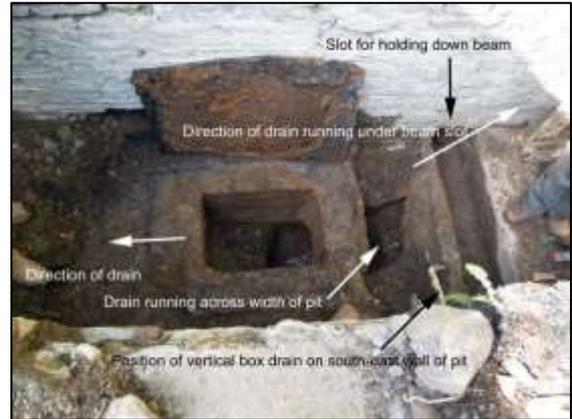
The winding drum pit of the Vertical Engine House was cleared of the remaining spoil in September 2015. At the bottom was a drain that ran towards the Old Boiler House in one direction and the alcove in the Old Pit heapstead in the other (photo 40). An engine bed was discovered in the northern corner (photo 41) in November 2015 when clearing spoil from the walls before they were patched/repointed/rebuilt. One nut is still attached to the bolt, together with a fragment of the cylinder casing. An attempt had been made to split the nut with a cold chisel, clear evidence that the cylinder did not surrender to the scrap metal men without a fight. Photo 42, taken from the top of the nearby heapstead, shows that corner of the building.

Photo 40 – Drain in base of winding drum pit, Vertical Engine House.

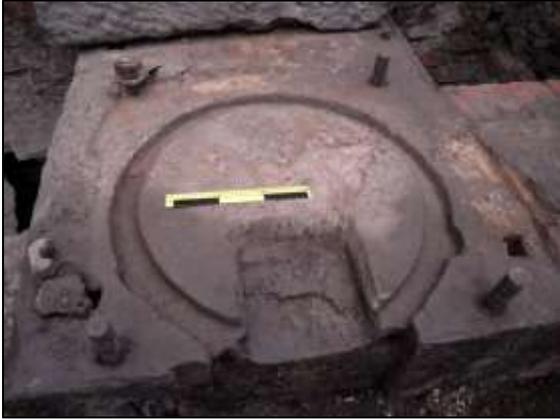
Photo 41 – A close-up of the engine bed in Vertical Engine House. Part of the cylinder casing is still attached to the bolt in the top left corner. (30 cm scale)

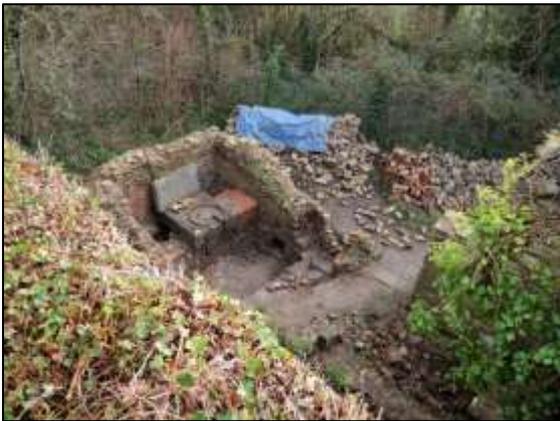
Photo 42 – View of engine bed area of Vertical Engine House from top of Old Pit heapstead.

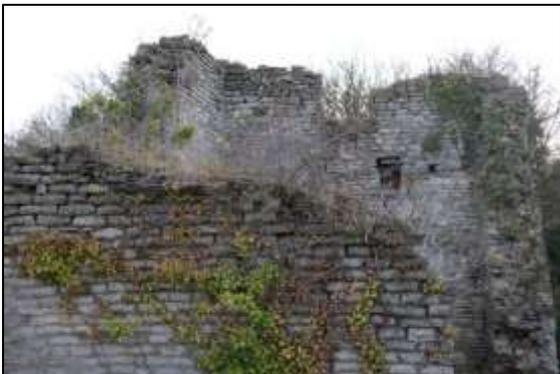
Photo 43 – Top of south-east wall of Cornish Engine House in background in December 2013.

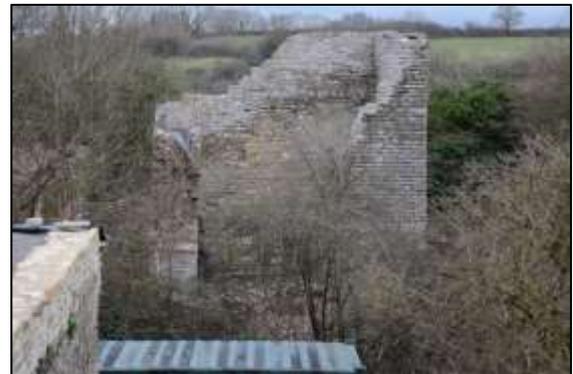
Photo 46 – Cornish Engine House from New Pit heapstead on 10 February 2016.

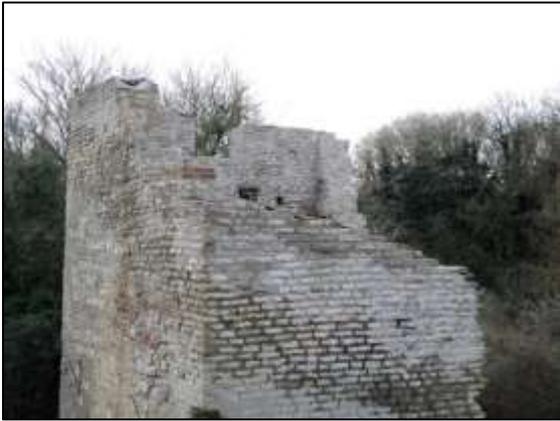
Photo 47 – Northern corner of the Cornish Engine House from the Old Pit heapstead on 10 February 2016.

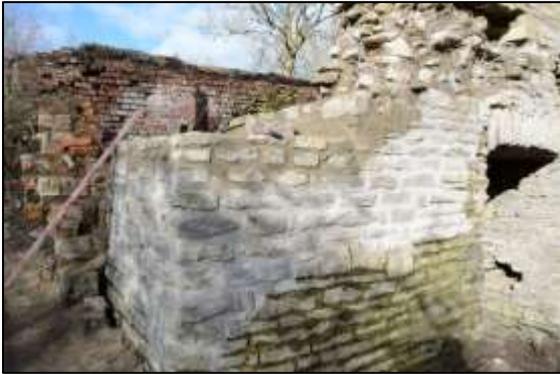
Photo 48 – A buttress is being built at the southern end of the bob (north-western) of the Cornish Engine House.

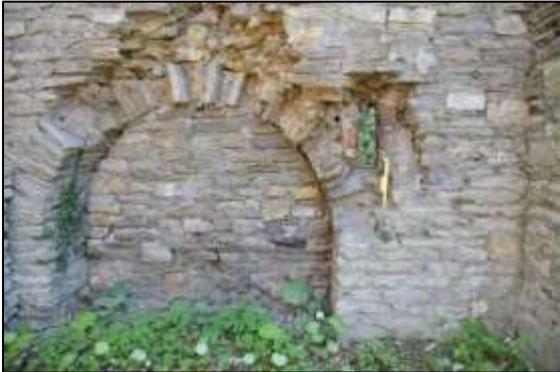
Photo 49 – Alcove in south-east wall of Cornish Engine House in July 2014... (30 cm scale in window slit to the right of alcove)

In January 2016 Historic England agreed to fund restoration work, mainly in the Old Pit area, and CWS Landscaping returned to site in the second week of the month. The southern corner of the Cornish Engine House had been rebuilt by the end of January and work on this building was largely completed by the middle of February. The south-east wall can be seen in the background of photo 43, taken from the Old Pit heapstead in September 2013. It also shows how much vegetation was still growing on the tops and side of the walls. Photos 44 and 45 show the top of the south-east wall at as the rebuild progressed, while photos 46 and 47 show the finished walls from different parts of the site. A buttress is being built at the southern end of the bob (north-west) wall to support the arch in the wall (photo 48). The area around the alcove in the south-east wall has also been patched, and photos 49 and 50 show the alcove before (July 2014) and after patching respectively.

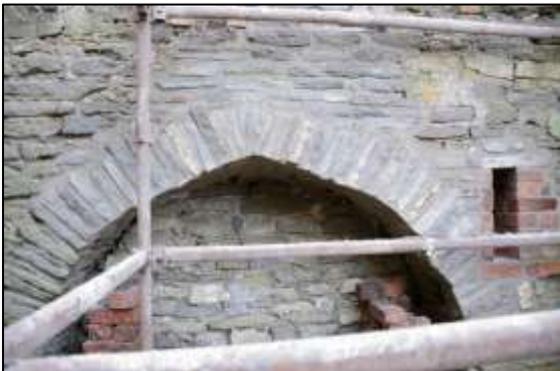
Photo 50 – ...and on 23 January 2016 after reinstatement of the arch and patching of the wall.

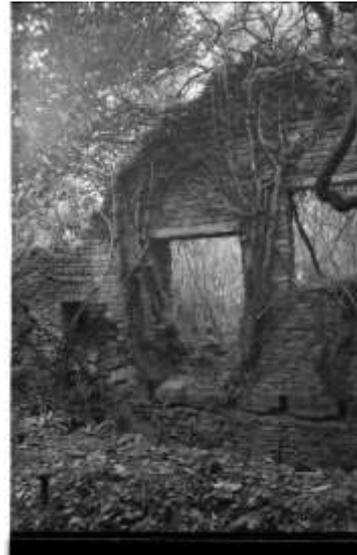
Photo 51 – The inside of the south-east wall of the Vertical Engine House in 1982. Note the fireplace to the left of the door opening in the centre. (@S Grudgings)

The masons are also working in the Vertical Engine House, where the south-east wall is currently being partly rebuilt. This includes the reinstatement of the fireplace seen to the left of the door in photo 51, dated 1982. This part of the wall can be seen in photo 52, at a time when spoil had been cleared away and just before rebuilding started. The position of the holding down bolt in front of the fireplace suggests that the latter may have been a later addition. Photo 53 shows an intermediate stage of rebuilding, while in photo 54 the arch above the fireplace has been rebuilt. The photo on the right is a close-up of the inscription on the keystone. A buttress is being built against the south-west wall between the winding drum pit and the adjacent engine bay to support an overhanging section of wall that is currently held up by ivy roots. This can be seen in photo 55, while photo 56 shows the wall of the Old Pit heapstead ramp being rebuilt.

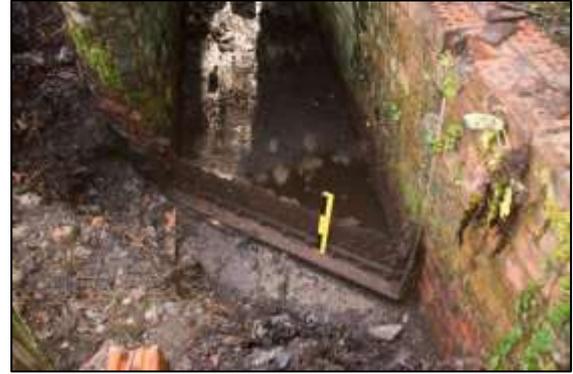
Clearance work by the volunteers at the heapstead end of the southern fan duct uncovered the bottom of one of the dampers (photo 57) still in place. It is still sitting against a cement seat (photo

Photo 57 – Remains of a damper in the southern fan duct. (30 cm scale)

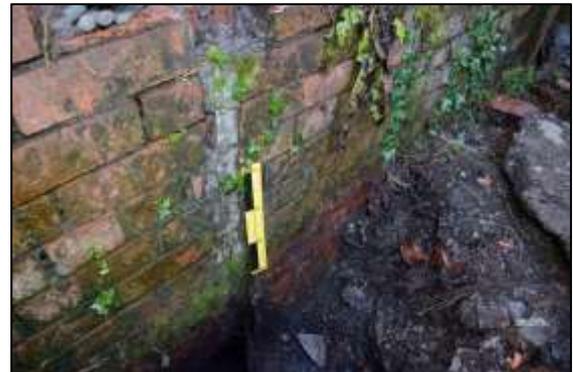
58) in that (southern) wall, and there is a mark on the opposite wall where it must have hit when closing the northern duct. The northern duct has been cleared of spoil, revealing a sloped bottom (photo 59). Photo 60 has been taken from the other direction to 59, and it shows the end wall of the slope. The bottom two courses of bricks have been laid on their edges. Spoil clearance outside and to the north of the ducts, at a position marked on photo 61, has uncovered two square engine beds (photo right). Adjacent to them is a length of armoured power cable. An 8½" long glass bottle, marked 'Holbrook & Co' was found in this area (photo 62). Spoil clearance outside the fence has uncovered what may be the position of the fan. A curved brick built structure has been found under the ground level, aligned with the engine bed found in 2013. Work here is continuing, so no photos are currently available.

Photo 58 – The damper in photo X closed against this cement seat in the southern wall of the duct. (30 cm scale)

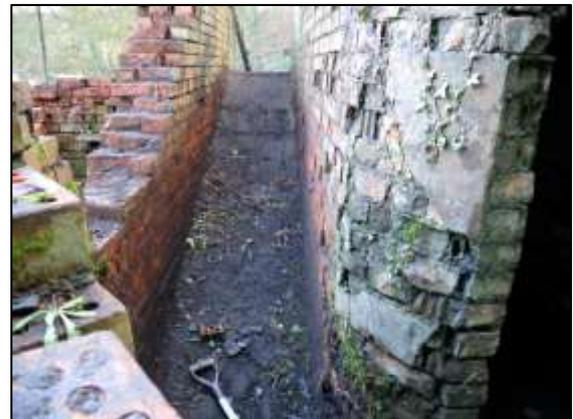
Photo 59 – The sloping floor of the northern fan duct, viewed from the heapstead end of the duct.

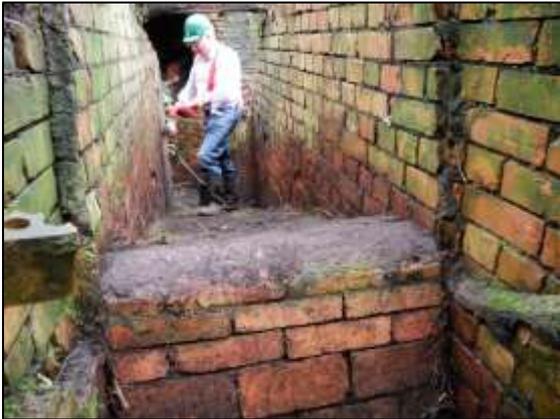
Photo 60 – The northern fan duct, looking towards the heapstead.

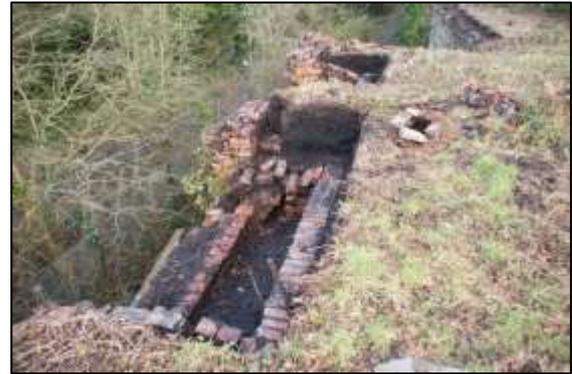
The masons stripped back the ivy and other shrubs growing along the top of the Old Pit heapstead walls so that the tops of the walls could be capped at a later date. This uncovered two structures (photos 63 and 64) that were probably tippler slots for loading railway wagons and these were investigated by the volunteers. One artefact found here was part of a spoken wheel, probably from a coal tub (photo 65). Cleaning off-site separated it into two pieces, the remains of the wheel and an unrelated piece of bent pipe. This area is still being investigated.

Photo 63 – View of the southern tippler slot on the Old Pit heapstead, with the northern slot at the top of the picture.

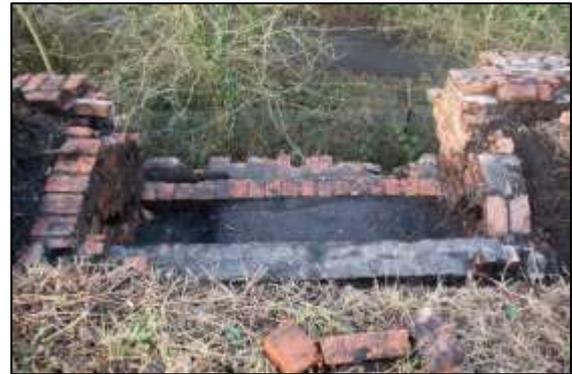
Photo 64 – View of the northern tippler slot.

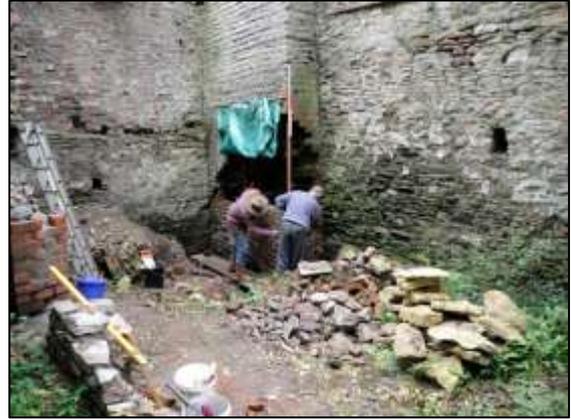
Photo 69 – An early stage in the rebuilding of the base of the chimney.
